**Hazard Identification Assessment Report
Woodsreef Mine Major Rehabilitation Project
NSW Trade and Investment
Division of Resources & Energy**

Report Number 610.10893.00030

1 December 2014

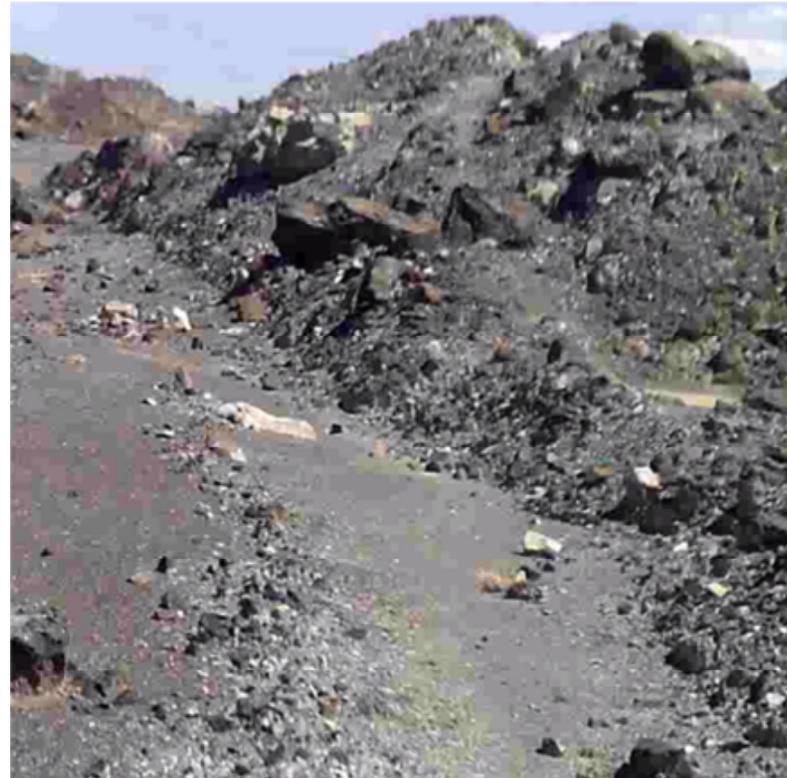
Waste / Overburden		Sample No 610.10893.00030/13
Site Observations		
Location	South of south dump adjacent to road, overburden	
GPS	282041 (Northing), 6633842 (Easting)	
Visual Findings	Crusting sediment	
Crusting (Soft, Medium, Hard)	Soft along road	
Migration Path	Off site	
Laboratory Analysis		
Whole Sample Description	light grey soil, rocks	
Asbestos Presence Fraction < 2mm	Chrysotile	
Asbestos Description Fraction < 2mm	Bundles	
% Asbestos (vol/vol approx.)	20%	
Trace Asbestos	Present	
Hazard Assessment	High

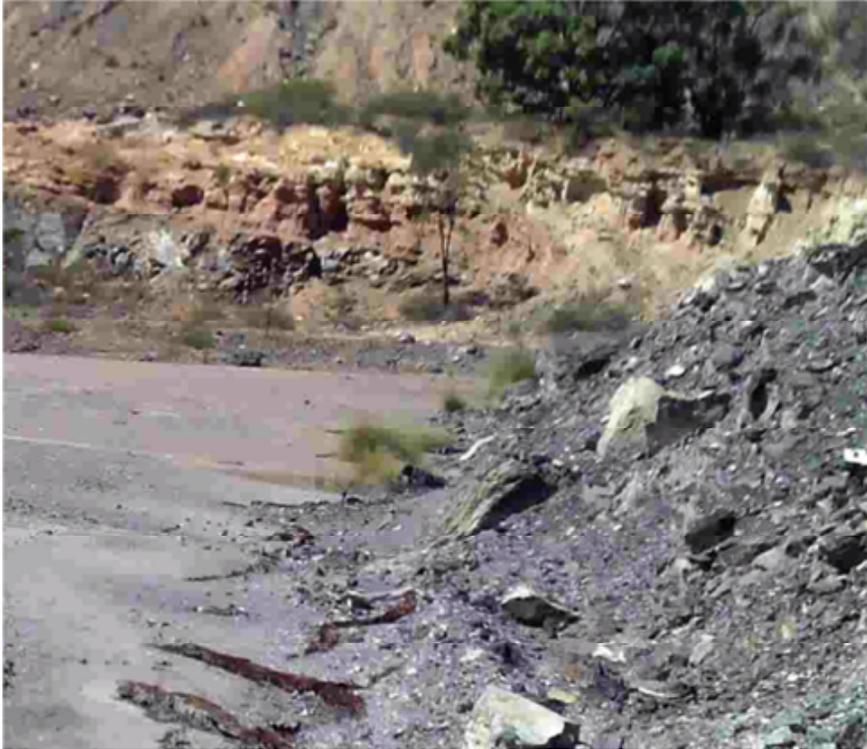
Waste / Overburden		Sample No 610.10893.00030/14	
Site Observations			
Location	South of south dump, east end of internal road on Waste/Overburden

GPS	282237 (Northing), 6633901 (Easting)		
Visual Findings	Soil		
Crusting (Soft, Medium, Hard)	Soft along road		
Migration Path	Off site		
Laboratory Analysis			
Whole Sample Description	light brown soil, rocks and organic material		
Asbestos Presence Fraction < 2mm	Chrysotile		
Asbestos Description Fraction < 2mm	Bundles		
% Asbestos (vol/vol approx.)	1%		
Trace Asbestos	Present		
Hazard Assessment	High

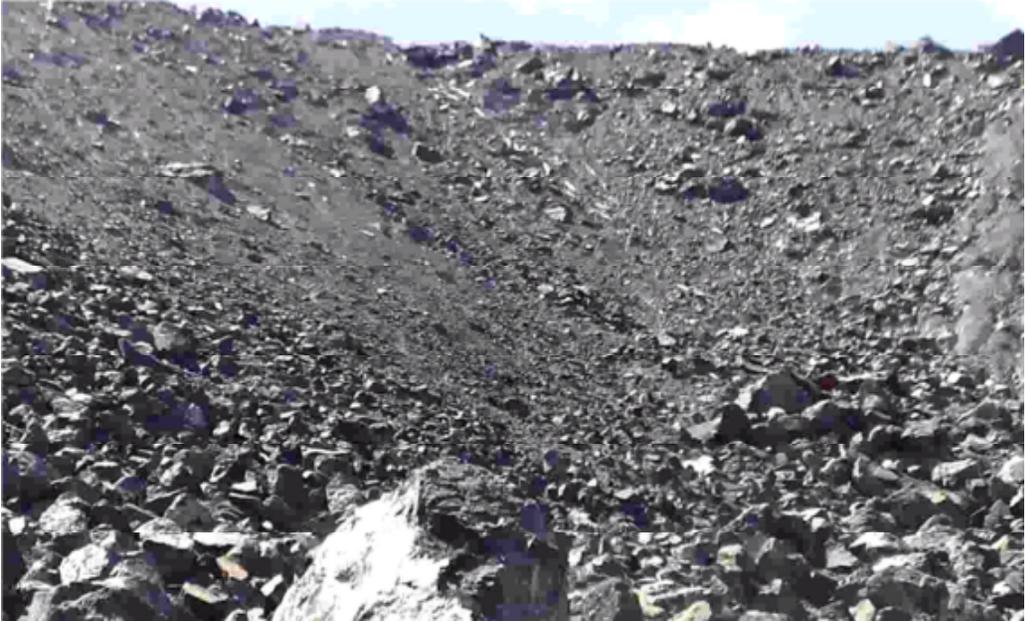
Waste / Overburden		Sample No 610.10893.00030/40
Site Observations		
Location	SW of south overburden

GPS	281987 (Northing), 6633007 (Easting)	
Visual Findings	Runoff soil	
Crusting (Soft, Medium, Hard)	Soft, fibres present	
Migration Path	Off site	
Laboratory Analysis		
Whole Sample Description	dark grey soil and rocks	
Asbestos Presence Fraction < 2mm	Chrysotile	
Asbestos Description Fraction < 2mm	Bundles	
% Asbestos (vol/vol approx.)	<0.1%	
Trace Asbestos	Absent	
Hazard Assessment	High

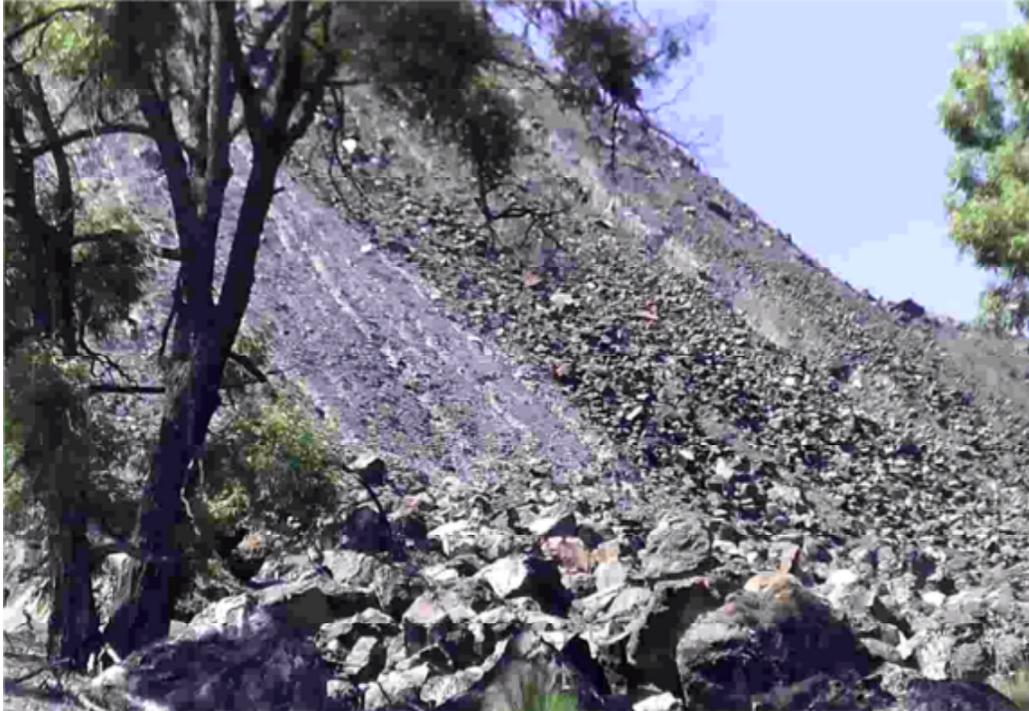
Waste / Overburden		Sample No 610.10893.00030/41
Site Observations		
Location	South central south overburden rock fall

GPS	281832 (Northing), 6632978 (Easting)	
Visual Findings	Rock material	
Crusting (Soft, Medium, Hard)	Soft, fibres present in fencing	
Migration Path	Off site	
Laboratory Analysis		
Whole Sample Description	light grey material, crusts and plant debris	
Asbestos Presence Fraction < 2mm	Chrysotile	
Asbestos Description Fraction < 2mm	Fibrous masses	
% Asbestos (vol/vol approx.)	90%	
Trace Asbestos	Present	
Hazard Assessment	Very High

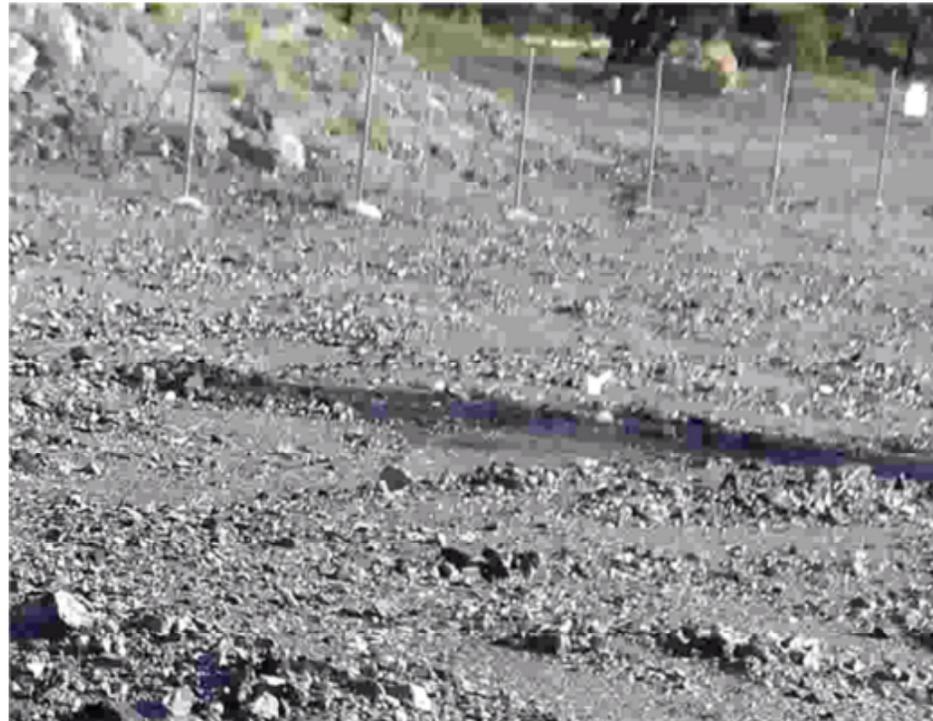
Road cuttings		Sample No 610.10893.00030/23
Site Observations		
Location	NE mine, south side road near manmade mound	
GPS	282236 (Northing), 6635160 (Easting)	
Visual Findings	Chrysotile	
Crusting (Soft, Medium, Hard)	No crusting, sediment trap	
Migration Path	Off site	
Laboratory Analysis		
Whole Sample Description	grey brown soil and rocks	
Asbestos Presence Fraction < 2mm	Chrysotile	
Asbestos Description Fraction < 2mm	Bundles	
% Asbestos (vol/vol approx.)	1%	
Trace Asbestos	Absent	
Hazard Assessment	High

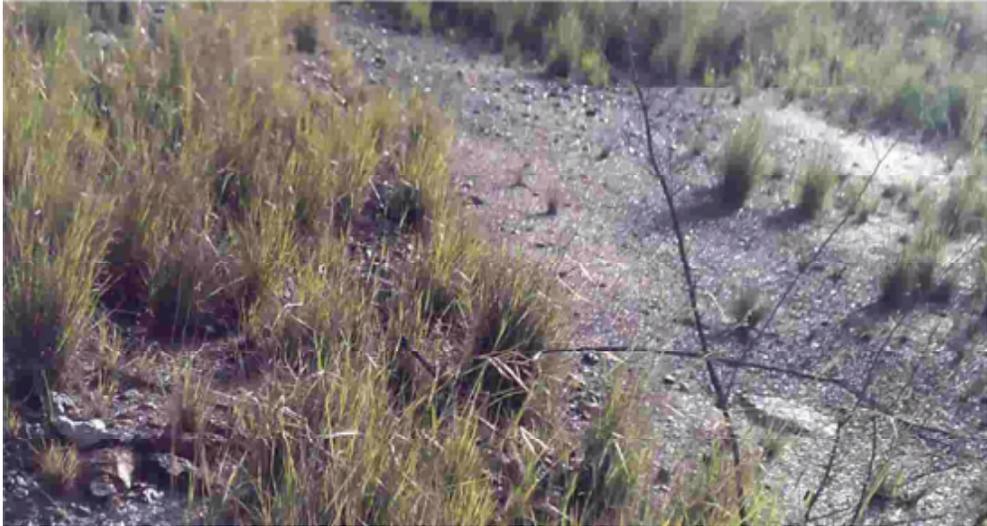
Road cuttings		Sample No 610.10893.00030/25
Site Observations		
Location	Corner of Mine Road and the Woodsreet Road

GPS	282959 (Northing), 6635333 (Easting)	
Visual Findings	Overburden material, soil rock	
Crusting (Soft, Medium, Hard)	Soft, no crusting	
Migration Path	Off site	
Laboratory Analysis		
Whole Sample Description	light grey soil and rocks	
Asbestos Presence Fraction < 2mm	Chrysotile	
Asbestos Description Fraction < 2mm	Bundles	
% Asbestos (vol/vol approx.)	0.5%	
Trace Asbestos	Present	
Hazard Assessment	High

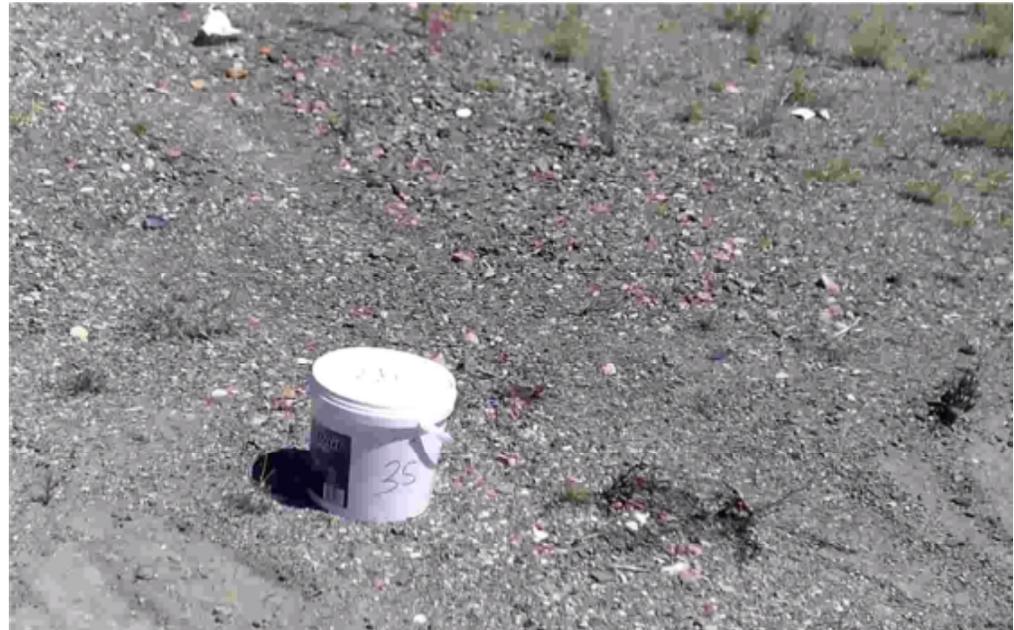
Road cuttings		Sample No 610.10893.00030/35
Site Observations		
Location	Entrance to tailings, runoff east of road	
GPS	282837 (Northing), 6634019 (Easting)	
Visual Findings	Road base soil	
Crusting (Soft, Medium, Hard)	Medium	
Migration Path	On site	
Laboratory Analysis		
Whole Sample Description	light brown/grey material, fibrous masses	
Asbestos Presence Fraction < 2mm	Chrysotile	
Asbestos Description Fraction < 2mm	Fibrous masses	
% Asbestos (vol/vol approx.)	40%	
Trace Asbestos	Present	
Hazard Assessment	Medium

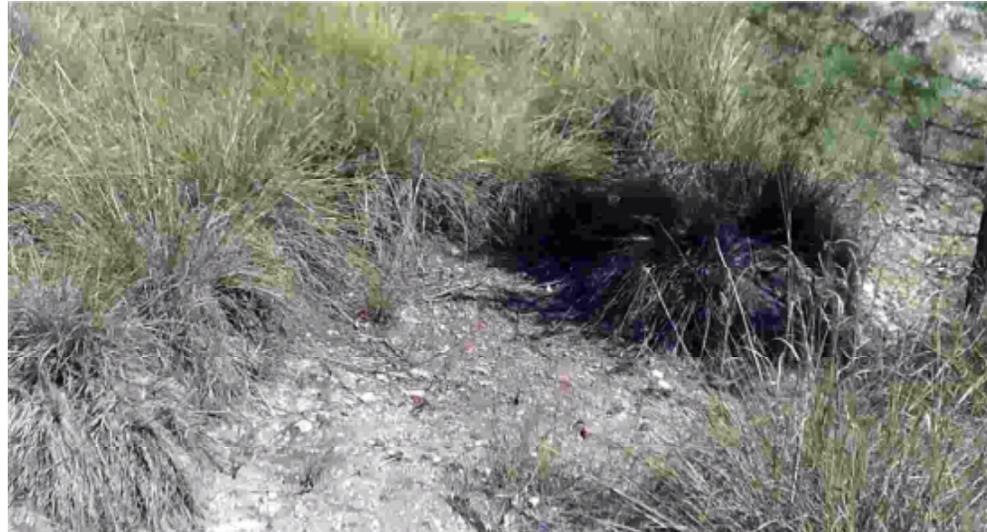
Road cuttings		Sample No 610.10893.00030/39
Site Observations		
Location	East of road near south end	
GPS	282623 (Northing), 6633224 (Easting)	
Visual Findings	Soil	
Crusting (Soft, Medium, Hard)	Soft, unprocessed rock	
Migration Path	Off site	
Laboratory Analysis		
Whole Sample Description	light brown/grey material and crusts	
Asbestos Presence Fraction < 2mm	Chrysotile	
Asbestos Description Fraction < 2mm	Fibrous masses	
% Asbestos (vol/vol approx.)	70%	
Trace Asbestos	Present	
Hazard Assessment	Very High

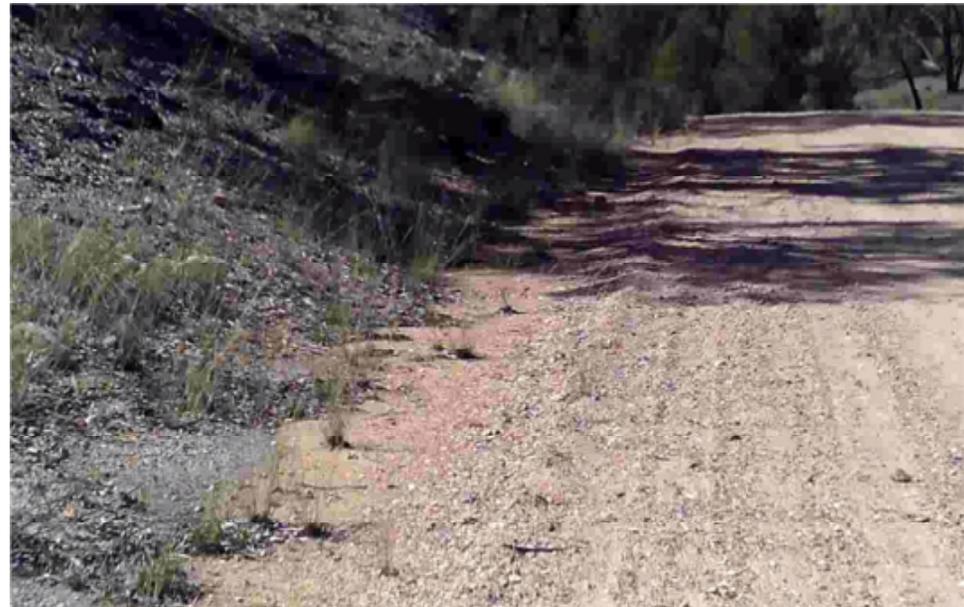
Road cuttings		Sample No 610.10893.00030/42
Site Observations		
Location	West side of Mine Road midway	
GPS	282986 (Northing), 6634256 (Easting)	
Visual Findings	Rock material	
Crusting (Soft, Medium, Hard)	Soft, fibres present in fencing	
Migration Path	On site	
Laboratory Analysis		
Whole Sample Description	grey brown soil and rocks	
Asbestos Presence Fraction < 2mm	Chrysotile	
Asbestos Description Fraction < 2mm	Bundles	
% Asbestos (vol/vol approx.)	<0.1%	
Trace Asbestos	Present	
Hazard Assessment	Medium

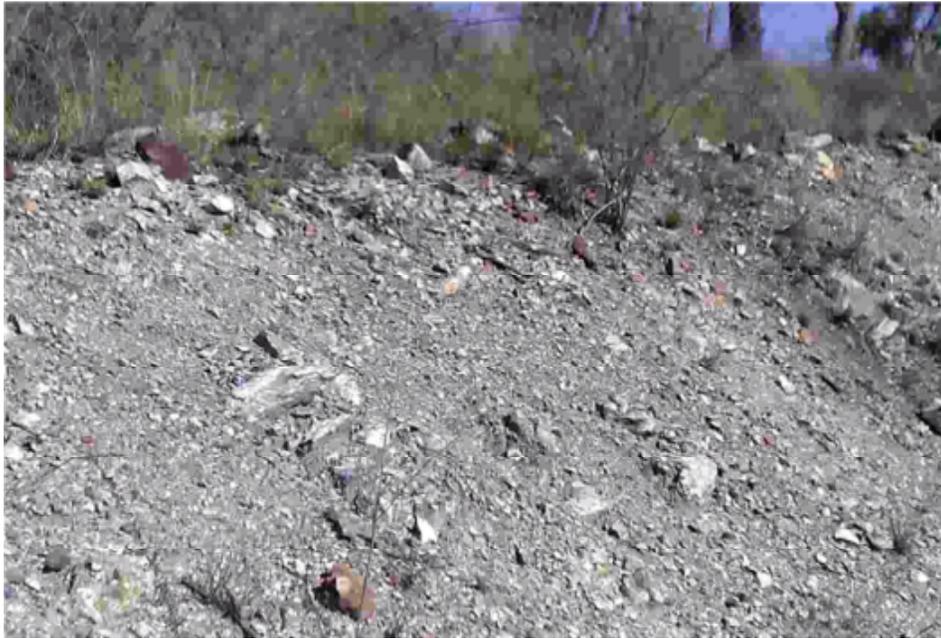
Road cuttings		Sample No 610.10893.00030/46
Site Observations		
Location	East side of Mine Road north near intersection

GPS	283199 (Northing), 6634780 (Easting)	
Visual Findings	Overburden waste material	
Crusting (Soft, Medium, Hard)	Soft, migration in rockfall - water runoff	
Migration Path	On site	
Laboratory Analysis		
Whole Sample Description	rocks, and soil	
Asbestos Presence Fraction < 2mm	Chrysotile	
Asbestos Description Fraction < 2mm	Bundles	
% Asbestos (vol/vol approx.)	<0.1%	
Trace Asbestos	Present	
Hazard Assessment	Medium

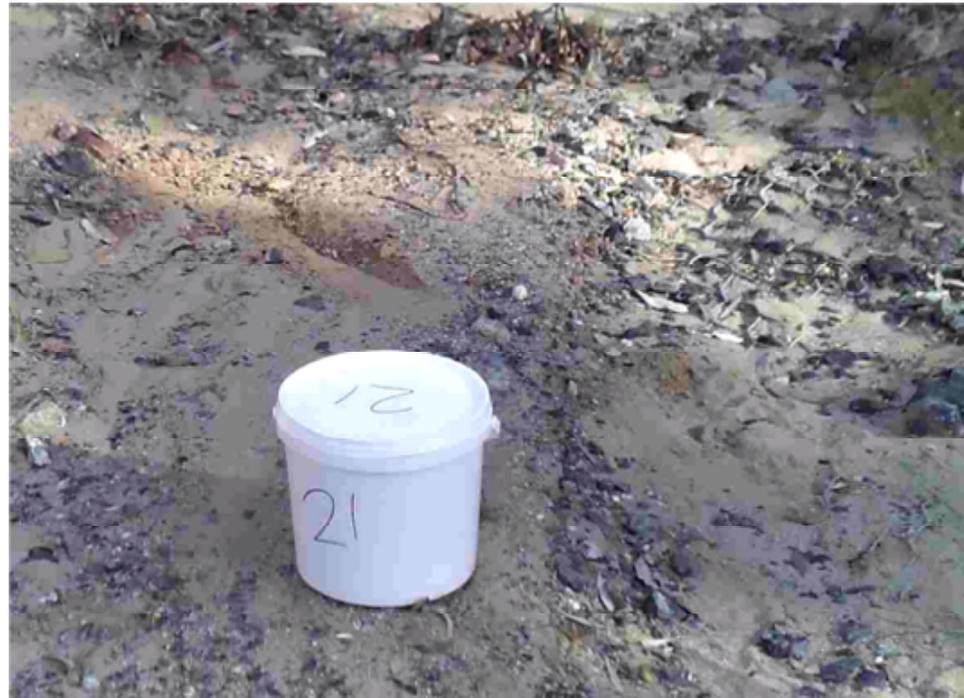
Siltation systems sediments		Sample No 610.10893.00030/21
Site Observations		
Location	Culvert 3, north of west dump	
GPS	281819 (Northing), 6634942 Easting)	
Visual Findings	Riverbed (sand/gravel)	
Crusting (Soft, Medium, Hard)	No crusting	
Migration Path	Off site	
Laboratory Analysis		
Whole Sample Description	sandy soil, rocks organic material	
Asbestos Presence Fraction < 2mm	Chrysotile	
Asbestos Description Fraction < 2mm	Bundles	
% Asbestos (vol/vol approx.)	<0.1%	
Trace Asbestos	Absent	
Hazard Assessment	High

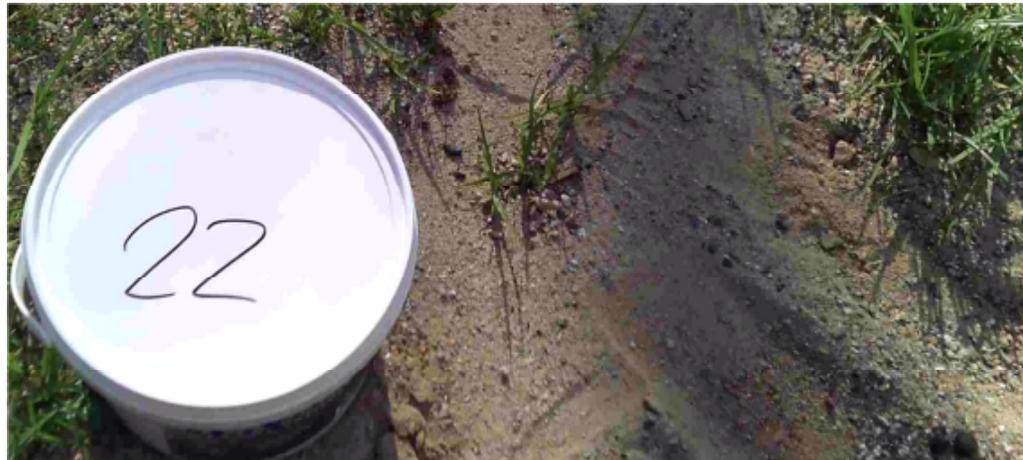
Siltation systems sediments	Sample No 610.10893.00030/22
Site Observations	
Location	Culvert 2 area upstream, east
GPS	281962 (Northing), 6634956 (Easting)
Visual Findings	Soil, sediment wash
Crusting (Soft, Medium, Hard)	Soft, collect from culvert
Migration Path	Off site
Laboratory Analysis	
Whole Sample Description	sandy soil and rocks
Asbestos Presence Fraction < 2mm	Absent
Asbestos Description Fraction < 2mm	-
% Asbestos (vol/vol approx.)	0%
Trace Asbestos	Absent
Hazard Assessment	Medium

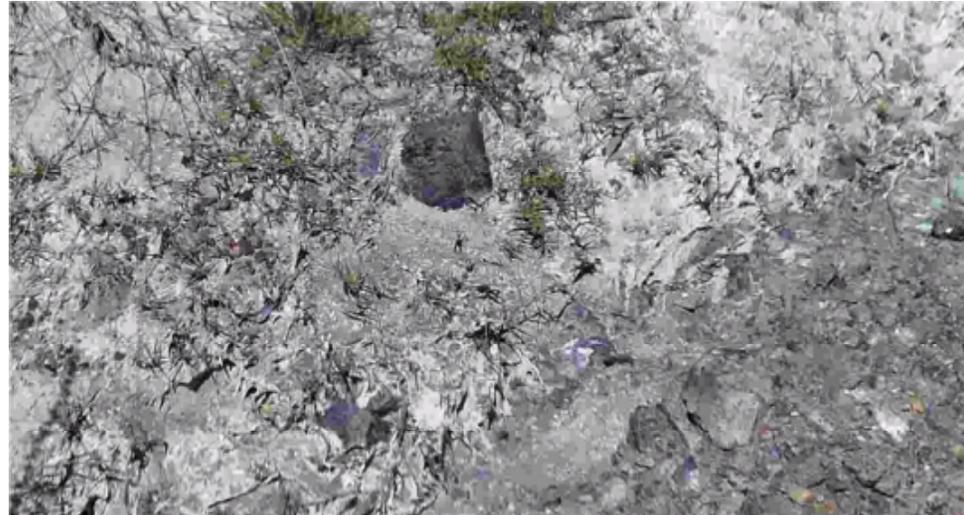
Siltation systems sediments		Sample No 610.10893.00030/36
Site Observations		
Location	Culvert to east of road	
GPS	282708 (Northing), 6633634 (Easting)	
Visual Findings	Tailings runoff	
Crusting (Soft, Medium, Hard)	Soft	
Migration Path	Off site	
Laboratory Analysis		
Whole Sample Description	light grey material, crusts and plant debris	
Asbestos Presence Fraction < 2mm	Chrysotile	
Asbestos Description Fraction < 2mm	Fibrous masses	
% Asbestos (vol/vol approx.)	40%	
Trace Asbestos	Present	
Hazard Assessment	Very High

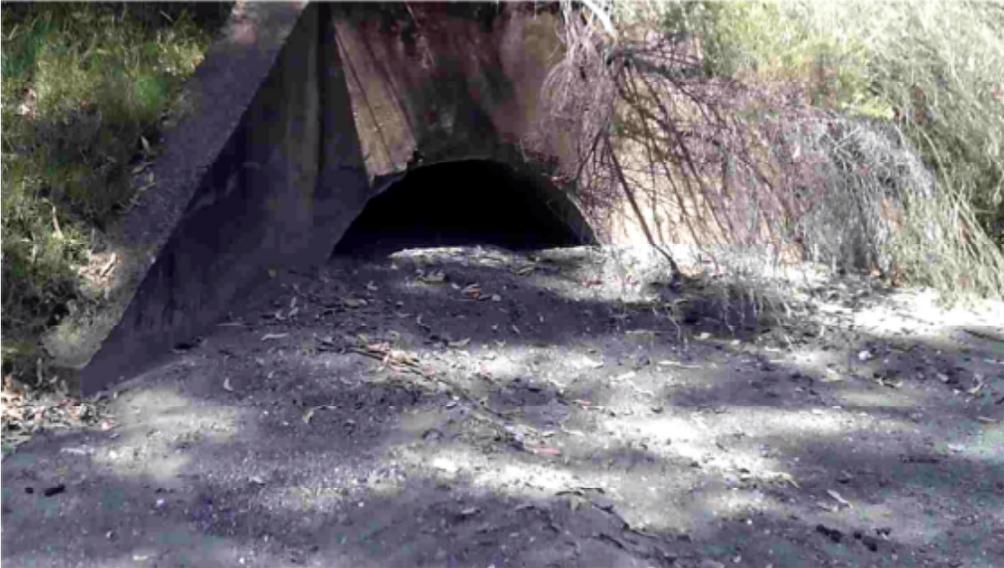
Siltation systems sediments		Sample No 610.10893.00030/37
Site Observations		
Location	Culvert to west of road

GPS	282694 (Northing), 6633640 (Easting)	
Visual Findings	Tailings soil	
Crusting (Soft, Medium, Hard)	Medium	
Migration Path	Off site	
Laboratory Analysis		
Whole Sample Description	grey /blue gravel, grey crusts	
Asbestos Presence Fraction < 2mm	Chrysotile	
Asbestos Description Fraction < 2mm	Bundles	
% Asbestos (vol/vol approx.)	1%	
Trace Asbestos	Absent	
Hazard Assessment	Medium

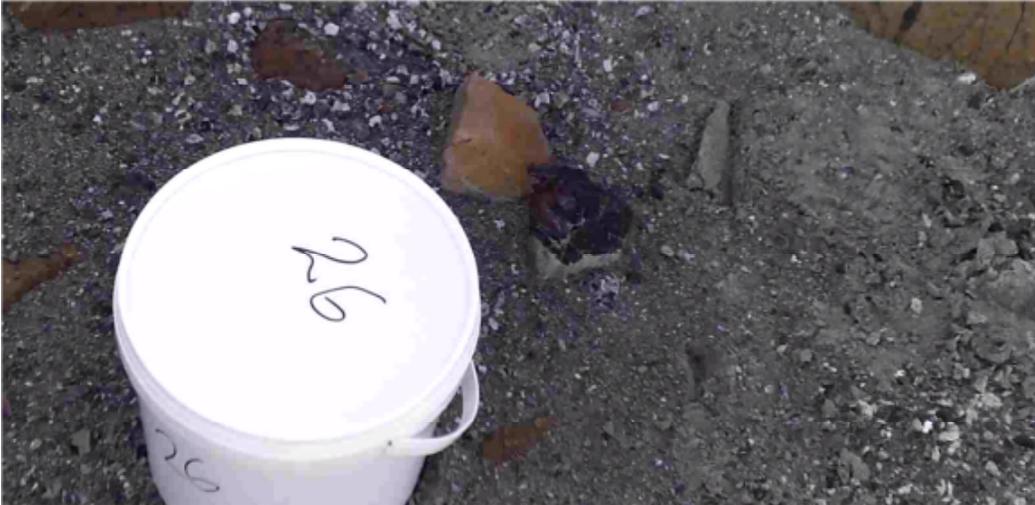
Tailings		Sample No 610.10893.00030/26
Site Observations		
Location	West side tailings east of Crow Mountain Road, conveyor belt

GPS	282819 (Northing), 6633875 (Easting)	
Visual Findings	Soil runoff	
Crusting (Soft, Medium, Hard)	Soft, unprocessed rock material also present	
Migration Path	Off site	
Laboratory Analysis		
Whole Sample Description	light grey material, crusts and rocks	
Asbestos Presence Fraction < 2mm	Chrysotile	
Asbestos Description Fraction < 2mm	Fibrous masses	
% Asbestos (vol/vol approx.)	95%	
Trace Asbestos	Present	
Hazard Assessment	Very High

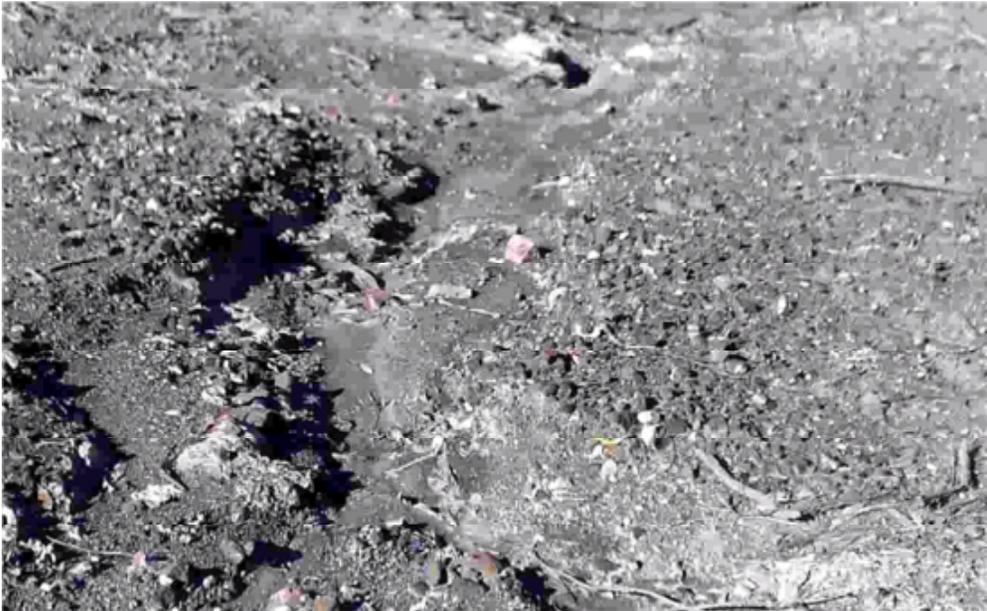
Tailings		Sample No 610.10893.00030/27
Site Observations		
Location	Midway along tailings east of Mountain Road

GPS	282713 (Northing), 6633506 (Easting)	
Visual Findings	Tailings soil	
Crusting (Soft, Medium, Hard)	Soft, hard- pebble/ rock	
Migration Path	Off site	
Laboratory Analysis		
Whole Sample Description	light grey material, crusts and rocks	
Asbestos Presence Fraction < 2mm	Chrysotile	
Asbestos Description Fraction < 2mm	Fibrous masses	
% Asbestos (vol/vol approx.)	2%	
Trace Asbestos	Present	
Hazard Assessment	Very High

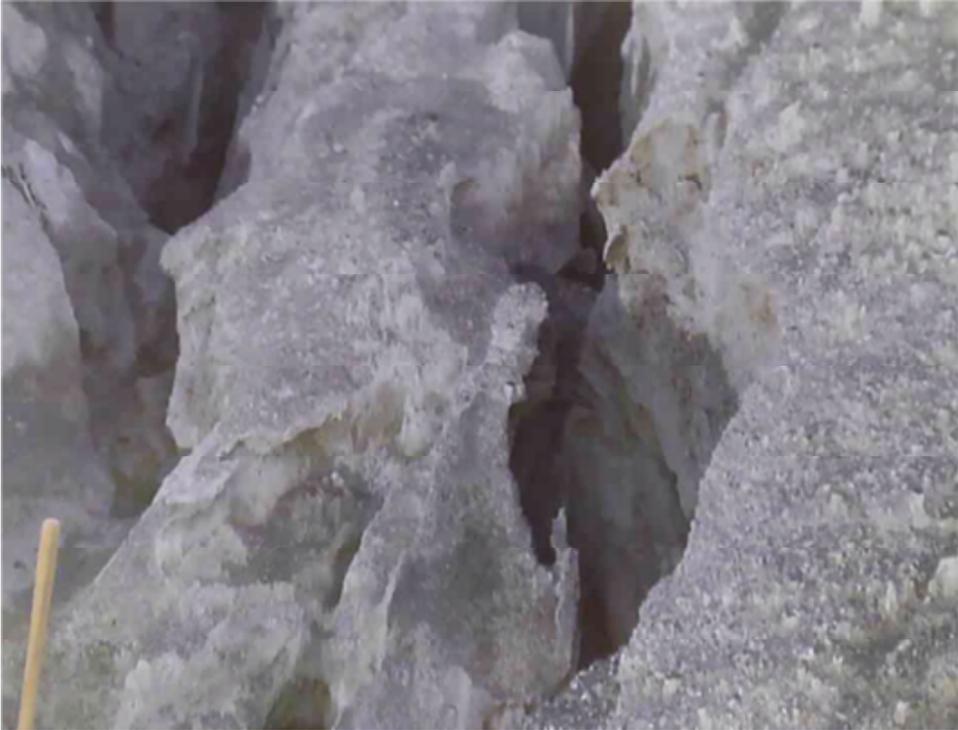
Tailings		Sample No 610.10893.00030/28
Site Observations		
Location	South end tailing, midway adjacent drainage area

GPS	282750 (Northing), 6632917 (Easting)	
Visual Findings	Tailings soil	
Crusting (Soft, Medium, Hard)	Soft, crusted surface	
Migration Path	Off site	
Laboratory Analysis		
Whole Sample Description	light grey material, crusts and rocks	
Asbestos Presence Fraction < 2mm	Chrysotile	
Asbestos Description Fraction < 2mm	Bundles	
% Asbestos (vol/vol approx.)	<0.1%	
Trace Asbestos	Present	
Hazard Assessment	High

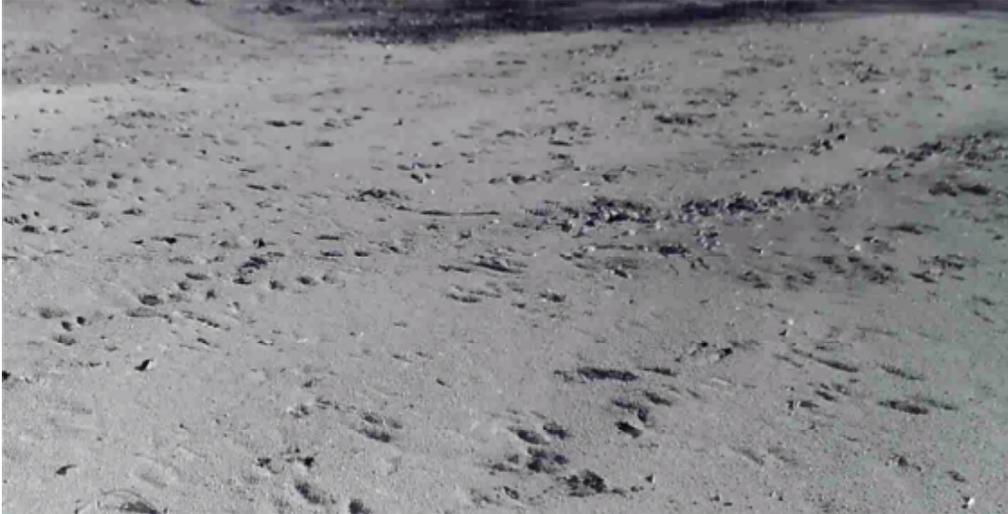
Tailings		Sample No 610.10893.00030/29
Site Observations		
Location	East side of tailing basin south between hills

GPS	283046 (Northing), 6633083 (Easting)	
Visual Findings	Tailings soil	
Crusting (Soft, Medium, Hard)	Soft, hard - rocky surface	
Migration Path	Off site	
Laboratory Analysis		
Whole Sample Description	light grey material, crusts	
Asbestos Presence Fraction < 2mm	Chrysotile	
Asbestos Description Fraction < 2mm	Bundles	
% Asbestos (vol/vol approx.)	80%	
Trace Asbestos	Present	
Hazard Assessment	Very High

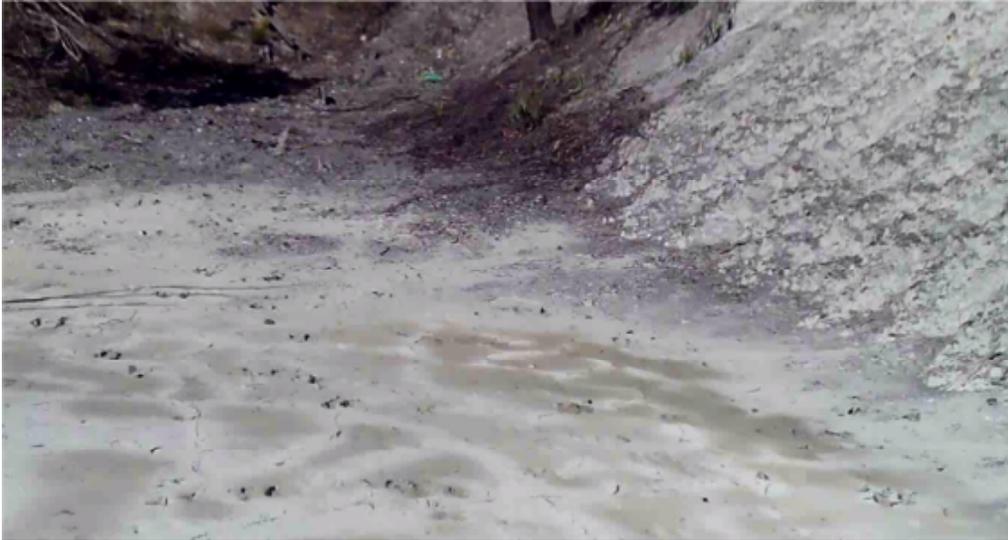
Tailings		Sample No 610.10893.00030/30
Site Observations		
Location	East side of tailing, midway basin

GPS	283150 (Northing), 6633290 (Easting)	
Visual Findings	Tailings runoff	
Crusting (Soft, Medium, Hard)	Soft, with fines	
Migration Path	Off site	
Laboratory Analysis		
Whole Sample Description	light grey material, crusts	
Asbestos Presence Fraction < 2mm	Chrysotile	
Asbestos Description Fraction < 2mm	Bundles	
% Asbestos (vol/vol approx.)	70%	
Trace Asbestos	Present	
Hazard Assessment	Very High

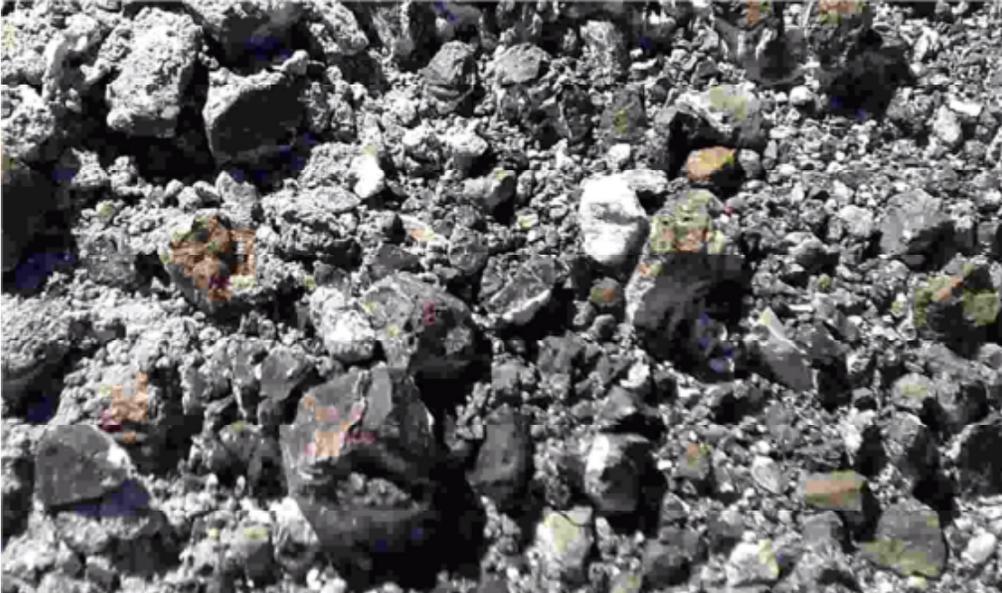
Tailings		Sample No 610.10893.00030/32
Site Observations		
Location	Top of tailings, north of telegraph pole

GPS	282981 (Northing), 6633843 (Easting)	
Visual Findings	Chrysotile	
Crusting (Soft, Medium, Hard)	Soft, fines - rocks smaller	
Migration Path	On site	
Laboratory Analysis		
Whole Sample Description	grey brown soil and rocks	
Asbestos Presence Fraction < 2mm	Chrysotile	
Asbestos Description Fraction < 2mm	Bundles	
% Asbestos (vol/vol approx.)	10%	
Trace Asbestos	Present	
Hazard Assessment	High

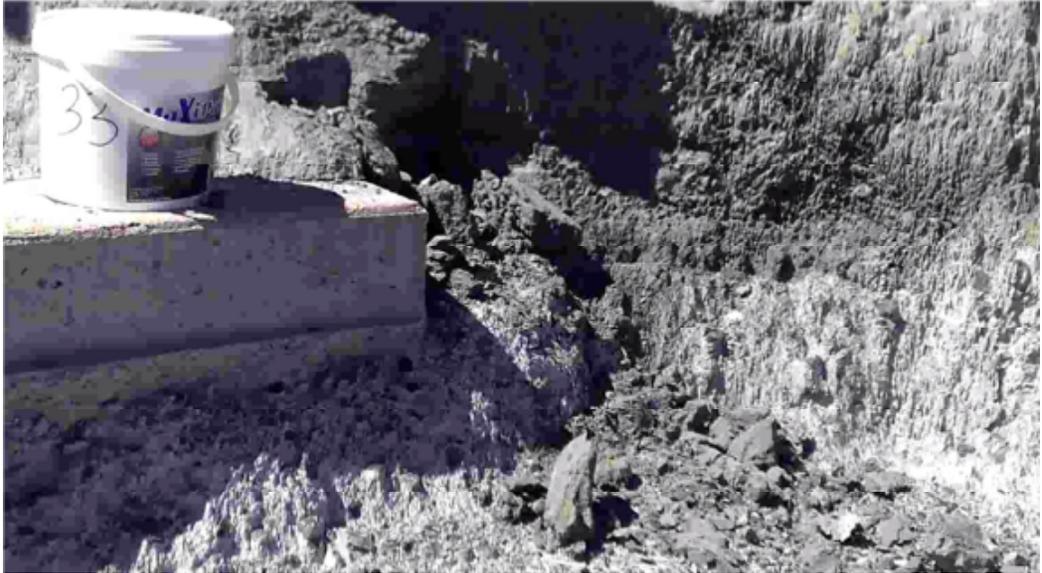
Tailings		Sample No 610.10893.00030/33
Site Observations		
Location	Top of tailings, near old building rubble

GPS	282994 (Northing), 6633737 (Easting)	
Visual Findings	Friable	
Crusting (Soft, Medium, Hard)	Soft, crusting pebbles	
Migration Path	Off site	
Laboratory Analysis		
Whole Sample Description	light grey material, crusts and plant debris	
Asbestos Presence Fraction < 2mm	Chrysotile	
Asbestos Description Fraction < 2mm	Fibrous masses	
% Asbestos (vol/vol approx.)	<0.1%	
Trace Asbestos	Present	
Hazard Assessment	High

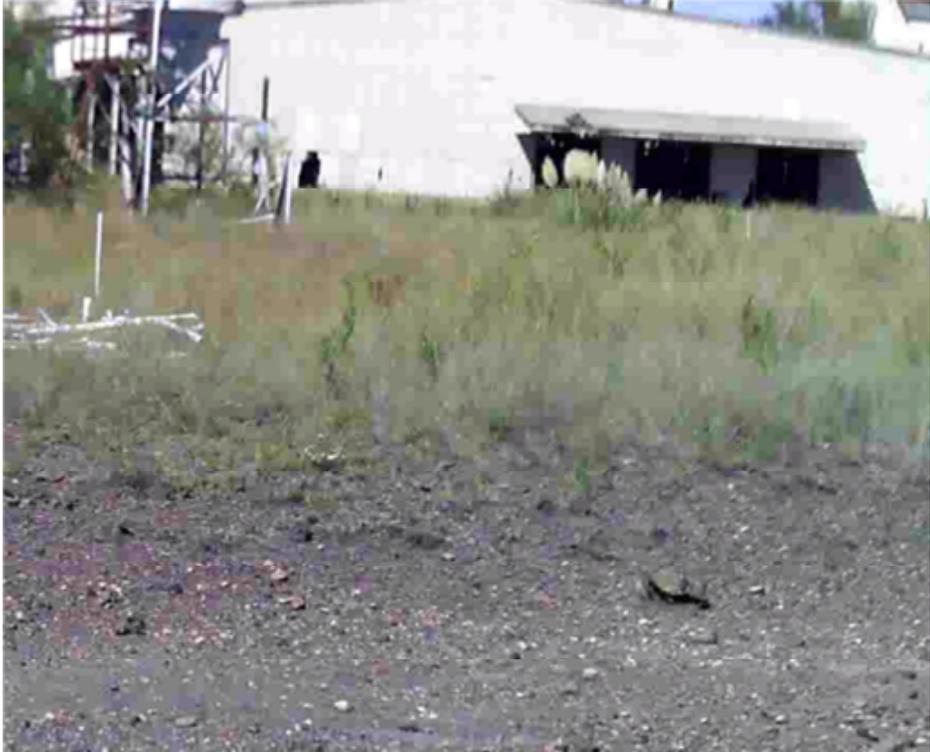
Mill Building Vicinity		Sample No 610.10893.00030/5
Site Observations		
Location	NE adjacent road to silos

GPS	282790 (Northing), 6634152 (Easting)	
Visual Findings	Soil Detritus	
Crusting (Soft, Medium, Hard)	Soft	
Migration Path	On site	
Laboratory Analysis		
Whole Sample Description	dark brown soil	
Asbestos Presence Fraction < 2mm	Chrysotile	
Asbestos Description Fraction < 2mm		
% Asbestos (vol/vol approx.)	<0.1%	
Trace Asbestos	Absent	
Hazard Assessment	High

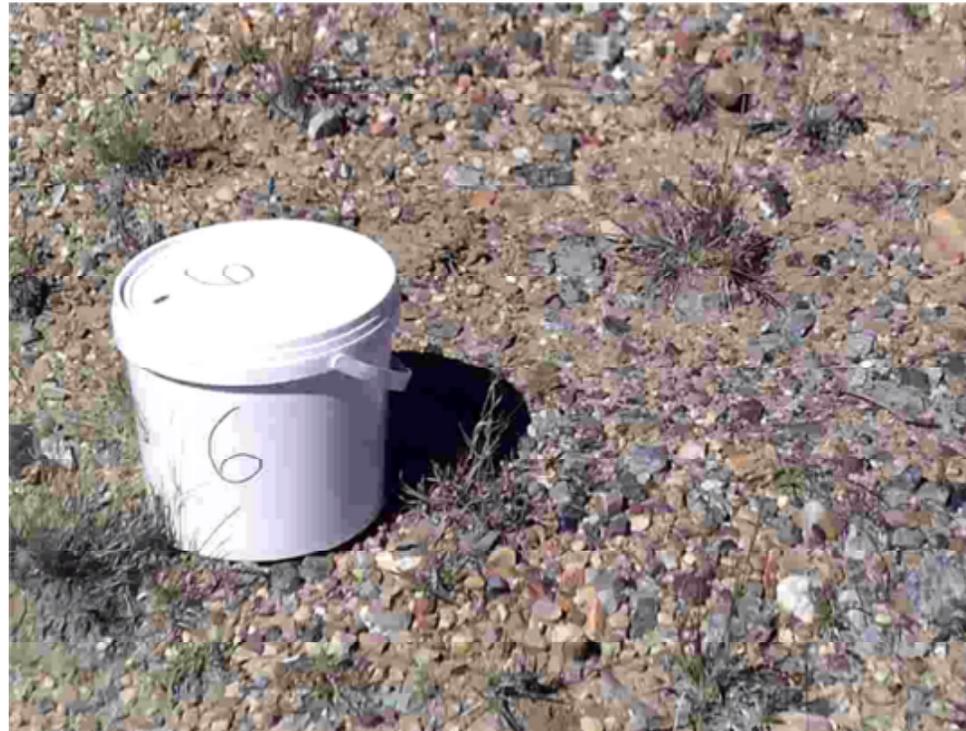
Mill Building Vicinity		Sample No 610.10893.00030/6
Site Observations		
Location	NE of silo, adjacent to Northern Pit	
GPS	282764 (Northing), 6634235 (Easting)	
Visual Findings	Soil Detritus	
Crusting (Soft, Medium, Hard)	None - rock	
Migration Path	On site	
Laboratory Analysis		
Whole Sample Description	light brown soil, rocks and organic material	
Asbestos Presence Fraction < 2mm	Chrysotile	
Asbestos Description Fraction < 2mm	Bundles	
% Asbestos (vol/vol approx.)	<0.1%	
Trace Asbestos	Absent	
Hazard Assessment	High

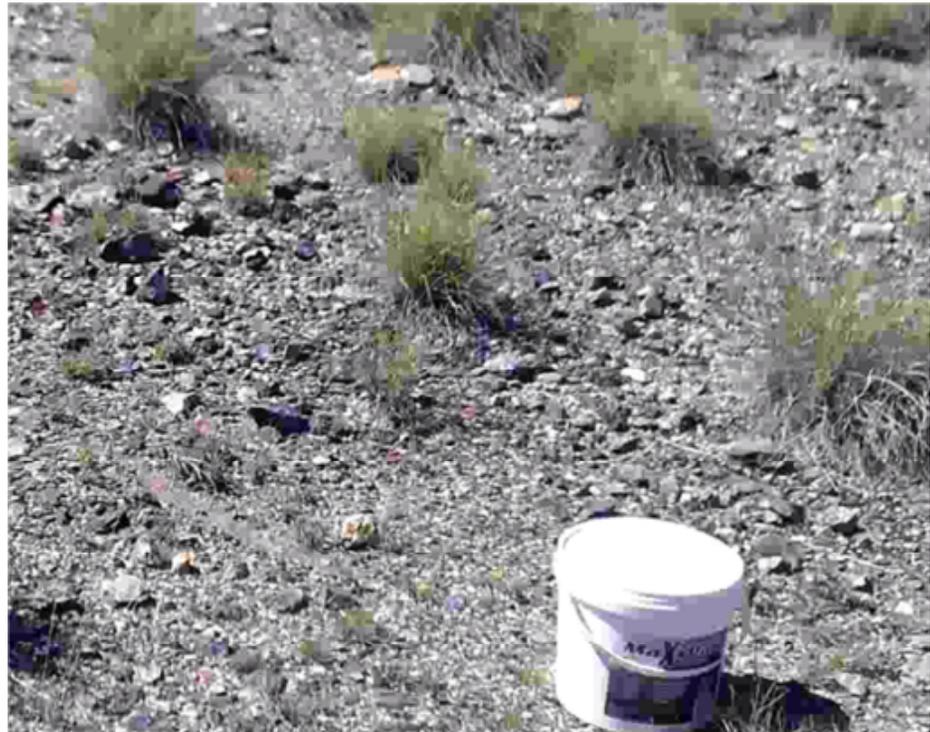
Mill Building Vicinity		Sample No 610.10893.00030/7
Site Observations		
Location	NW of silo adjacent to Centre Pit	
GPS	282547 (Northing), 6634144 (Easting)	
Visual Findings	Soil	
Crusting (Soft, Medium, Hard)	Hard pebble surface	
Migration Path	On site	
Laboratory Analysis		
Whole Sample Description	light brown soil, rocks and organic material	
Asbestos Presence Fraction < 2mm	Chrysotile	
Asbestos Description Fraction < 2mm		
% Asbestos (vol/vol approx.)	<0.1%	
Trace Asbestos	Absent	
Hazard Assessment	Medium

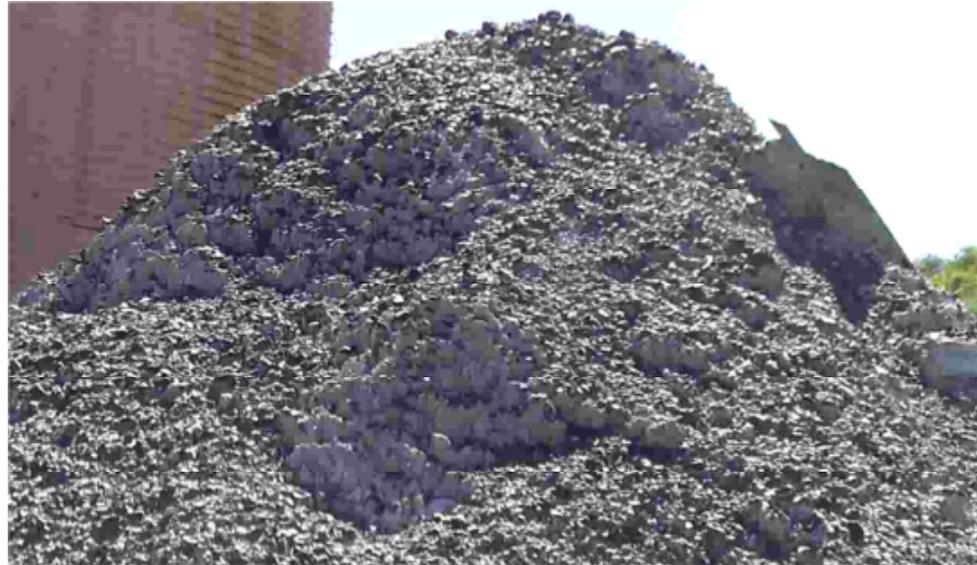
Mill Building Vicinity	Sample No 610.10893.00030/8
Site Observations	
Location	Silos, south of stockpile
GPS	282635 (Northing), 6634135 (Easting)
Visual Findings	Soil
Crusting (Soft, Medium, Hard)	Hard
Migration Path	On site
Laboratory Analysis	
Whole Sample Description	light grey soil, rocks and organic material
Asbestos Presence Fraction < 2mm	Chrysotile
Asbestos Description Fraction < 2mm	Bundles
% Asbestos (vol/vol approx.)	70%
Trace Asbestos	Present
Hazard Assessment	High

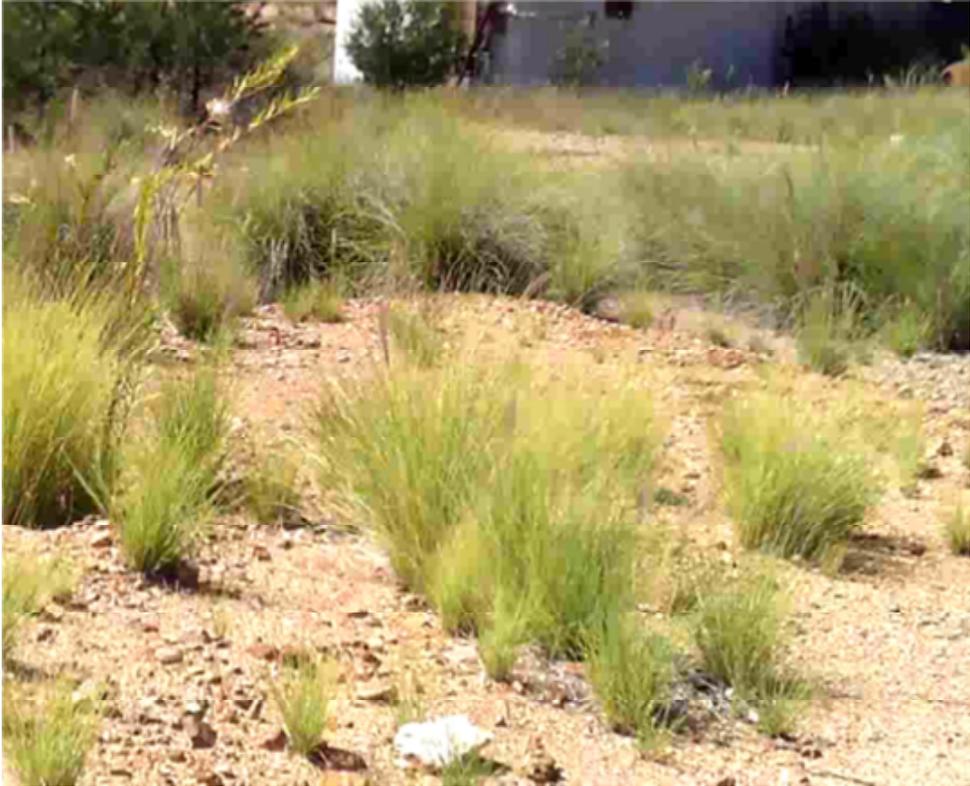
Mill Building Vicinity		Sample No 610.10893.00030/9
Site Observations		
Location	West of main building, adjacent to old water tank

GPS	282583 (Northing), 6634031 (Easting)	
Visual Findings	Stockpile debris	
Crusting (Soft, Medium, Hard)	Pebble crusting, soft	
Migration Path	Off site	
Laboratory Analysis		
Whole Sample Description	light brown soil, rocks and organic material	
Asbestos Presence Fraction < 2mm	Chrysotile	
Asbestos Description Fraction < 2mm	Bundles	
% Asbestos (vol/vol approx.)	<0.1%	
Trace Asbestos	Absent	
Hazard Assessment	Low

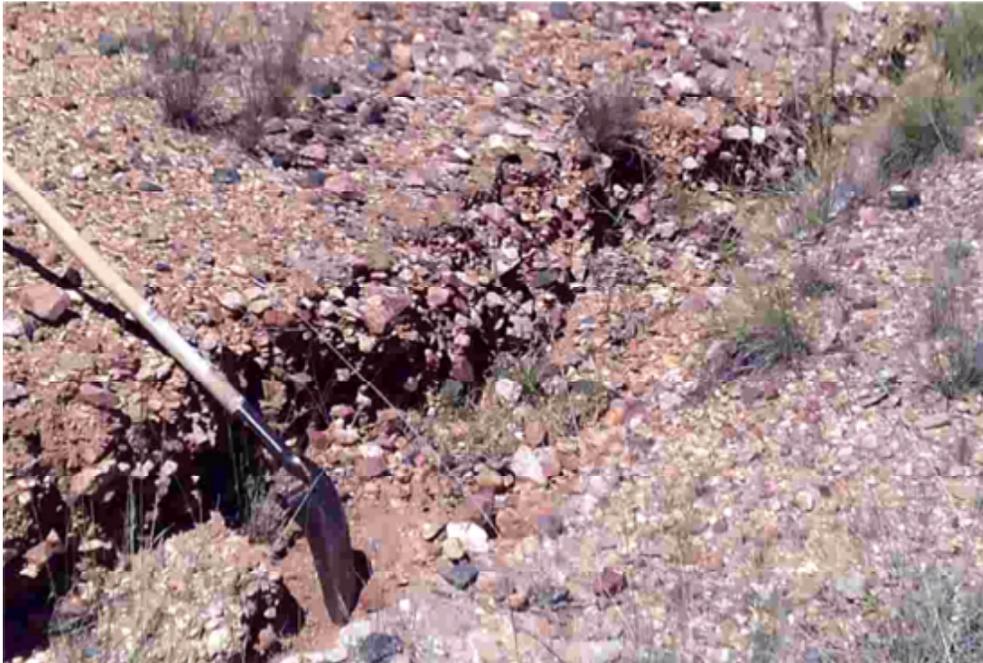
Mill Building Vicinity		Sample No 610.10893.00030/10
Site Observations		
Location	Emplacement area, SE

GPS	282505 (Northing), 6633883 (Easting)	
Visual Findings	Soil	
Crusting (Soft, Medium, Hard)	Hard, pebbly	
Migration Path	Off site	
Laboratory Analysis		
Whole Sample Description	orange brown soil and rocks	
Asbestos Presence Fraction < 2mm	Chrysotile	
Asbestos Description Fraction < 2mm	Bundles	
% Asbestos (vol/vol approx.)	<0.1%	
Trace Asbestos	Absent	
Hazard Assessment	Low

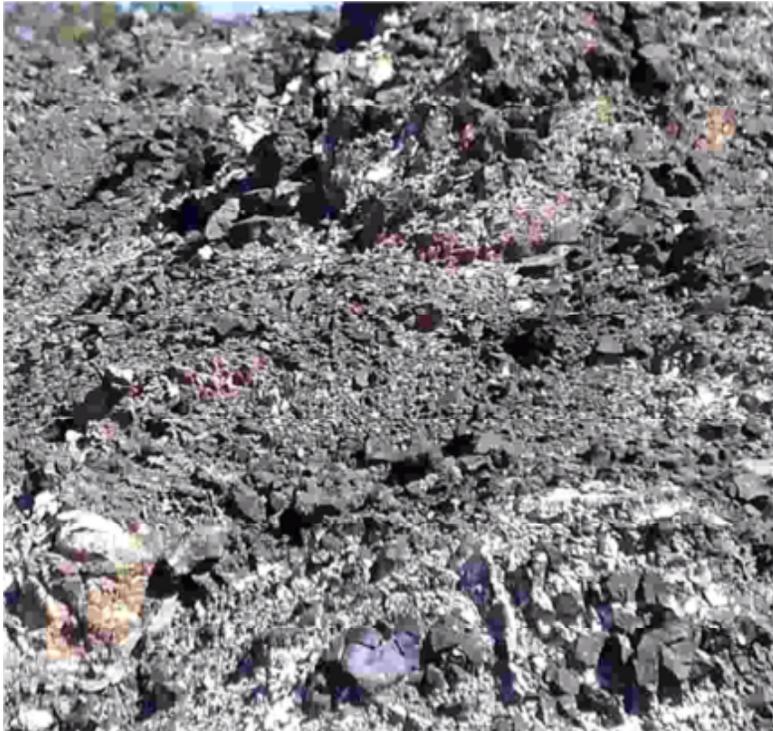
Mill Building Vicinity		Sample No 610.10893.00030/11
Site Observations		
Location	Stockpile south of building

GPS	282594 (Northing), 6633888 (Easting)	
Visual Findings	Soil	
Crusting (Soft, Medium, Hard)	Unprocessed-rock	
Migration Path	Off site	
Laboratory Analysis		
Whole Sample Description	grey brown soil and rocks	
Asbestos Presence Fraction < 2mm	Chrysotile	
Asbestos Description Fraction < 2mm	bundles	
% Asbestos (vol/vol approx.)	20%	
Trace Asbestos	Present	
Hazard Assessment	Medium

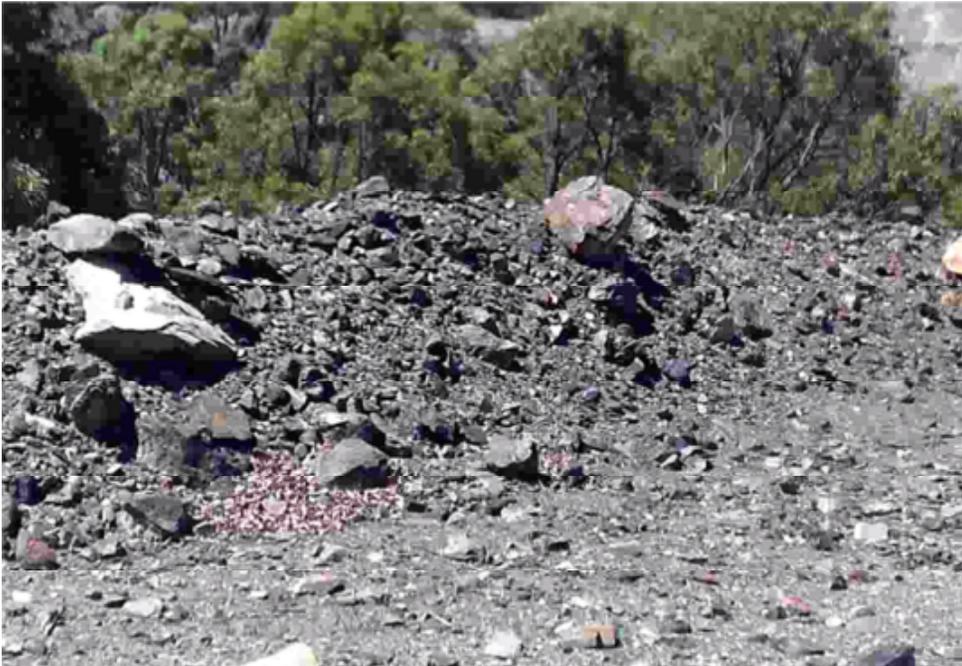
Mill Building Vicinity		Sample No 610.10893.00030/15
Site Observations		
Location	Stockpile south of building, west of culvert 1

GPS	282569 (Northing), 6633676 (Easting)	
Visual Findings	Soil	
Crusting (Soft, Medium, Hard)	Fragments of FCS, unprocessed rock	
Migration Path	Off site	
Laboratory Analysis		
Whole Sample Description	light brown soil, rocks	
Asbestos Presence Fraction < 2mm	Chrysotile	
Asbestos Description Fraction < 2mm	Bundles	
% Asbestos (vol/vol approx.)	90%	
Trace Asbestos	Present	
Hazard Assessment	High

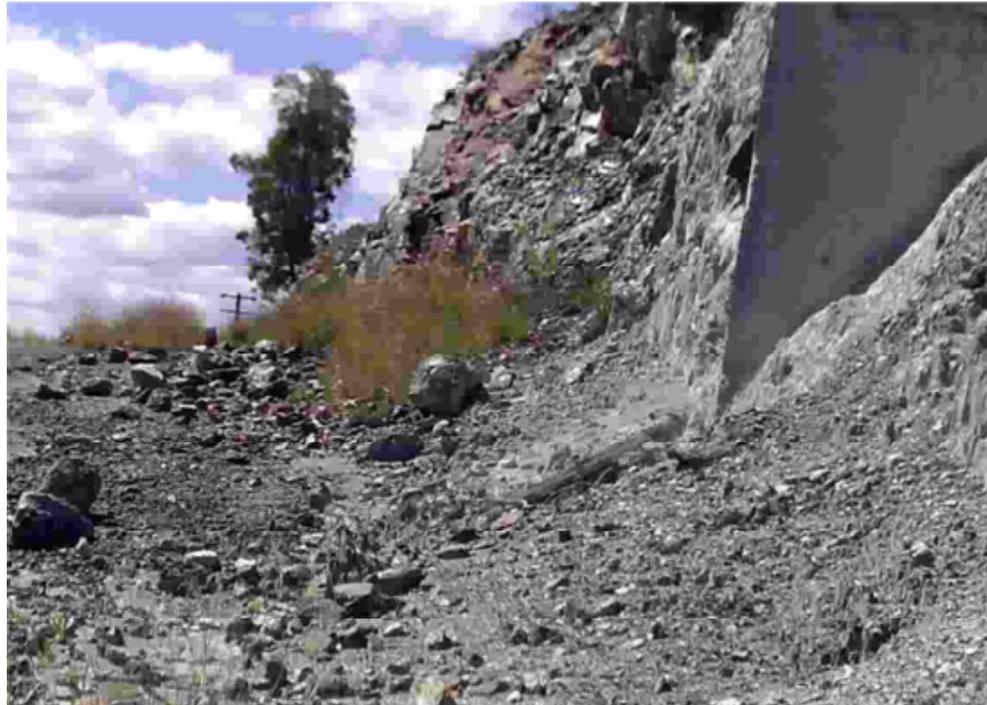
Proposed Containment Cell Vicinity		Sample No 610.10893.00030/1
Site Observations		
Location	Inside Building NW	
GPS	282698 (Northing), 6634033 (Easting)	
Visual Findings	Soil Detritus	
Crusting (Soft, Medium, Hard)	Medium	
Migration Path	On Site	
Laboratory Analysis		
Whole Sample Description	light brown/grey material, fibrous masses	
Asbestos Presence Fraction < 2mm	Chrysotile	
Asbestos Description Fraction < 2mm	Fibrous mass	
% Asbestos (vol/vol approx.)	70%	
Trace Asbestos	Present	
Hazard Assessment	High
