**Hazard Identification Assessment Report
Woodsreef Mine Major Rehabilitation Project
NSW Trade and Investment
Division of Resources & Energy**

Report Number 610.10893.00030

1 December 2014

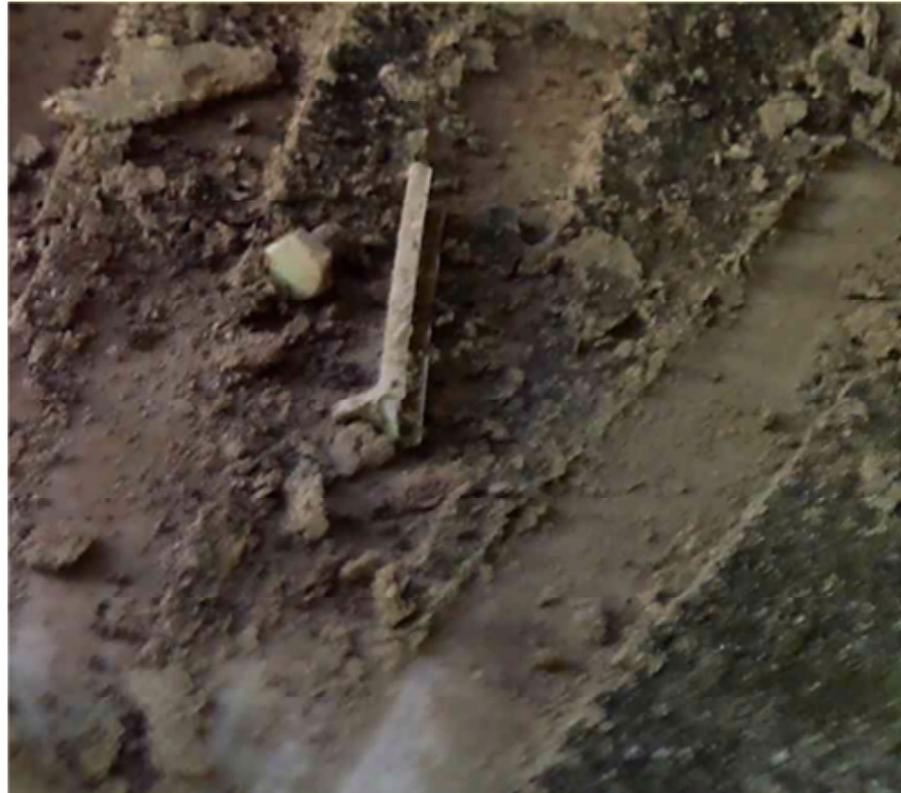
Proposed Containment Cell Vicinity		Sample No 610.10893.00030/2
Site Observations		
Location	Inside Building NE	
GPS	282724 (Northing), 6634017 (Easting)	
Visual Findings	Detritus	
Crusting (Soft, Medium, Hard)	Medium	
Migration Path	On site	
Laboratory Analysis		
Whole Sample Description	light brown/grey material, fibrous masses	
Asbestos Presence Fraction < 2mm	Chrysotile	
Asbestos Description Fraction < 2mm	Fibrous masses	
% Asbestos (vol/vol approx.)	50%	
Trace Asbestos	Present	
Hazard Assessment	High

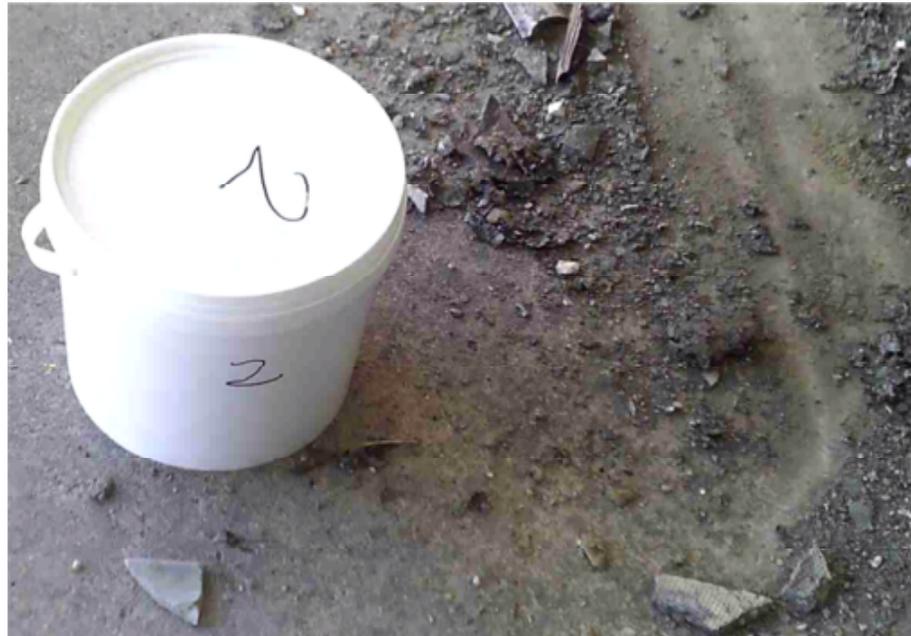
Proposed Containment Cell Vicinity		610.10893.00030/3
Site Observations		
Location	Inside Building NE	
GPS	282715 (Northing), 6634027 (Easting)	
Visual Findings	Soil Debris	
Crusting (Soft, Medium, Hard)	Medium	
Migration Path	On site	
Laboratory Analysis		
Whole Sample Description	light brown/grey material, fibrous masses	
Asbestos Presence Fraction < 2mm	Chrysotile	
Asbestos Description Fraction < 2mm	Fibrous masses	
% Asbestos (vol/vol approx.)	40%	
Trace Asbestos	Present	
Hazard Assessment	High

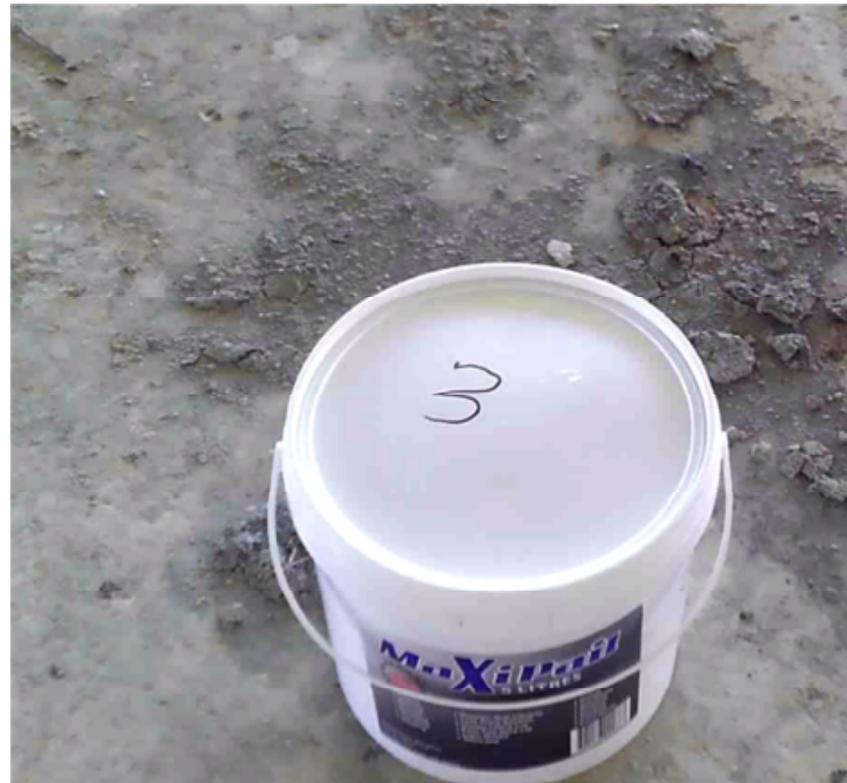
Proposed Containment Cell Vicinity		Sample No 610.10893.00030/4
Site Observations		
Location	On concrete slab, east of building	
GPS	282747 (Northing), 6634031 (Easting)	
Visual Findings	Detritus, Debris	
Crusting (Soft, Medium, Hard)	Soft	
Migration Path	Off site	
Laboratory Analysis		
Whole Sample Description	light brown/grey material, fibrous masses	
Asbestos Presence Fraction < 2mm	Chrysotile	
Asbestos Description Fraction < 2mm	Fibrous masses	
% Asbestos (vol/vol approx.)	25%	
Trace Asbestos	Present	
Hazard Assessment	High
