**NSW
Resources
Regulator**

COMPLIANCE AUDIT PROGRAM

MANDALONG COAL MINE

Centennial Mandalong Pty Ltd

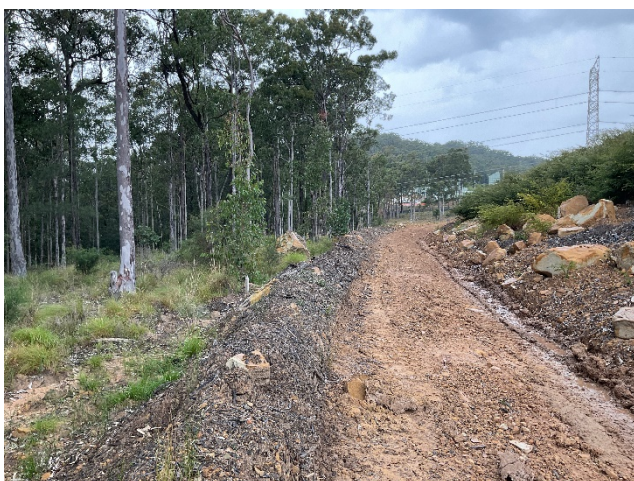
It was noted that construction works at the MSSS have generated a small quantity of topsoil which has been stockpiled separately from the subsurface material. Erosion control measures were observed to be in place around the stockpiles (Figure 1) but not all stockpiles had been seeded with a cover crop or other vegetative material (Figure 2 and Figure 3) as listed in section 3.4.6 of the MOP. Planning for re-use or rehabilitation of the stockpiled material at MSSS has not yet been defined. This is raised as observation of concern number 1. Centennial Mandalong should review stockpile management at MSSS and seed the stockpile if required. Planning for re-use or rehabilitation of the stockpile should commence and progress reported in the annual report.

Figure 1. Mulched drainage control bund around stockpile

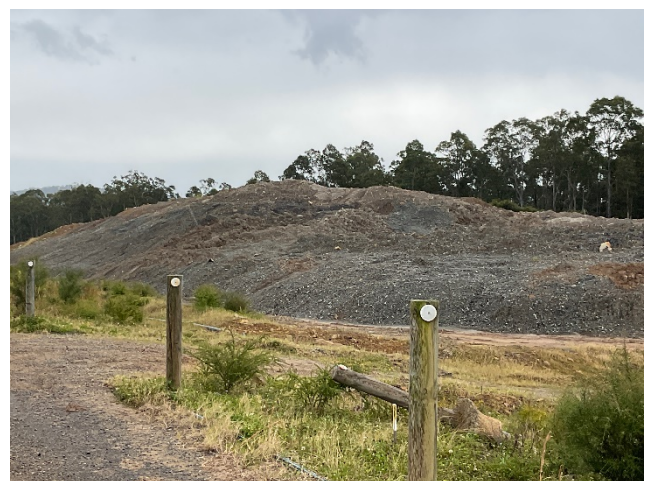
Figure 2. Part of stockpile not seeded or vegetated

OBSERVATION OF CONCERN NO.	DESCRIPTION OF ISSUE	RECOMMENDATION
1	It was observed that not all the stockpiles at MSSS had been seeded with a cover crop or other vegetative material as listed in section 3.4.6 of the MOP. Planning for re-use or rehabilitation of the stockpiled material at MSSS has not yet been defined.	Centennial Mandalong should review stockpile management at MSSS and seed the stockpile, if required. Planning for re-use or rehabilitation of the stockpile should be commenced and progress reported in the annual report.

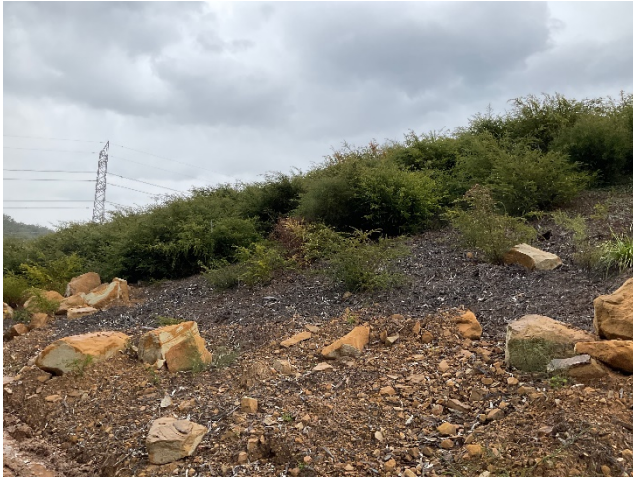
Figure 3. Part of the stockpile has been revegetated

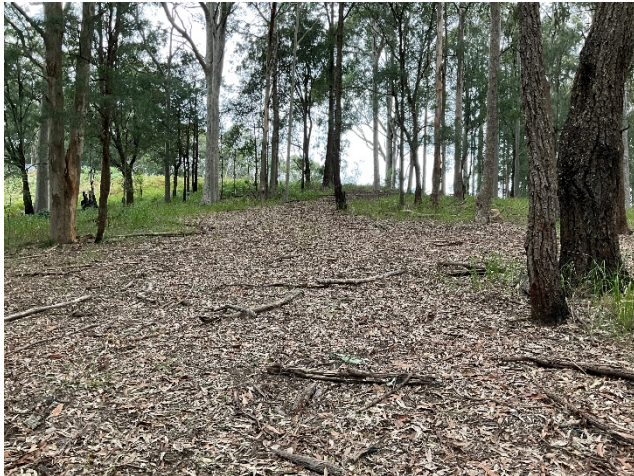
- Exploration boreholes 18A and 42B had been rehabilitated to a good standard (Figure 4 and Figure 5).

Figure 4. Rehabilitation of exploration borehole 42B including access track

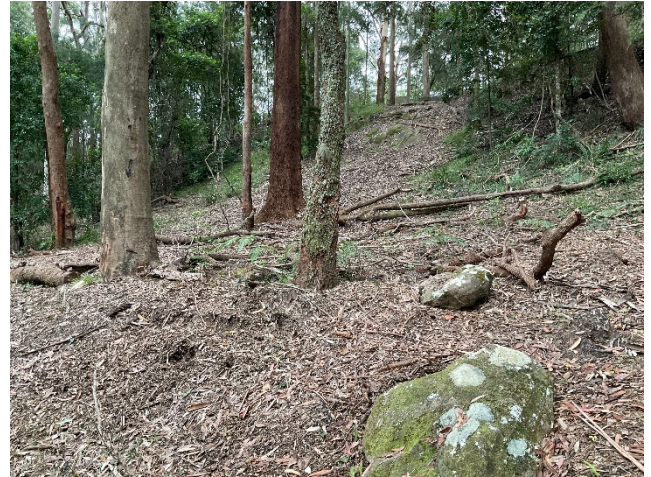
Figure 5. Rehabilitation of exploration borehole 18A

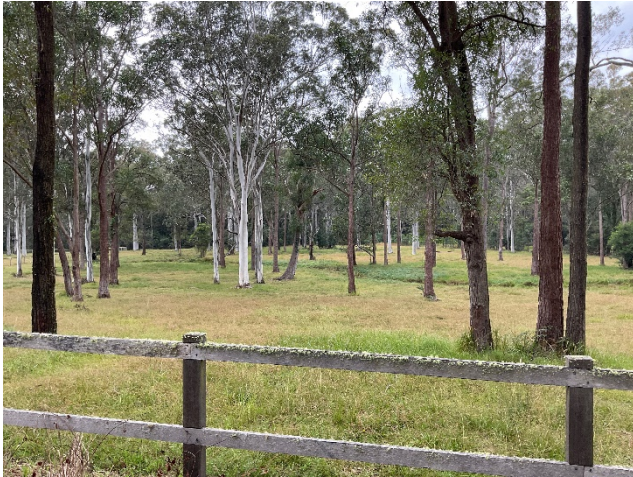
- For Domain 8 underground mining area, as described in section 3.2.1 above, Centennial Mandalong has undertaken digital terrain modelling to identify areas where remediation works may be required. The annual reviews were noted to include a flowpath condition report that identified any areas where remediation may be required. Two areas where remediation works have been undertaken were inspected during the audit. In ML1443, a drainage line was reinstated/reshaped to reduce the ponding of water on the property (Figure 6). In ML1722, water ponding was creating access issues for the landowner so upgraded drainage works were installed to allow water to flow more effectively through the property without ponding (Figure 7).

Figure 6. Drainage line realignment over ML1443

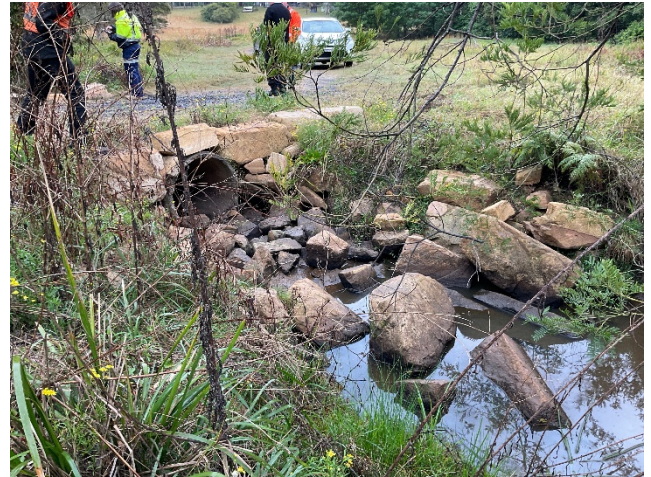
Figure 7. Drainage works to rectify subsidence impacts over LW26 in ML1722
