WEEKLY INCIDENT SUMMARY

Week ending Friday 5 November 2021

Dangerous incident
IncNot0040997
Underground coal
Ground or strata

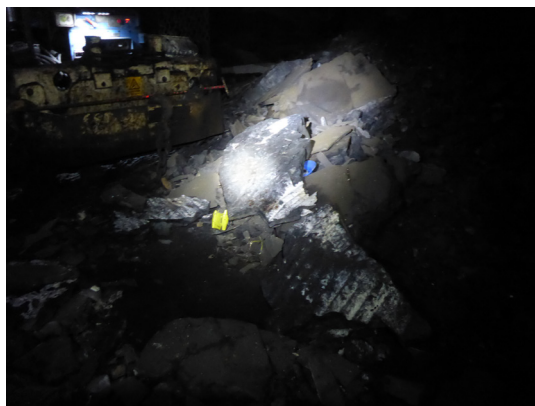
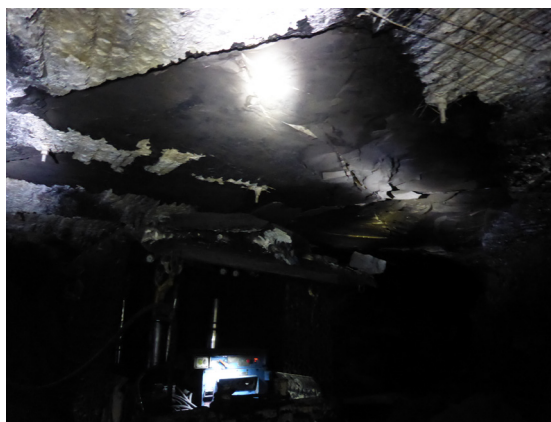
A roof fall in an underground coal mine resulted in two workers suffering spinal, chest and leg injuries. The ply fell from between roof bolts.

The incident is under investigation. Further information may be released at a later date.

Refer to [NSW code of practice: Strata control in underground coal mines](#)

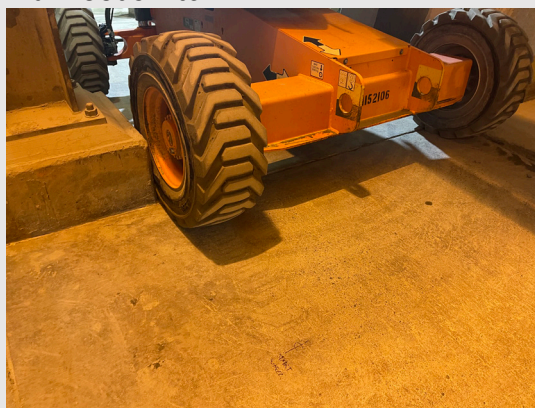
Dangerous incident
IncNot0041024
Underground
metals

A worker was in the process of repositioning an elevated work platform (EWP) when the machine unexpectedly rolled forward approximately one metre. The movement occurred when the operator placed his foot on the dead man switch and before operating the hand controls. The movement stopped when the operator released the dead man foot switch.

Mechanical engineering control plans must set out the control measures for the unintended operation of plant. This must include function testing as part of the introduction of plant to site process and pre-use inspections by operators.

Mine operators should ensure:

- all pieces of hired equipment have a thorough mechanical and electrical inspection to assess the plant's operation
- thorough pre-work inspections are carried out by competent people
- hired equipment is maintained in accordance with a suitable maintenance strategy considering the original equipment manufacturer's recommendations and relevant Australian Standards. For EWPs this should include AS 1418.10 and AS 2550.10.
