**NSW
Resources
Regulator**

Quarterly safety report

October to December 2021

Title: Quarterly safety report October to December 2021

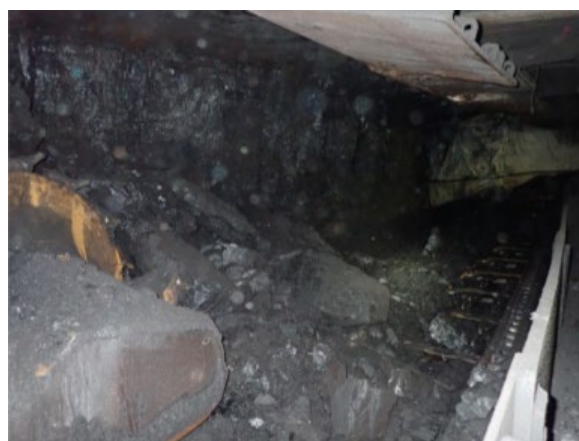
DANGEROUS INCIDENT - GOOD PLANNING AVOIDS RISK TO WORKERS FROM COAL BURST

A coal burst occurred while a longwall was in full remote operation. The workers were operating from the main gate as per their coal burst Trigger Action Response Plan (TARP).

Below: Debris at the face after the coal burst.

Identification of increased coal burst potential and properly implemented TARPs reduces the likelihood of a coal burst exposing workers to risk. TARPs should be continually reviewed to ensure that the triggers and controls remain appropriate as mining conditions evolve.

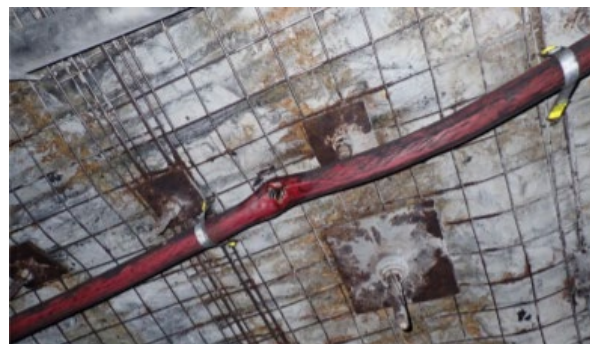
DANGEROUS INCIDENT - UNDERGROUND VEHICLE CONTACTS ELECTRICAL SERVICE LINE

A high voltage cable supplying a conveyor starter in an underground coal mine was found to have impact damage. The PVC outer sheath was damaged and the armoring distorted, exposing the internal lead sheath. It was discovered hanging from the roof about one metre from the rib. A duckbill carrying an air track was sitting underneath the cable.

Below: Damaged HV electrical cable hanging from roof of drive.

When developing control measures to manage the risks associated with roads or other vehicle operating areas, the placement of services that may be exposed to risk of damage such as cables and pipelines must be considered.

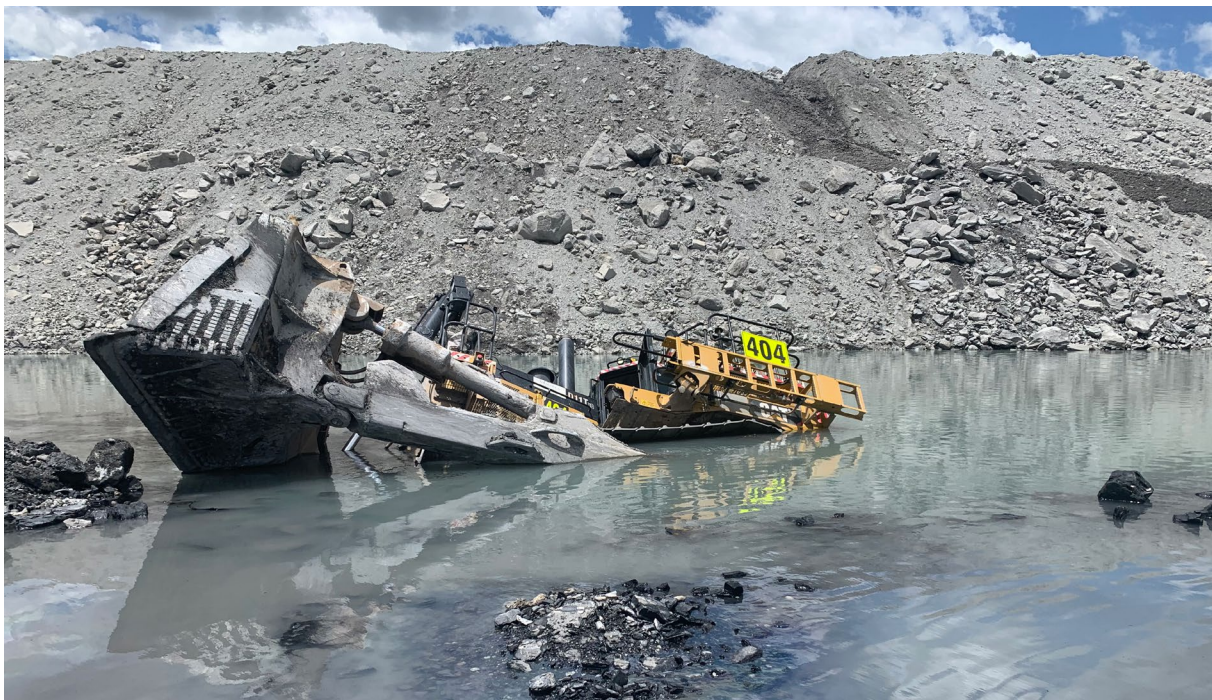
Below: The partially submerged dozer.

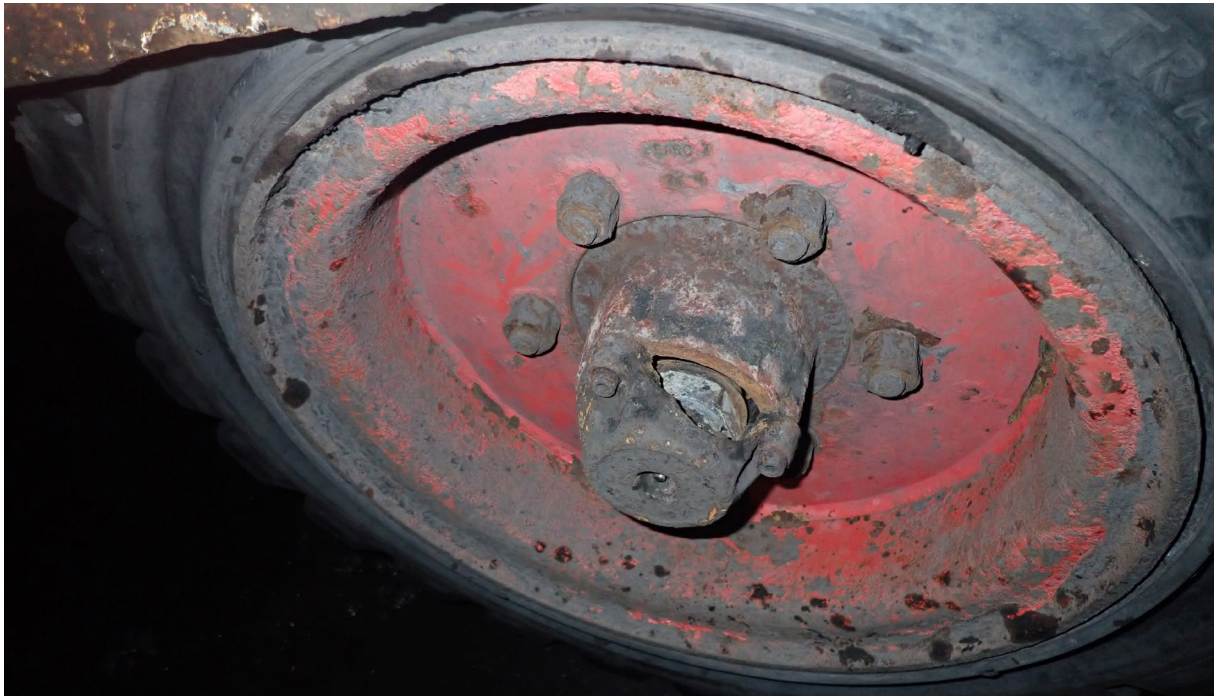
DANGEROUS INCIDENT - FIRE IN WHEEL BEARING

A fire occurred in the wheel bearing of a supply trailer in an underground coal mine. The fire was extinguished using a water hose. The investigation identified a damaged bearing cover that had failed to protect the bearing from contamination.

Below: The damaged wheel bearing cover.

Ancillary equipment such as trailers, attachments and supply pods should have suitable maintenance schedules to manage the plant through its lifecycle. This should consider the environmental conditions and the frequency of use.

Workers must always inspect plant for damage that may affect the safe use of the plant before commencing work.

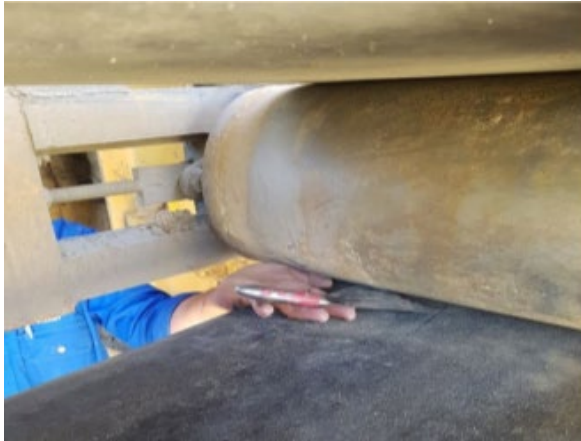
A worker at a sand mine was cleaning excessive build up on the tail roller of an operating conveyor. While using a small scraper to clean the build-up off, the worker's hand got pulled into the roller by the conveyor belt. It was common practice in this workplace to go into the guarded area and clean the tail roller without isolating the conveyor.

Above: Area where worker's hand was caught.

Under no circumstances should workers enter a guarded area without implementing isolation procedures. Mine operators should review the adequacy of their guarding and isolation arrangements, to protect workers from the risk of entanglement with operating plant. Guidance on guarding requirements can be found in Australian Standard AS/NZ 4024 Safety of Machinery.

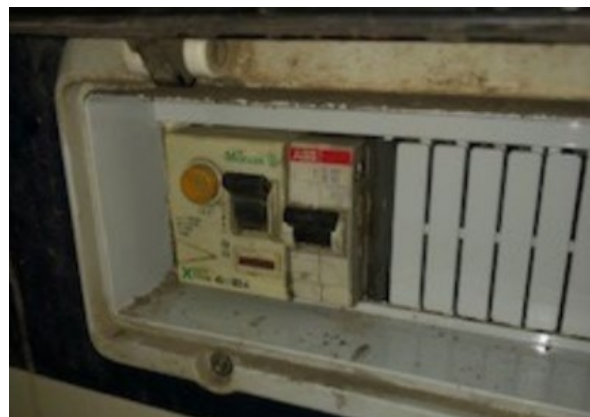
DANGEROUS INCIDENT - WORKER SHOCKED RESETTING CIRCUIT BREAKER

Below: Circuit breaker and control cabinet.
