WEEKLY INCIDENT SUMMARY

Week ending Friday 11 February 2022

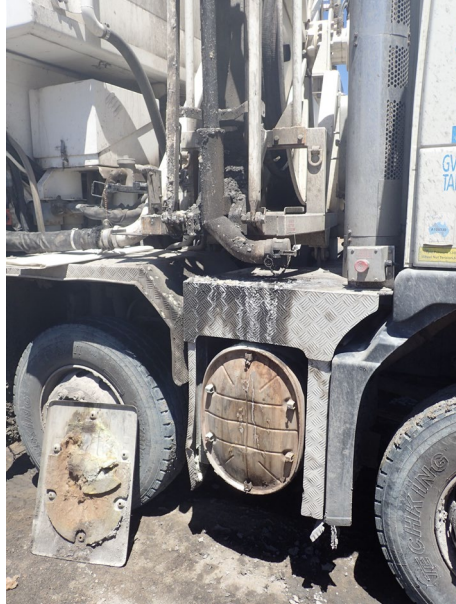
INCIDENT TYPE	SUMMARY	COMMENTS TO INDUSTRY
Dangerous incident IncNot0041565 Open cut coal Fire or explosion

<p>A fire occurred on a mobile manufacturing unit (MMU) truck after it returned empty from the pit. The operator was checking the machine and observed a flame coming from above a cover over exhaust components behind the rear of the cab. Flames were visible about 10 centimetres high at the top of the cover. He extinguished the flame with a hand-held extinguisher.</p> <p>A preliminary investigation indicated that small amounts of explosive emulsion dripped off the delivery hose and accumulated on top of the cover. The build-up contaminated the insulation behind the cover and on top of the unshielded exhaust components. The</p>	<p>Owners of mobile manufacturing units should assess potential ignition points that make contact with raw or finished product. Areas where spillage may accumulate should have engineering controls in place to minimise the risk of fire. MMU operators should regularly inspect for spillage and should be trained to manage any spillage of emulsion.</p>

heat from the exhaust components ignited the hydrocarbons in the explosive product, resulting in a small fire.

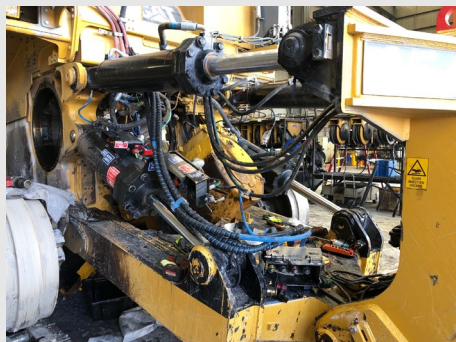
Dangerous incident
IncNot0041570
Open cut coal

While removing the transmission from a dozer, two bolts attaching the lifting device to the transmission failed, allowing the transmission to fall onto the ripper frame of the dozer. Nobody was injured.

A preliminary investigation suggested incorrect-sized bolts were used to connect the lifting rig to the transmission.

When procedures are developed for lifting tasks, relevant details, such as bolt sizes, should be included to allow workers to safely conduct lifting tasks.

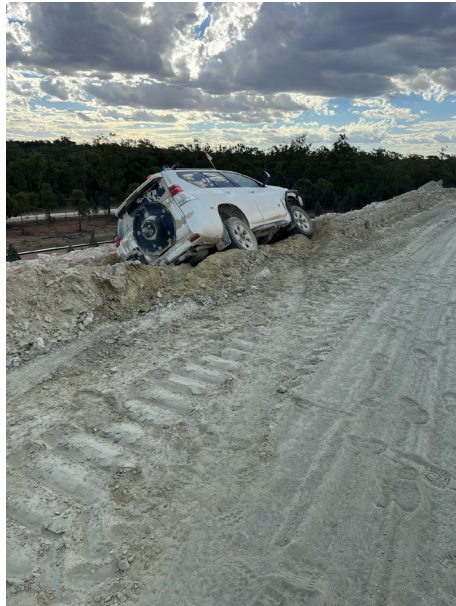
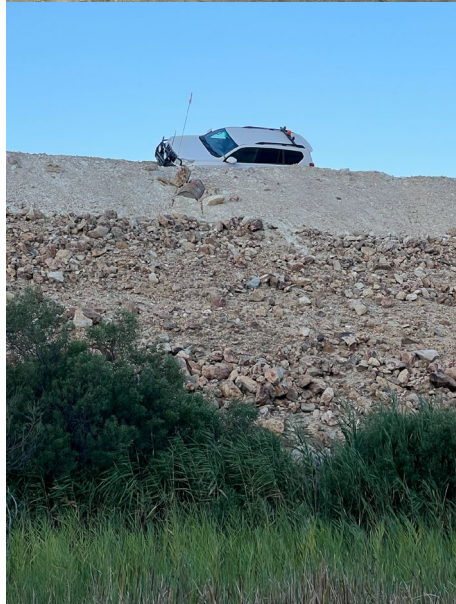
Dangerous incident
IncNot0041594
Underground coal
Roads or other
vehicle operating
areas

A light vehicle with two passengers on board drove up onto a windrow at the top of a tailings dam, tipping the vehicle onto the passenger's side. Both occupants exited through the driver's side door and were uninjured. The windrow was constructed of light material and was quite narrow.

Mine operators should ensure that bunds are designed, constructed and maintained to a standard that is suitable to protect workers from harm.

Principal hazard management plans for roads or other vehicle operating areas should consider factors that may affect operator visibility such as sunlight, fog, or dust.

Vehicle operators must maintain situational awareness and remain focused on the task to manage risks while driving.
