WEEKLY INCIDENT SUMMARY

Week ending Friday 18 February 2022

Mine safety reference ISR22-07

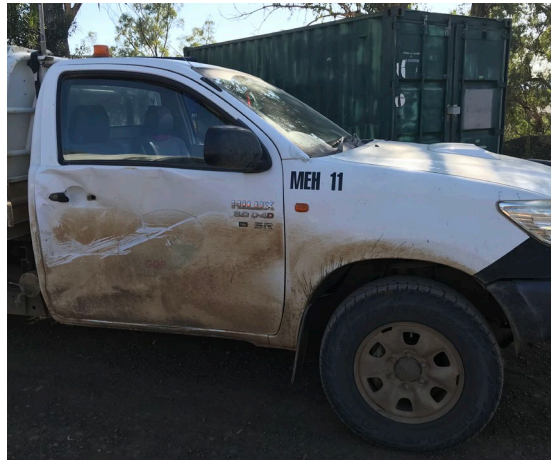
INCIDENT TYPE	SUMMARY	COMMENTS TO INDUSTRY
Dangerous incident IncNot0041643 Quarrying Roads and other vehicle operating areas

<p>A worker parked on the offside of a wheel loader and had a brief conversation with the loader operator. The worker then walked towards a mill. The loader operator then reversed the loader, hitting the driver's side door of the worker's ute. The worker was not near the vehicle when the collision occurred.</p>	<p>Past incidents similar to this have resulted in fatalities.</p> <p>Effective separation of light vehicle parking areas and pedestrians from mobile equipment operations should be a fundamental consideration when risk assessing operations and implementing controls.</p> <p>Workers must be adequately trained in the controls identified and compliance audited.</p>

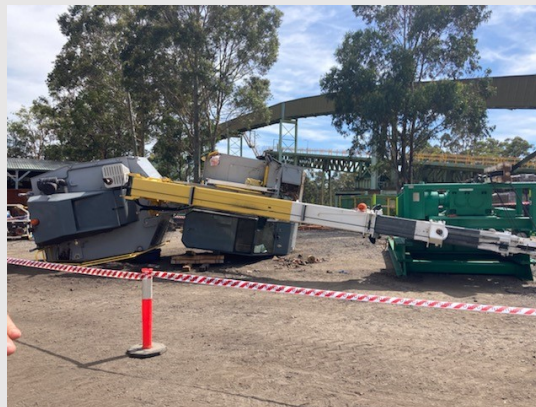
Dangerous incident
IncNot0041631
Underground coal
Roads or other
vehicle operating
areas

A 25 tonne Franna crane was tasked to move a 7 tonne belt reeler. When the load was lifted, the crane rolled onto its side. The crane was in an articulated position at the time of the incident. The operator was able to exit the crane uninjured.

When planning for safe lifting activities, factors that must be considered include the:

- cross grade
- travel path
- crane configuration including articulation of Franna cranes
- ground conditions
- load movement
- weather conditions
- interaction with other plant and mobile equipment.

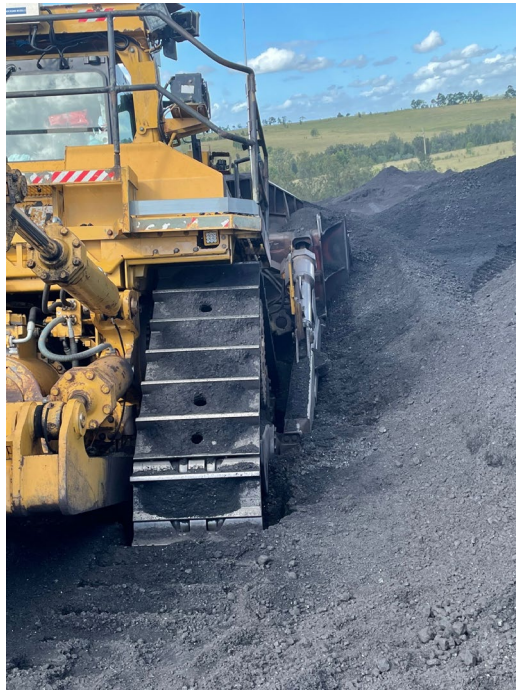
Dangerous incident
IncNot0041605
Open cut coal

A dozer was working on a stockpile during train loading operations when the active valve ceased feeding. Train loading was then completed on an alternate valve.

The dozer operator then attempted to clear the original valve when a void opened underneath the dozer. The dozer did not fall into the void because the blade and ripper were still on solid coal. The dozer driver got out safely.

The hazard of concealed voids exists on stockpiles and must be included in risk assessments, training and procedures for operators.

Operators must be trained to identify when the risk of concealed voids is present and the procedure required to control the hazard.

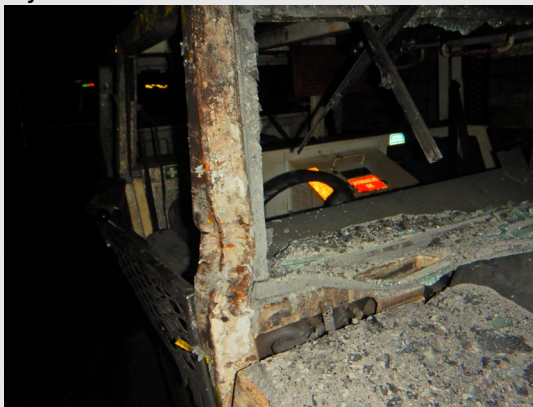
Dangerous incident
IncNot0041628
Underground coal

While driving out of a mine following a load haul dump (LHD), a personnel transport driver lost control and hit the rib on the driver's side. The windscreen and pillar were damaged. There were no injuries.

Drivers must maintain focus on the task at hand.

If a driver's visibility is affected, the driver should slow down, find a safe place to stop and address the issue rather than continuing to drive with obstructed vision.
