WEEKLY INCIDENT SUMMARY

Week ending Friday 21 January 2022

Mine safety reference	ISR22-03
Date published	1 February 2022
Approved by	Deputy Chief Inspector Office of the Chief Inspector

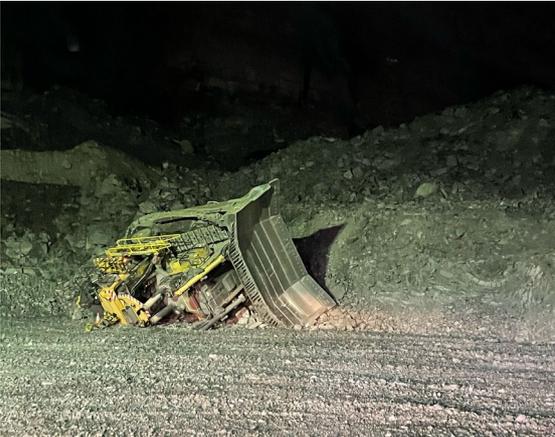
INCIDENT TYPE	SUMMARY	COMMENTS TO INDUSTRY
Dangerous incident IncNot0041461 Open cut coal Roads or other vehicle operating areas

A dozer working around an excavator went over a bank and slowly rolled onto its right-hand side. The driver was able to escape and was not injured.

Mine operators should consider recommendations in safety bulletins SB19-01 and SB19-10. Refer to Safety Bulletins SB19-01 Rise in dozer incident putting operators at risk and SB19-10 Dozer incidents increase despite warnings

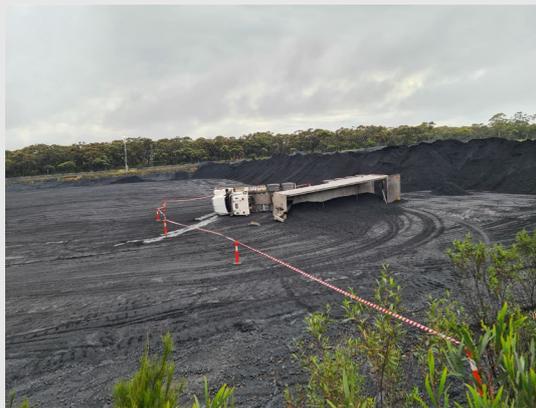
Dangerous incident
IncNot0041424
Open cut coal
Roads or other
vehicle operating
areas

The operator of single-trailer road truck was trying to dump a load at a stockpile while being spotted by the loader operator (in the cabin of the loader). The truck operator noticed that the truck had become unstable at the first stage of the lift so repositioned and reattempted dumping the load. On the second attempt, the trailer and cabin of the road truck overturned. The truck operator was helped out of the cabin by first responders and an ambulance was called to the site. The truck operator was cleared of significant injury.

Mine operators should identify all work activities on the mine site where trucks are used and review control measures for truck rollovers. This review should consider:

- risk controls to prevent a truck roll
- risk controls to mitigate the risk of injury following a truck rollover.

Refer to Safety Bulletin [SB17-01 Industry reports more truck rollover incidents](#)

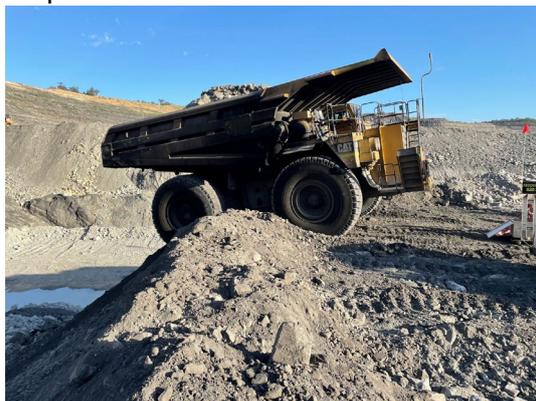
Dangerous incident
IncNot0041431
Open cut coal
Roads or other
vehicle operating
areas

A haul truck was trying to dump material on a working dump face when it went through a windrow and came to rest with the rear wheels through the windrow. The dump dozer saw the incident as it occurred and attempted to stop the truck over the radio.

When designing a dump, ground stability should be a primary consideration. Material consistency, wet conditions and dipping ground stability should also be considered. Inspections should verify the dump integrity. Areas that do not meet the standard should be demarcated, communicated and remediated to meet the standard.

Refer to Safety Bulletin [SB18-11 Windrow management and demarcation](#)
