# WEEKLY INCIDENT SUMMARY

Week ending Friday 11 March 2022

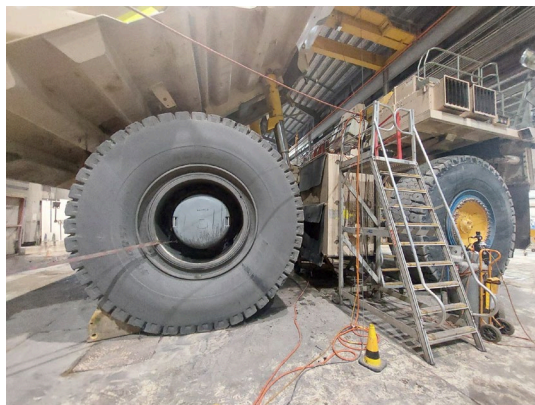
INCIDENT TYPE	SUMMARY	COMMENTS TO INDUSTRY
Dangerous incident IncNot0041760 Surface coal	A boilermaker suffered an electric shock while conducting chassis repairs on a haul truck with a MIG welder. The boilermaker was between the main alternator and the chassis when he felt a shock across his chest.	Mine operators should verify that workers carrying out welding have identified appropriate earthing points, their personal protection equipment (PPE) is dry and they are appropriately trained. Welding machines must be isolated when not in use.  Refer to: <ul style="list-style-type: none"> <li><a href="#">Safety Bulletin SB19-03 Welding-related electric shocks increase</a></li> <li><a href="#">NSW Resources Regulator Information Sheet No.2: Basic welding practices</a></li> </ul>

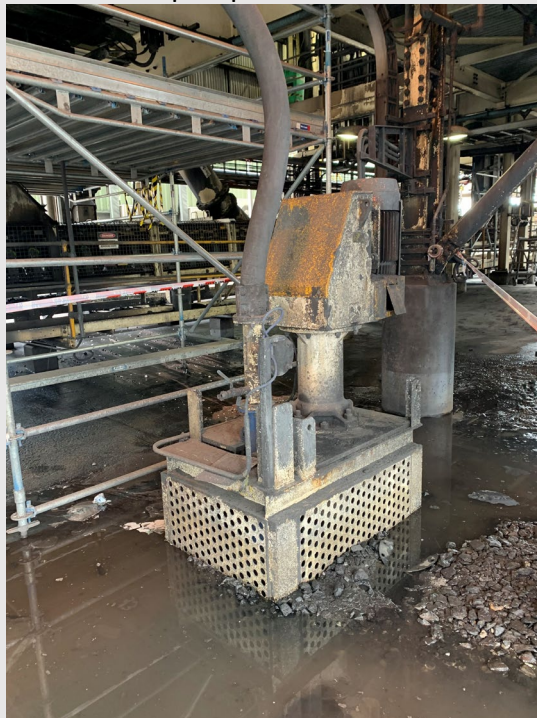
Dangerous incident  
IncNot0041774  
Open cut coal

An electrician placed his personal isolation lock onto a lock box and began work on a sump pump. As the electrician began to remove the main junction box screws, the pump started. The electrician was not injured.

The work procedure contained incorrect isolation information and the electrician failed to test for dead before starting work on the pump.

When group isolation systems are used, the isolation must be confirmed for all the required tasks. When workers lock onto a group isolation, they must check that the isolation is suitable for the task they are conducting. Mine workers must be trained and competent in isolation procedures and should always test for dead before starting work.

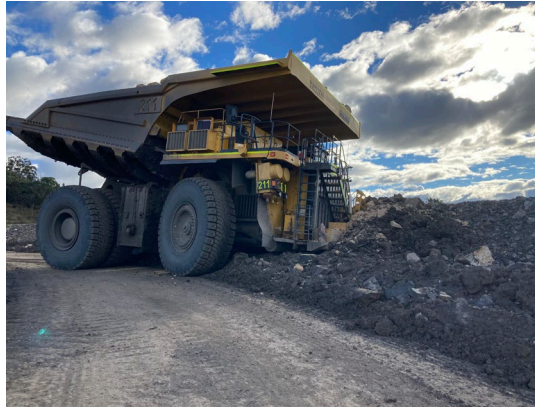
Dangerous incident  
IncNot0041771  
Open cut coal  
Roads or other  
vehicle operating  
areas

While descending a ramp, a haul truck gained speed and exceeded the operating range of the retard system. The operator failed to apply the service brake in time and was unable to safely negotiate a 90° corner at the base of the ramp. The truck hit the left side windrow.

Workers must operate vehicles at a speed that is appropriate to the prevailing conditions. Engineering controls that minimise the risk of loss of control should be considered, including the use of speed-limiting devices, speed monitoring and alarms. Mobile plant operating characteristics, including stopping distances, maneuverability and speeds must be considered when developing control measures to manage the risks of operating

vehicles. This should consider both loaded and unloaded vehicles.
