WEEKLY INCIDENT SUMMARY

Week ending Friday 18 March 2022

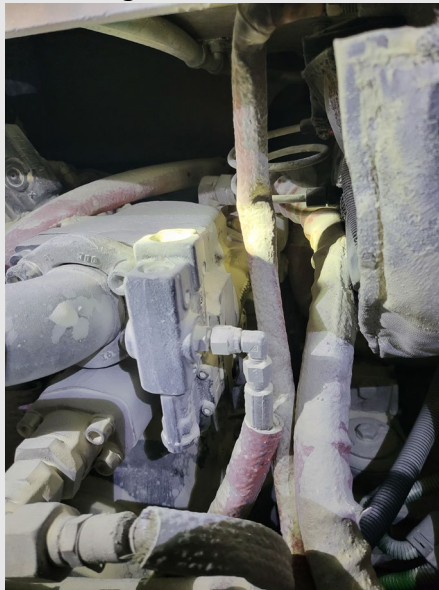
A spray rig was being trammed up the decline when it stopped to allow traffic to pass. The operator exited the rig and noticed smoke coming from the offside near the exhaust. The operator extinguished the fire using a hand-held fire extinguisher.

Hose management and protection is critical in preventing fires on mobile plant. Rubbing hoses are a well-known cause. Mine operators must have a system in place to identify defects and poor hose standards, assess the criticality and put controls in place to prevent a fire. [MDG15 Guideline for mobile and transportable plant for use at mines \(other than underground coal mines\)](#) and [AS 5062 Fire protection for mobile and transportable equipment](#) provide guidance for mines. For more resources, refer to our webpage: [Fires on mobile plant safety](#)
