# WEEKLY INCIDENT SUMMARY

Week ending Friday 8 April 2022

**Mine safety reference** ISR22-14

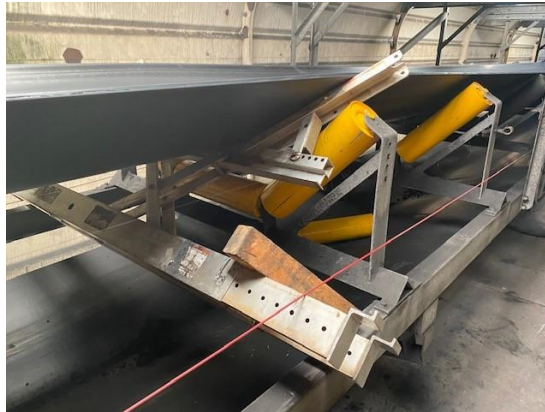
INCIDENT TYPE	SUMMARY	COMMENTS TO INDUSTRY
Dangerous incident IncNot0041965 Open cut coal mine	A conveyor belt moved approximately 300 mm when a splice clamp was released. The movement caused the conveyor lifters to topple over, near where a roller change was being carried out. The belt was isolated at the time of the incident and the counterweight was on the deck. There were no injuries.	Safe systems of work for people dealing with plant or structures must include the isolation, dissipation of energy and control of all mechanical energy sources from plant or structures.

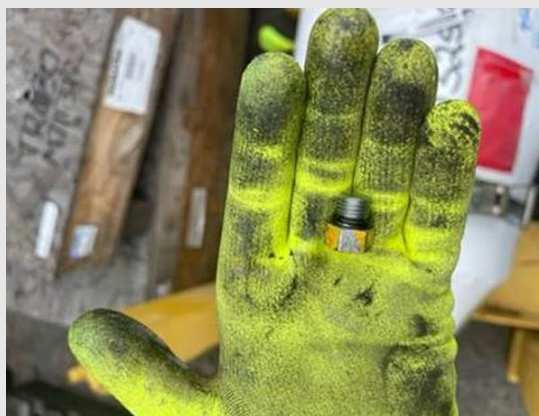
Dangerous incident  
IncNot0041952  
Open cut coal mine

A mechanical technician removed a plug from the right-hand rear strut of a dump truck believing it was a grease port.

The plug was tapped into the chamber of the strut and the technician was using a hand ratchet and socket. The plug was forced out under pressure (approximately 170-200 psi). The technician was just outside the direct line of fire of the plug and was covered in fluid from the strut. The plug was found on the ground a couple of metres away from the technician.

Workers who are unfamiliar with a task(s) must be provided with adequate information, instructions, and supervision.

Pre-task hazard assessments should include the assessment of pressurized systems and identification of controls.

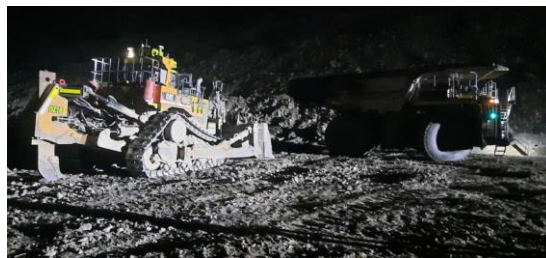
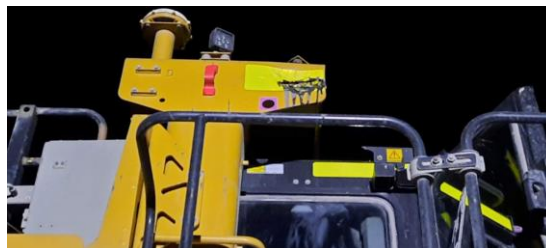
Dangerous incident  
IncNot0041947  
Open cut coal mine

A rear-dump truck entered an overburden dump, stopped and prepared to reverse. A nearby dozer established radio contact and advised the truck operator that it needed to sweep the area behind the truck and proceeded to do so. As the dozer went to

This incident and other similar incidents have been caused by a lack of positive communication between operators.

take a second sweep, the operator of the truck, thinking the dozer had already completed the clean-up, started to reverse. The dozer operator saw the truck reversing and blew the dozer's horn. The truck heard the horn and braked, however the truck tray still made contact with the dozer ROPS, causing some denting. No one was injured.

Dig and dump areas must operate under robust procedures and

controls. Operators must be trained when to establish positive communication as part of digging and dumping operations.
