# SAFETY BULLETIN

## Crane incidents on the rise

This safety bulletin provides safety advice for the NSW mining industry.

**Mine safety reference** SB22-05

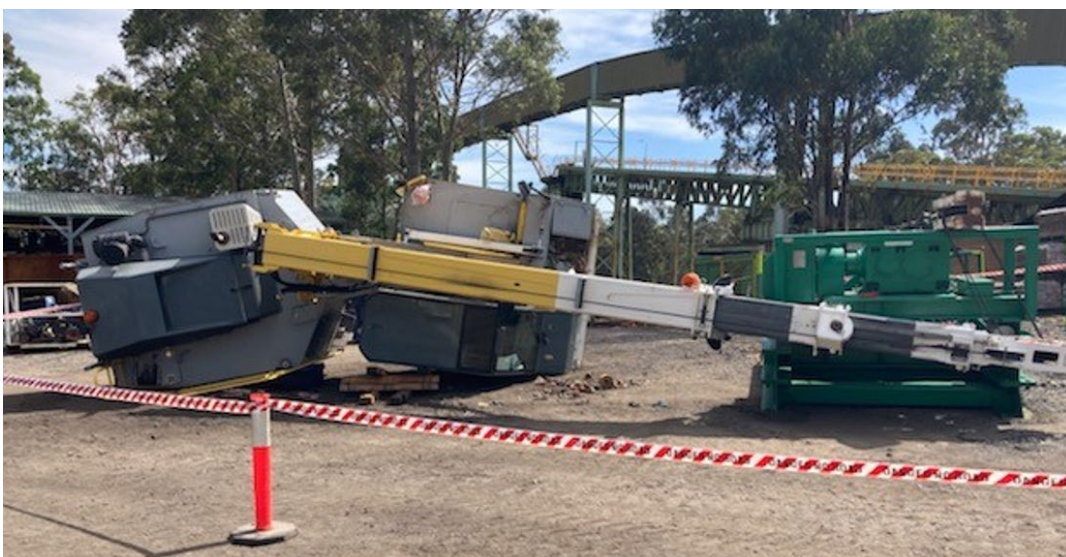
A 25 tonne pick and carry articulated mobile crane (see figure 1) was being used to relocate a belt winder that weighed approximately seven tonnes. During the relocation, the crane was articulated and slowly rolled onto its side. The operator was uninjured and was able to exit the crane.

*Figure 1 – Articulated mobile crane overturned - cause still under investigation.*

A lift permit and safe work method statement were in place for the lifting operation, which included supervision and spotters. Environmental conditions were good, and the ground was relatively flat. Witnesses said the belt winder was rigged level when it was lifted. The crane reversed approximately five metres before articulating and then overturning. Initial investigation found the crane was not overloaded when it was positioned straight but became overloaded when it was articulated to 21 degrees. The mine operator reported that the overload alarm activated but was ignored.

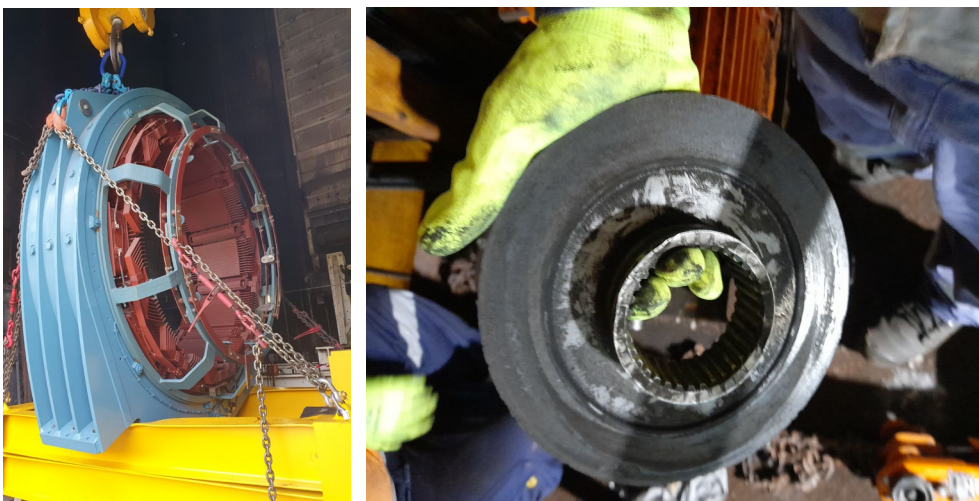
A 20 tonne overhead crane was being used to lift a motor stator weighing 18.3 tonne up to the motor room of a powered winding system. Approximately 10 metres off the ground the crane stopped without input from the operator and the load descended, landing on the transport frame it was lifted from. The crane brake that applied automatically failed to hold the load but did slow its descent.

*Figure 3 - Motor stator (left) - restrained after fall and brake disc (right)*

Inspections by the crane subcontractor in the month before the incident found the brake was in good condition. Damage to the brake was therefore attributed to have occurred as a result of the incident. Visual inspections confirmed no damage or failure of the crane electric motor, gearbox, shafts, drum or ropes.

Post-incident load testing with a 15 tonne load tripped mid lift and the load dropped a few centimetres. The raise full current limit switch (CRL) was found to have inadvertently activated. Analysis of the circuit shows uncoupling of two of the three phases when the CRL trips. The remaining single phase caused the motor to reverse and prevented the brake from applying. The drum brake was unable to stop the load due to the momentum developed by the descending load and the time delay in brake application.

Ultimately the root cause was attributed to the rope pressing against the rings of the CRL and causing it to activate prematurely. The electrical circuit was upgraded in 2013, however this limit switch was not replaced.

Following the incident, the electrical circuit was altered to include three phase isolation when the CRL trips, an additional brake contact was introduced to ensure faster brake application, a new start button inhibits auto-start after reset of the E-Stop and the mechanical assembly of the CRL altered to prevent inadvertent activation.
