WEEKLY INCIDENT SUMMARY

Week ending Friday 13 May 2022

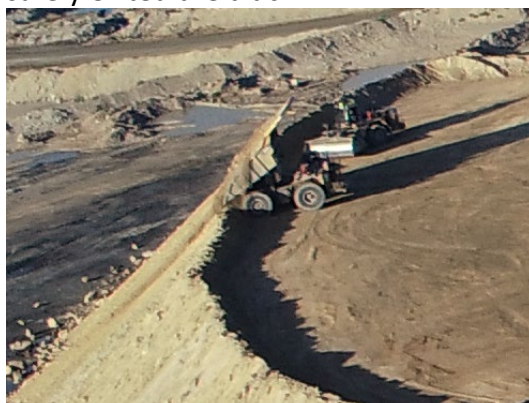
INCIDENT TYPE	SUMMARY	COMMENTS TO INDUSTRY
Dangerous incident IncNot0042136 Open cut coal mine Roads or other vehicle operating areas	A haul truck operator was reversing at an angle into a corner to tip its load when the right side rear wheels pushed through a windrow, causing the truck to bottom out on the windrow. The driver safely exited the truck.	Mine operators should review their tipping procedures and consider controls such as tipping short in corners, using a spotter in similar circumstances and training/competency/experience of operators.

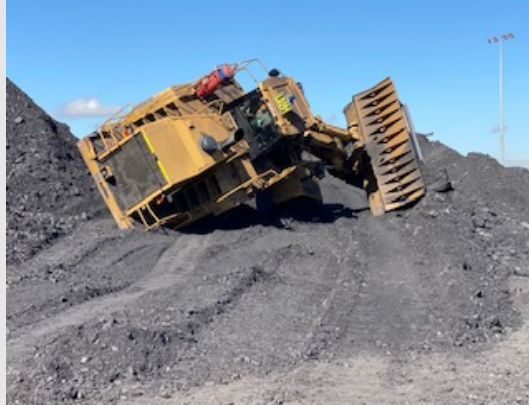
Dangerous incident
IncNot0042141
Coal processing
plant
Ground or strata
failure

A wheel loader was creating a ramp on a stockpile when the loader drove over a soft area and a rear wheel sank. The operator safely exited the loader.

When working on grades and slopes, operators must be cautious when raising implements, such as buckets, and when articulating. When planning tasks, the equipment to be used should be fit for purpose considering the operating environment and task requirements.

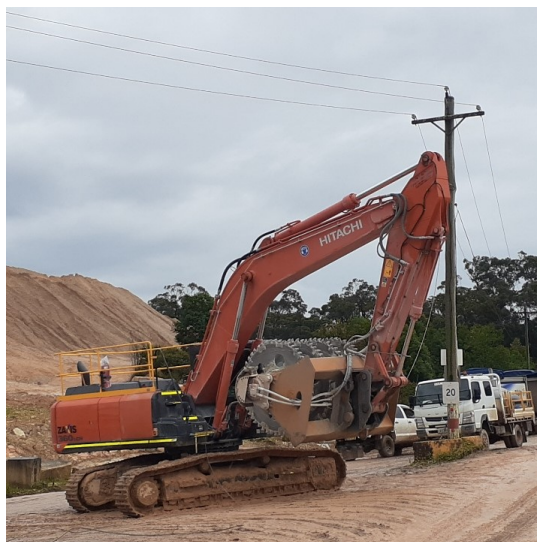
Dangerous incident
IncNot0042164
Construction
materials

An excavator made contact with an under-slung earth wire on a three-phase aerial supply. The excavator applied tension to the earth wire causing the phase conductors to clash, arc and trip. The earth wire snapped.

When developing roads or other vehicle operating areas, the potential for interaction between mobile plant and fixed structures, such as overhead power lines, must be assessed. Controls must be put in place considering the hierarchy of controls in accordance with [Work Health and Safety Regulation 2017 clause 36 Hierarchy of control measures](#)
