WEEKLY INCIDENT SUMMARY

Week ending Friday 17 June 2022

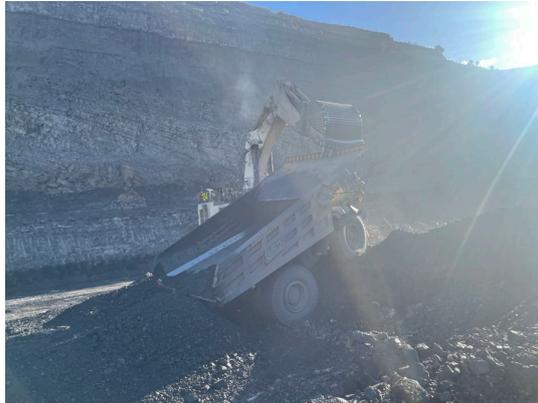
INCIDENT TYPE	SUMMARY	COMMENTS TO INDUSTRY
Dangerous incident IncNot0042358 Open cut coal mine Roads or other vehicle operating areas	A loaded haul truck operator accidentally reversed and breached a windrow while being loaded by an excavator on the same level. The truck stopped on the coal floor below. The seam was 2.5 metres high. A digger operator stopped the truck from moving further by putting the digger bucket onto the body.	While being loaded, haul trucks should have appropriate braking system applied. Dig areas should be designed and maintained to allow ease of maneuvering, without requiring excessive acceleration or braking to position for loading. Windrows should be designed and constructed to suit the mobile plant operating in the area. Workers report and rectify non-compliant work areas.

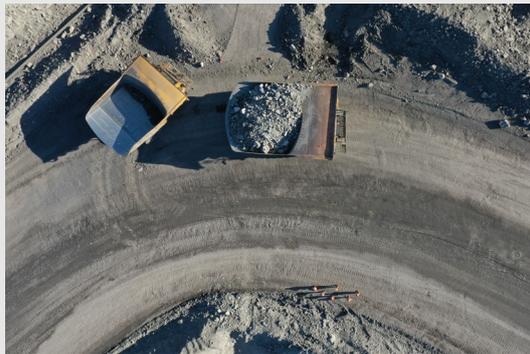
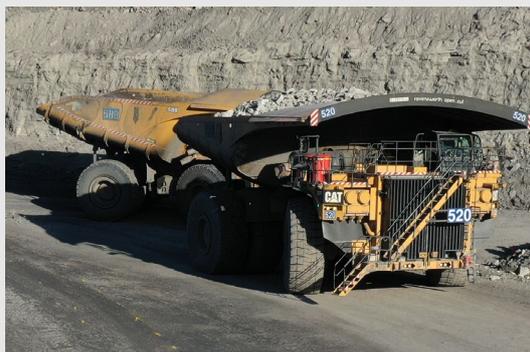
Dangerous incident
IncNot0042381
Open cut coal mine
Roads or other
vehicle operating
areas

A loaded haul truck was travelling down a ramp towards a bend. An empty haul truck was travelling towards the bend to continue up the ramp. The empty haul truck entered the corner at an excessive speed, lost traction and started to slide. The rear of the truck slid, the dovetail struck the side of the loaded truck and spun 180 degrees. The empty truck came to a stop behind the loaded truck. Both workers were uninjured.

Workers must operate vehicles and equipment at a speed that is appropriate to the prevailing conditions. Workers must remain vigilant in monitoring changes in conditions in operating environments.

Engineering controls that minimise the risk of loss of control should be considered, including the use of centre bunding, speed monitoring systems and alarms.

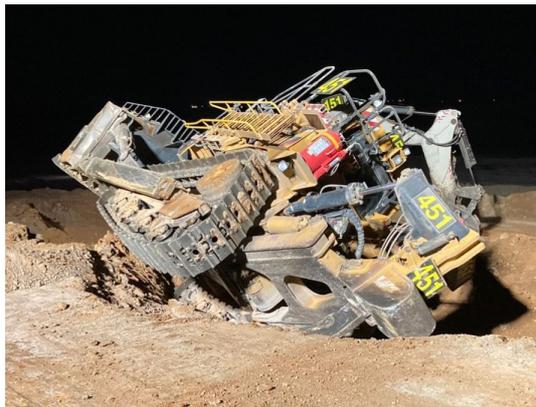
Dangerous incident
IncNot0042391
Open cut coal mine
Roads or other
vehicle operating
areas

A dozer was operating on a bench approximately 1.5m high. While reversing, the dozer slid off the side of the bench. Dirt was pushed up against the dozer to prevent it from rolling further.

Situational awareness is a key control when operating mobile equipment. Operators should minimise reversing and consider this when planning tasks. Lighting plants should be strategically placed to provide adequate lighting for tasks and reduce glare.

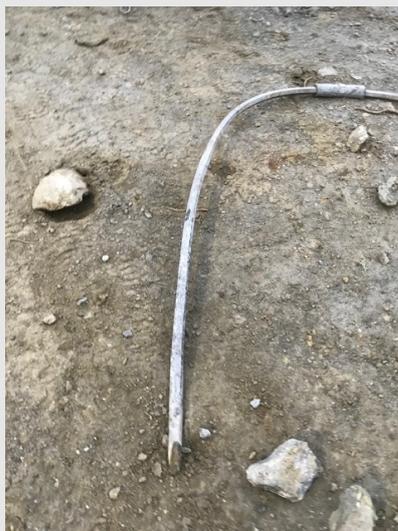
Severe incident
IncNot0042418
Underground
metals mine

A worker was hit in the face by a barring steel that ejected from a jaw crusher. The worker was standing on a platform above the operating jaw at the time. The barring steel entered the crusher in production feed. The worker lost four teeth in the incident.

Crushers and rotating equipment involve large energies that are capable of ejecting material with large amounts of force and speed. Mine operators should review access over and around crushers, feeder breakers and other processing equipment to ensure workers are not exposed to the risk of ejecting material.

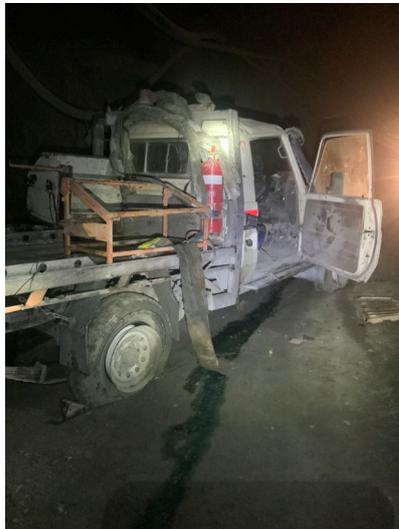
Dangerous incident
IncNot0042409
Underground
metals mine
Roads or other
vehicle operating
areas

Two workers were travelling down a main decline in a light vehicle. The vehicle hit a slippery part of the decline that resulted in the vehicle sliding into a drain. The vehicle rolled 360 degrees, coming to rest on its wheels and facing back up the decline. Neither occupant was injured.

Equipment operators must maintain situational awareness and remain vigilant regarding the risk of machine rollovers. This incident underpins the importance of wearing seatbelts as a mitigating control and demonstrates roll overs can occur in unexpected situations. Mine operators should ensure that light vehicles rollover is considered in the risk assessment for roads and other vehicle operating areas, including at underground mines.
