WEEKLY INCIDENT SUMMARY

Week ending Friday 1 July 2022

Mine safety reference ISR22-26

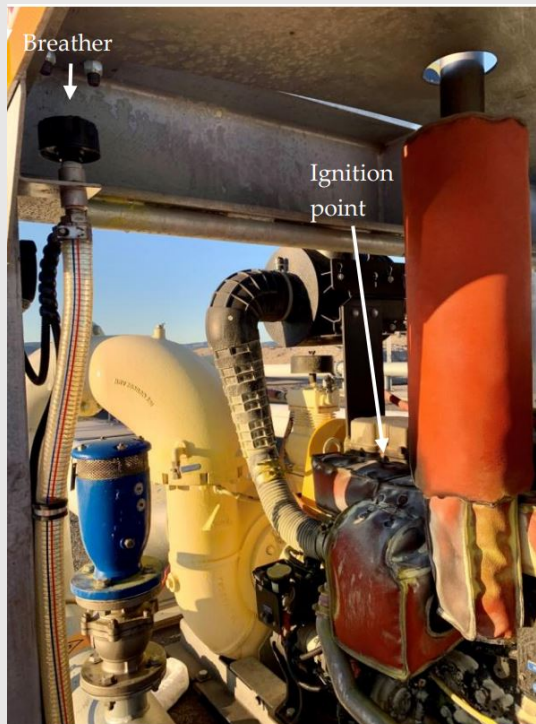
Dangerous incident
IncNot0042452
Open cut coal mine
Fire or explosion

A diesel pump was being refuelled during commissioning. The auto-fill nozzle clicked off indicating the system was full. The fuel gauge indicated the tank was 87% full, so the operator pushed the nozzle back on and held it in position to continue filling the diesel tank. The operator noticed diesel flowing from the breather so disconnected and reeled the hose back to the truck. Fuel made contact with the exhaust lagging and ignited. The flame was extinguished using a fire extinguisher.

Workers must never override safety devices when refuelling. This includes repeatedly filling after the nozzle has clicked off, tying the nozzle handle back to avoid holding it or modifying nozzles to fill machines that are not compatible. Breathers should be position clear of ignition points and hot surfaces.
