WEEKLY INCIDENT SUMMARY

Week ending Friday 15 July 2022

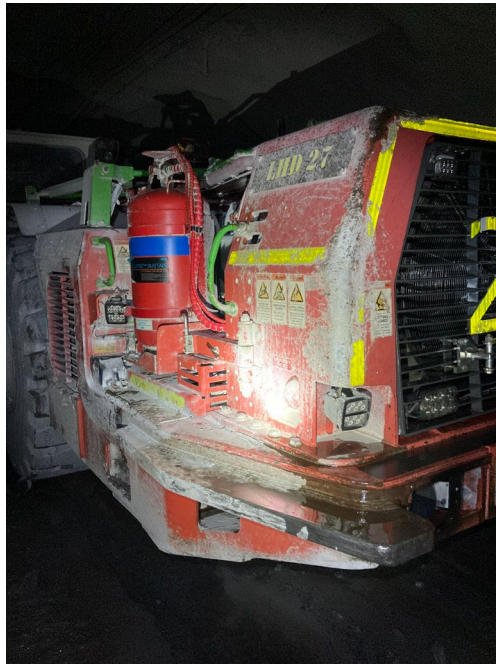
INCIDENT TYPE	SUMMARY	COMMENTS TO INDUSTRY
Dangerous incident IncNot0042577 Underground metals mine Fire or explosion

A tele-remote loader tripped off on low hydraulic oil. An operator went to investigate and found a small fire in the engine bay. The fire was extinguished with a hand-held extinguisher. A hydraulic hose failed and sprayed fluid onto hot engine components.	Hose management and protection is critical in preventing fires on mobile plant. Mine operators must have a system in place to identify defects and poor hose standards, assess the criticality and put controls in place to prevent a fire. Escape of fluid ignited by hot surfaces was identified as one of the top 2 causes of fires on mobile plant. For more resources, refer to our web page: Fires on mobile plant safety

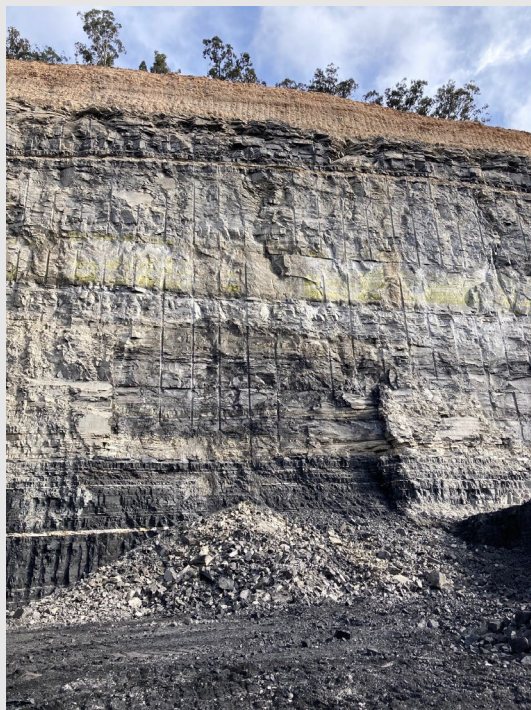
Dangerous incident
IncNot0042587
Open cut coal mine
Ground or strata
failure

While a dump truck was being loaded at the toe of a highwall, material from in front of the presplit fell from the highwall and landed in the rear of the truck tray. The truck tray head-board lifted two to 3 metres and then free fell back down into the lowered position. The 2 operators in the cab were shaken and suffered minor injuries. The highwall where the failure occurred was not excavated back to the presplit wall, leaving potentially loose material hanging up on the wall. As the coal was removed below, the material in front of the presplit wall collapsed quickly. The loose material on the wall was not identified as part of the site's geotechnical hazard reports.

Mine operators must have safe systems of work in place to inspect highwalls. These inspections must consider conditions that may affect highwall stability. An assessment of the integrity of the highwall must be conducted before commencing work beneath the highwall. Loose material or overhanging rocks must be removed before any work commences or appropriate controls, such as an exclusion zone, put into place. Refer to Safety Bulletin: [SB20-01 Failure of highwalls, low walls and dumps](#).

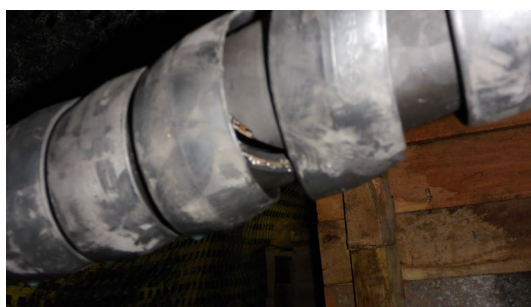
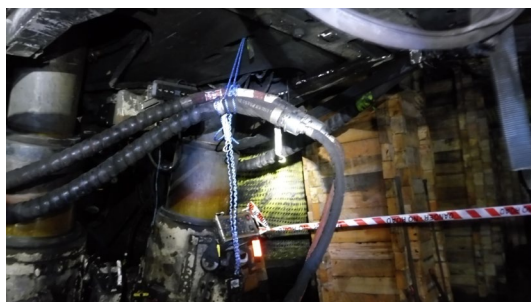
Dangerous incident
IncNot0042593
Underground coal
mine

While lowering a roof support on a longwall recovery face, a fitter was hit in the chest by a release of fluid from a 63 mm return hose. The worker was about 1 metre from the point of failure.

Mine operators must develop and adhere to strict inspection and maintenance standards to avoid hose failures because of damaged and aged hoses.

When procedures specify the use of remotes and pendants, workers should not be entering no go zones to operate roof supports manually.
