WEEKLY INCIDENT SUMMARY

Week ending Friday 24 June 2022

This incident summary provides information on reportable incidents and safety advice for the NSW mining industry. To report an incident to the NSW Resources Regulator: phone 1300 814 609 24 hours a day, 7 days a week.

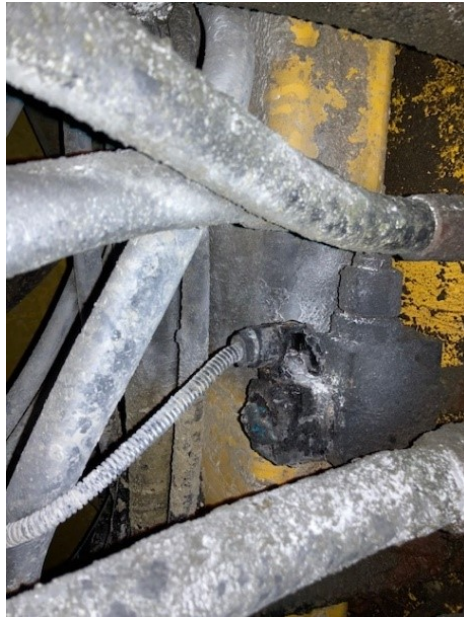
INCIDENT TYPE	SUMMARY	COMMENTS TO INDUSTRY
Dangerous incident IncNot0042420 Underground metals mine Fire or explosion

A shotcrete crew was setting up underground when a glow was noticed under the shotcrete unit. On inspection, small flames were seen. The flames were extinguished with a hand-held extinguisher. The incident appears to have been caused by high resistance at a corroded DIN connector on the solenoid coil.	Mine operators must develop and adhere to inspection and maintenance standards to ensure plant is fit for purpose. Electrical components should be inspected, tested, and maintained in accordance with the manufacturer's recommendations.

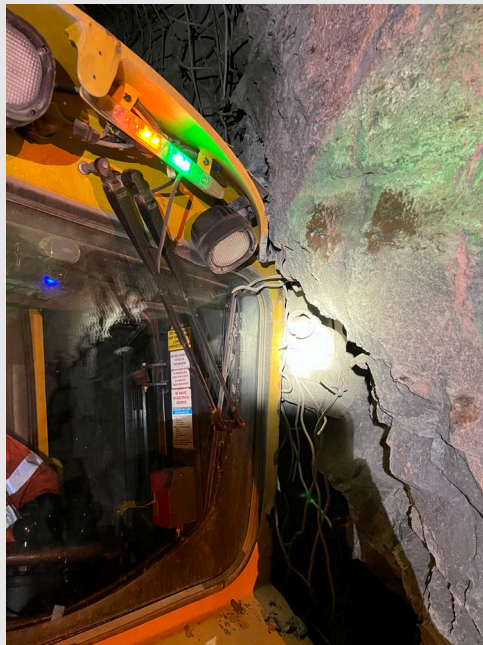
Dangerous incident
IncNot0042423
Underground
metals mine
Roads or other
vehicle operating
areas

A worker was driving a loaded haul truck up a decline at the end of night shift. The worker fell asleep and the truck hit the decline wall.

Workers must present to work fit for duty. This involves having suitable sleep before starting a night shift.

Mine operators are reminded of their obligations under the health control plan to ensure control measures have been identified and implemented to ensure workers are fit to carry out work and minimise the risk that workers could be impaired by fatigue.

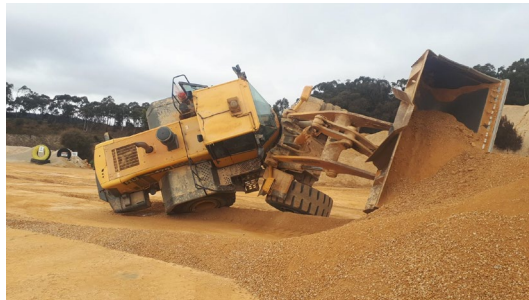
Dangerous incident
IncNot0042438
Construction
materials
Roads or other
vehicle operating
areas

A worker was blending material using a wheel loader when the loader tipped. The worker articulated the loader with a raise bucket of material to be square to the stockpile and as the front wheels rode up the stockpile, it rolled.

When operating articulated machines workers must remain vigilant to the risk of rolling over. Articulating on grades, raised buckets and attachments and hazards such as holes increase the risk of rolling over.
