# WEEKLY INCIDENT SUMMARY

Week ending Friday 8 July 2022

This incident summary provides information on reportable incidents and safety advice for the NSW mining industry. To report an incident to the NSW Resources Regulator: phone 1300 814 609 24 hours a day, 7 days a week.

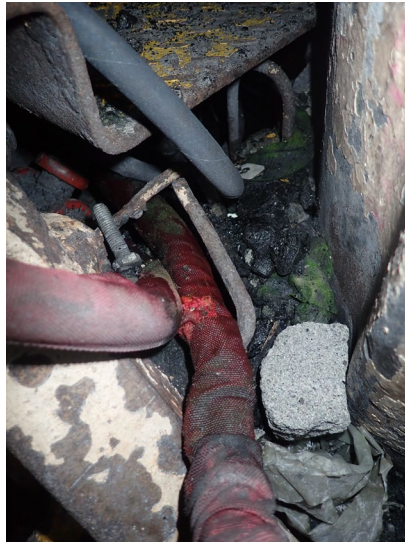
INCIDENT TYPE	SUMMARY	COMMENTS TO INDUSTRY
Dangerous incident IncNot0042489 Underground coal mine	A worker was standing on a roof support when a high set hose failed on the adjacent support. The worker was struck with fluid on the arm. The mine uses a fluorescent dye additive in the longwall fluid. An inspection with a black light revealed emulsion in a pre-existing abrasion on the worker's arm. The worker was later cleared of injury when	Mine operators must develop and adhere to strict inspection and maintenance standards to avoid hose failure due to damaged and aged hoses. The life cycle of hydraulic hoses must be managed. High-risk hoses should have hose replacement schedules documented in the mines' maintenance systems. For further information refer to: <a href="#">MDG-41-Fluid-power-systems</a>

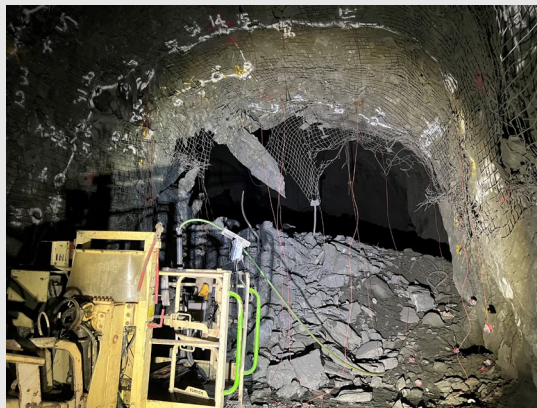
Dangerous incident  
IncNot0042491  
Underground  
metals mine  
Ground or strata

While charging an up-hole stope, workers were at an explosives hole charging unit when a brow failure occurred.

The failure was estimated at 20 tonnes, with some material breaching the bund. Nobody was injured.

Underground mines should confirm workers are not exposed to the risk of strata failure by reviewing:

- the adequacy of their strata support at brow points
- monitoring arrangements
- associated trigger action response plans (TARPs)

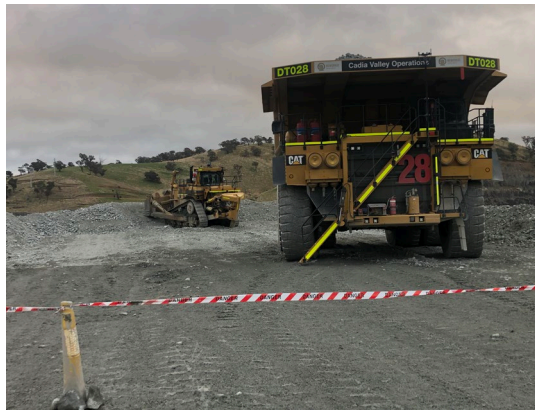
Dangerous incident  
IncNot0042496  
Underground  
metals mine  
Roads or other  
vehicle operating  
areas

A rear dump operator entered a tip head but could not establish positive communications due to 2-way congestion. The operator did not attempt positive communications and started to back up, hitting the ripper on the dozer. The truck operator thought the dozer was moving out of the way.

These types of accidents are becoming far too common in the NSW mining industry. As a minimum, mine operators should put effective measures in place to monitor compliance to positive communication requirements and take action to correct as necessary.

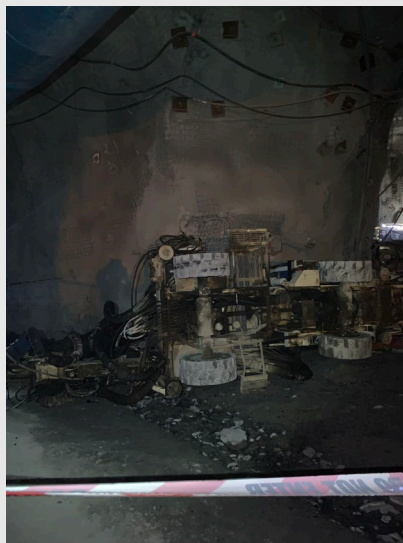
High potential  
incident  
IncNot0042512  
Underground  
metals mine  
Roads or other  
vehicle operating  
areas

A diamond drill rig rolled over while maneuvering into a new drill site underground. The operator was reversing into position when the rig slipped into a gutter and rolled over onto its side. No-one was injured.

Equipment operators must maintain situational awareness and remain vigilant regarding the risk of machine rollovers. When planning tasks and travel paths, workers and supervisors must consider rollover hazards such as cross grades, windrows, drains and potholes.
