INVESTIGATION REPORT

DANGEROUS INCIDENT AT BOGGABRI MINE

Failure to adequately control falling object hazard

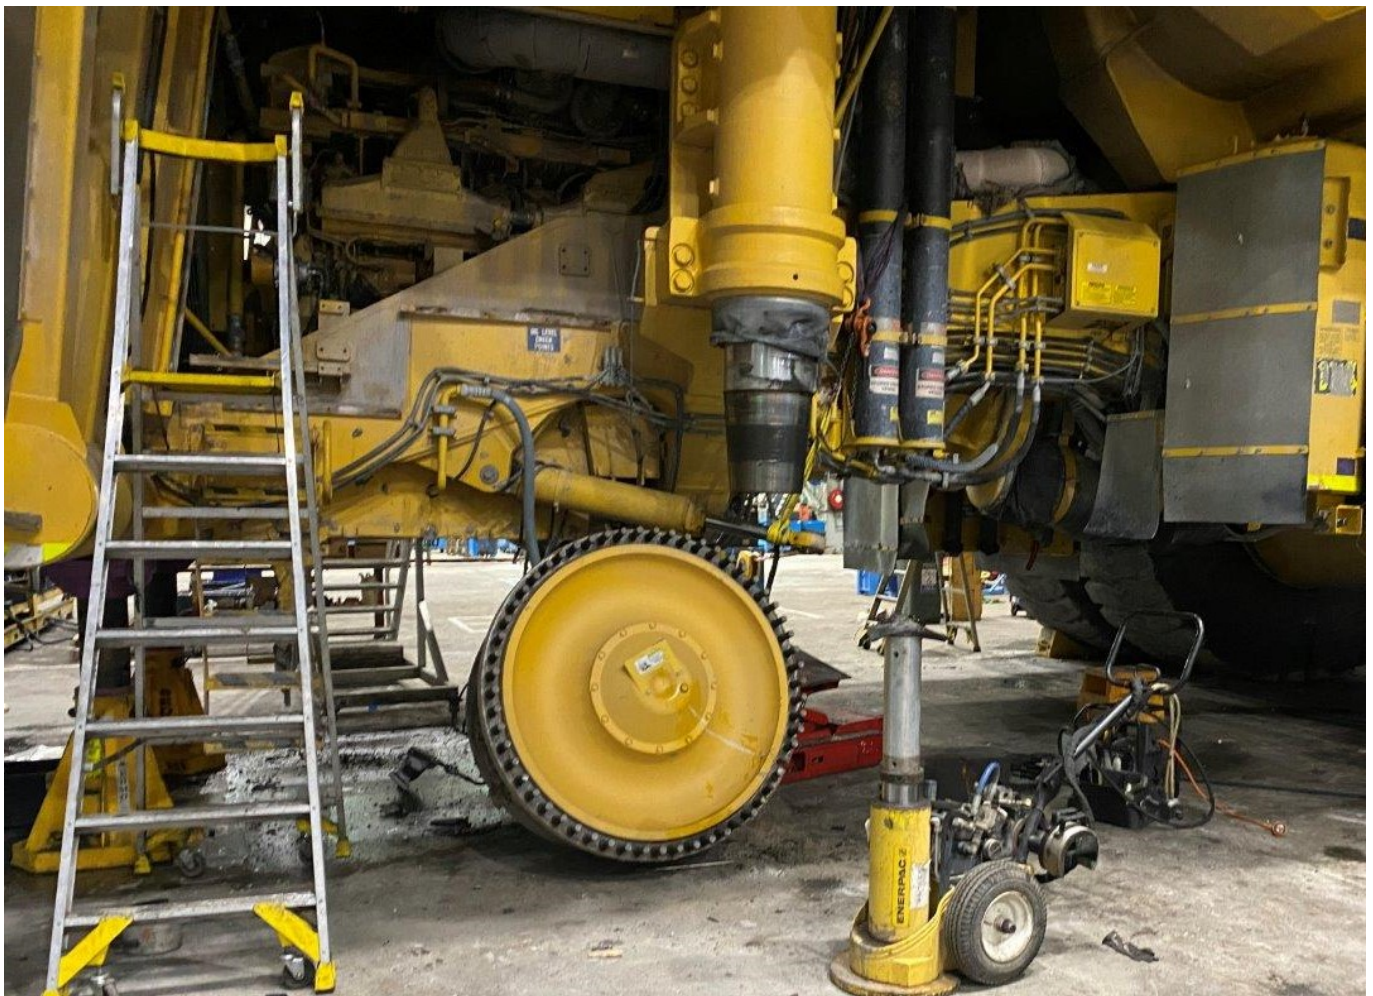
Figure 1 The incident scene.

A dangerous incident occurred at the mechanical workshop at Boggabri Mine on 31 January 2022. Three workers were preparing to remove a wheel hub and strut from position one of a Komatsu 930E dump truck when the wheel hub fell to the ground, narrowly missing the workers. None of the workers were injured as a result of the incident.

The wheel spindle hub was separated from the strut. The weight of the hub was supported on the floor jack and movement temporarily constrained by the taper of the strut still being inside the hub. The hub began to turn around the taper joint, slipping on the top of the jack. The hub fell to the floor with the 3 workers in close proximity. This occurred around 3 am.

- The hub fell as it was not appropriately supported on a single point. When the hub moved it toppled off the jack as it was not restrained.
- The method of supporting the hub/spindle assembly with only a floor jack while separating the taper had become an accepted practice on site. Neither the mine nor the inspectors' investigation could determine when this occurred.
- Change management and risk review was not conducted to vary from the OEM procedure.
- Although the separation of the hub and supporting it was identified as a hazard in the JSEA completed by the work crew, the significance of the falling object hazard and the requirement for a method to ensure it was secured was not fully appreciated.

- When procedures vary from OEM or existing site procedures, a change management process should be followed to identify any additional risks.
- Subject matter experts and workforce representation should be included during the risk management process. This includes when identifying hazards and determining controls for tasks including major component replacement.
- Mine operators should provide appropriate task specific tool and equipment available to minimise falling object and other hazards for major component change out.
- When supporting loads, the potential for loads shifting during all steps of the process should be assessed.
- When large, bulky or awkwardly shaped components are being changed, suitable aids such as frames and jigs should be provided and used by workers.
