SAFETY BULLETIN

Mobile lighting plant at mining workplaces

CM9 reference	RDOC22/101999
Mine safety reference	SB22-10
Date published	5 August 2022
Authorised by	Chief Inspector Office of the Chief Inspector

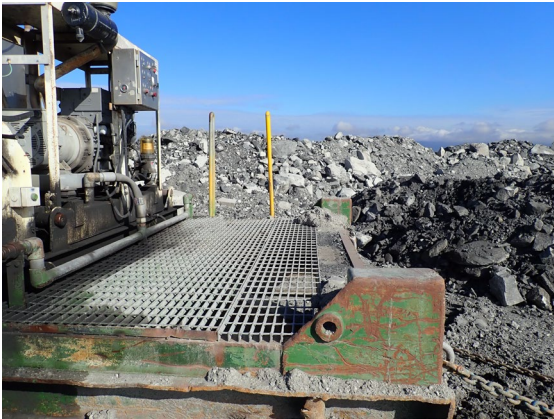
- Raised platforms without handrails or other controls to prevent a fall from the platforms.
- Buckled and uneven surfaces creating trip hazards for operational and maintenance workers.

Figure 1– Fall from Heights risk - sled style lighting plant

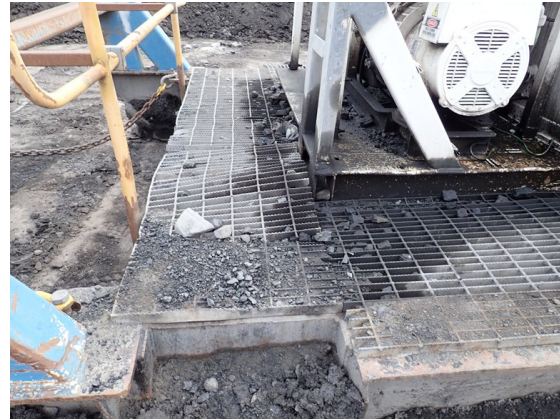
Figure 2 – Damaged platforms

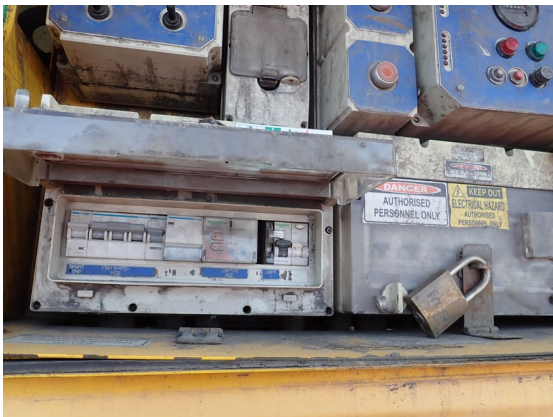
Figure 3– Unsecured LV electrical protection devices – accessible by non-electrical workers

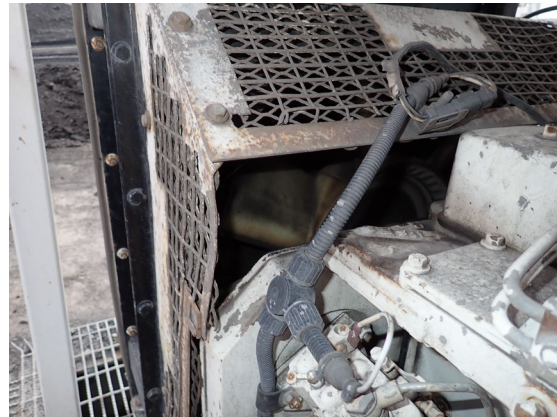
- Damaged stabiliser legs and missing wheel chocks for trailer units.
- Damaged, unusable tow plugs and wiring.
- Damaged, inadequate or ineffective guarding of rotating parts - fan blades and pulleys.

Figure 4– Ineffective guarding against rotating parts
