**NSW
Resources
Regulator**

FIRES ON MOBILE PLANT

October – December 2021

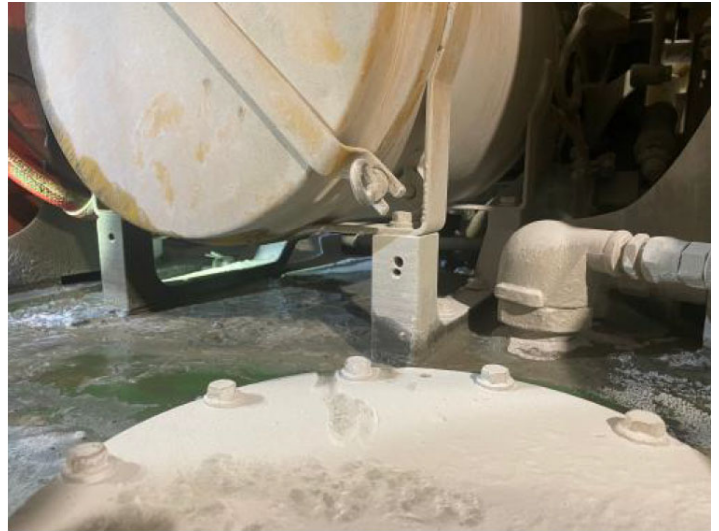
Figure 1: Loader fire

While refuelling a Caterpillar R3000 loader at an underground metalliferous mine, pressure caused a bolt to be released from an air filter housing, allowing fuel to spray onto the turbo exhaust system. A service person used a fire extinguisher to extinguish the fire. Fuel then sprayed onto the DPF box and caught fire and a second extinguisher was used to extinguish the fire.

<p>While refuelling a Caterpillar R3000 loader at an underground metalliferous mine, pressure caused a bolt to be released from the air filter housing</p>	<p>The air filter box hold down bolt that is mounted on top of the fuel tank had stripped thread,</p>

This incident is an important reminder that before undertaking any changes, an assessment of that change should be conducted to ensure no other hazards are introduced as a result of the change.

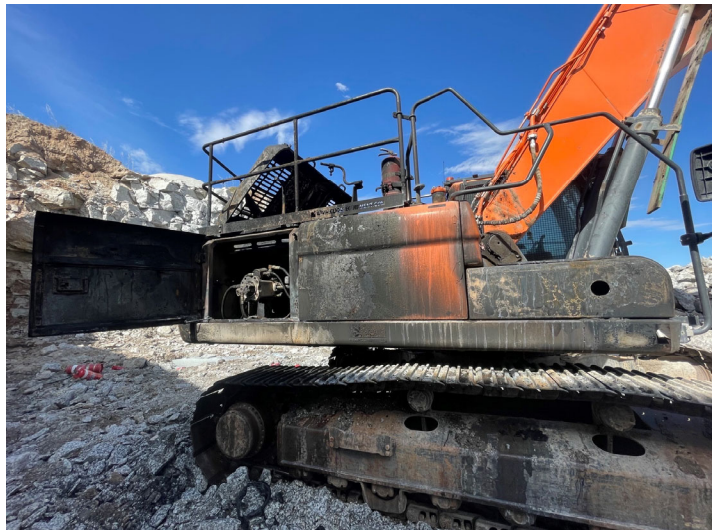
Figure 2: Excavator fire

At an open cut quarry, a worker was operating a Doosan DX300LC excavator when they noticed a fire in the engine bay. The operator stopped and exited the machine. Workers tried unsuccessfully to stop the fire with extinguishers. The fire brigade was called and attended the scene. The fire was put out by the fire brigade. The machine was destroyed.

This incident is an important reminder to have a system in place to check and clean engine bays of equipment to prevent the build-up of combustible materials.

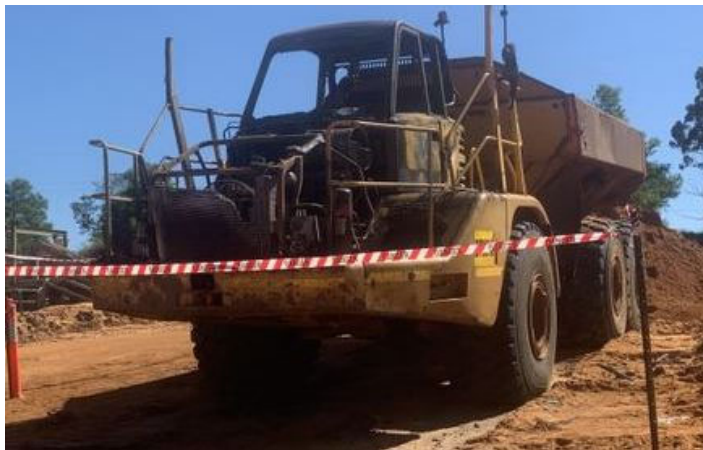
Figure 3: Articulated dump truck fire

At an open cut quarry, a Caterpillar 740 articulated dump truck caught on fire. The operator stopped the machine and called for assistance.

This incident is a reminder of the importance of quality maintenance and pre-use inspections in the prevention of premature failure of components.
