WEEKLY INCIDENT SUMMARY

Week ending Friday 26 August 2022

Mine safety reference ISR22-33

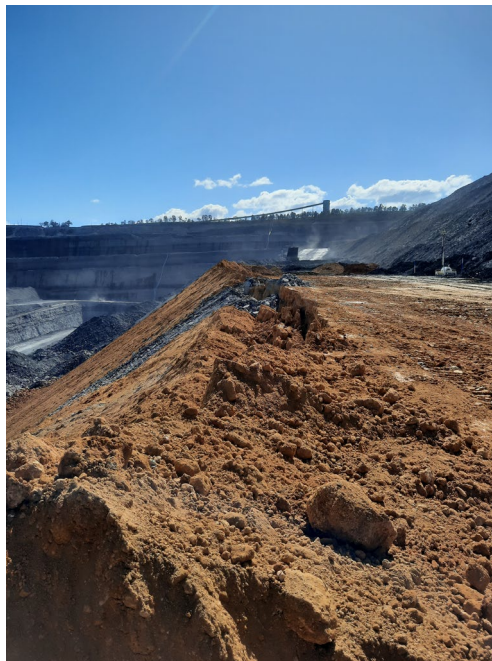
Dangerous incident
IncNot0042849
Open cut coal
mines
Ground or strata
failure

The edge of a dump failed, causing a slump of about 80 metres in length. No vehicles were operating on the edge at that time.

Mines should review their dump trigger action response plans (TARPs) because of continued wet weather. Water management practices around dumps should also be audited and reviewed. Geotechnical assessments of dumps should be undertaken when dump material changes or the dump design is modified.

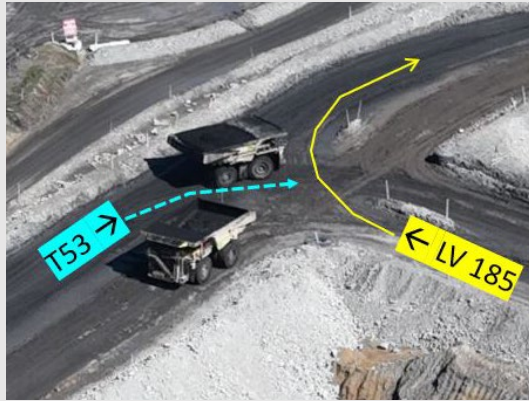
Dangerous incident
IncNot0042874
Open cut coal mine
Roads or other
vehicle operating
areas

A light vehicle narrowly avoided a collision with a haul truck at a T-intersection. Two haul trucks were approaching the intersection from different directions. The light vehicle driver was concentrating on the truck approaching on the right, which was turning into the lane adjacent to the light

vehicle. The light vehicle failed to notice the truck on their left, requiring the truck to brake to avoid a collision.

Light vehicle operators need to maintain constant vigilance when driving on haul roads. It is imperative that drivers check for vehicles both left and right at T intersections before proceeding through a corner.

The design of intersection must consider height of windrows and positioning of lights that may affect the visibility of drivers.
