Safety Alert

Date: October 2022

Service brakes fail on moving articulated dump truck

Safety Alert SA22-05

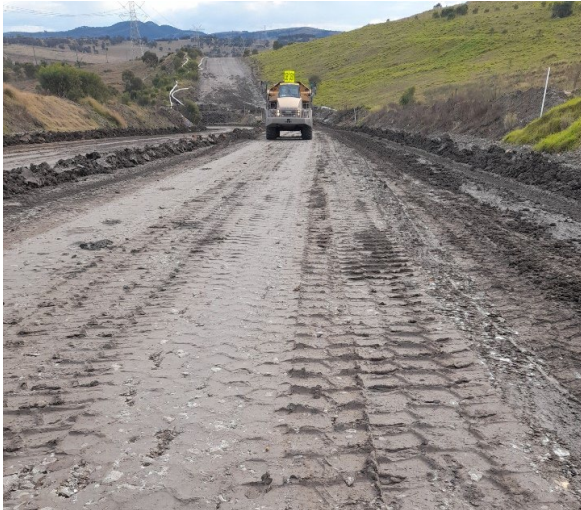
A loaded Caterpillar 740 articulated ejector truck ran out of diesel fuel and shut down ascending a 10% gradient.

The truck stopped, then rolled backwards for 49 m when the truck's service brakes (dynamic brakes) failed. The truck was only brought to rest when the park brake was activated. Park brakes are not designed for dynamic applications.

Figure 1 The Caterpillar 740 articulated truck involved in the incident

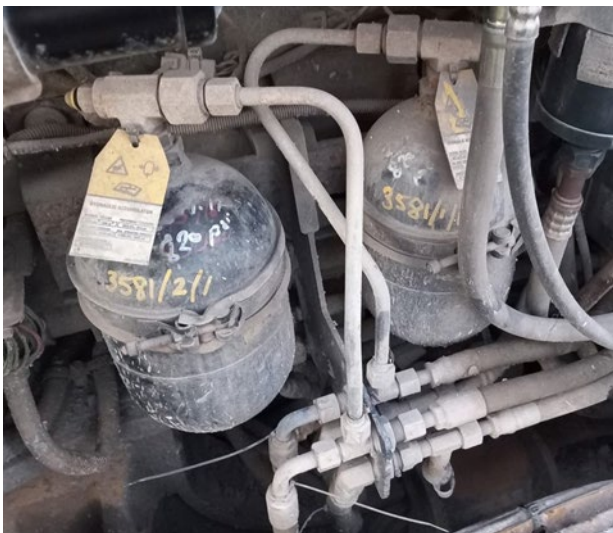
Figure 2 Front and rear brake accumulators

When data was retrieved from the truck, there were 53 low brake pump pressure alarms over the previous 829 hours of operation. This indicated an intermittent fault, such as failed brake accumulators for some time. These alarms were both inside the truck cabin and the vehicle monitoring system. There was no record of either the truck operator saying alarms were heard or the maintenance team acting on the intermittent alarms.

4. Both front and rear service brake accumulators were inoperable.

Both the front and rear service brake accumulators had no pre-charge pressure. The OEM required this to be checked at each 2000-hour service. The OEM dealer completed the previous 2000-hour service on the truck. This accumulator check was not done by the service technician at the time. The service sheet was submitted with accumulator tests marked with not applicable. Neither supervisors of the dealer, equipment owner or mine representative identified these 2 accumulators were not checked in the 2000-hour service.

1. verify that accumulators on service brakes are being checked at the service intervals as recommended by the OEM
2. regularly check (daily or weekly) service brake accumulator. A test, such as turning off the vehicle and testing the number of brake pedal applications after shutting down should be developed with the OEM or a competent person
3. ensure their defect management system records and documents when a defect is rectified
4. ensure there is a system to identify, and investigate intermittent alarms and the system is documented
5. ensure there is documented system for communication of prestart checks, defects and maintenance activities between mine operators, vehicle owners and the organisation that maintain vehicles
