WEEKLY INCIDENT SUMMARY

Week ending Friday 30 September 2022

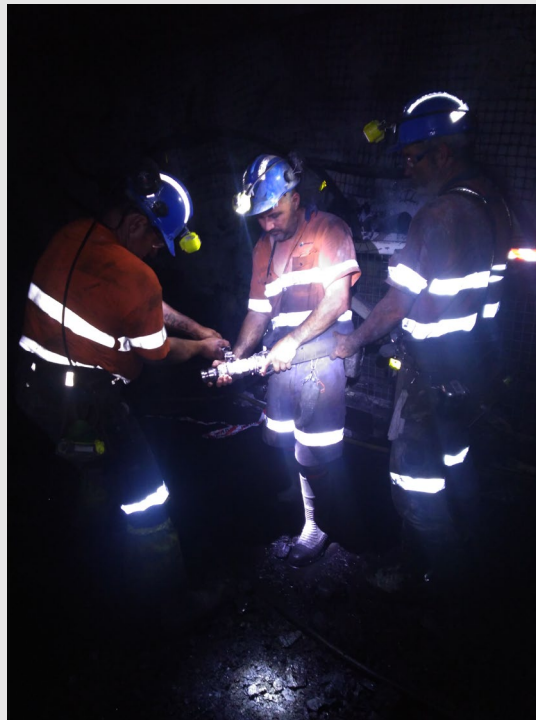
Dangerous incident
IncNot0043103
Underground coal
mine

A worker sustained a laceration to his leg from a flailing water hose while setting up water supply to a continuous miner. Three workers were in the process of removing a ball valve tap in order to join two bull hoses. After checking that the line was isolated two workers held the hose while another attempted to flush the line by opening the ball valve. When the valve was opened the pressure has whipped the hose out of the workers hands allowing it to flail around.

Mines should consider including fixed drainage points to prevent workers from releasing stored pressure from loose hoses. Consider using gate valves in place of ball valves to better control the release of energy. Workers are reminded of the risks involved in whipping hoses.

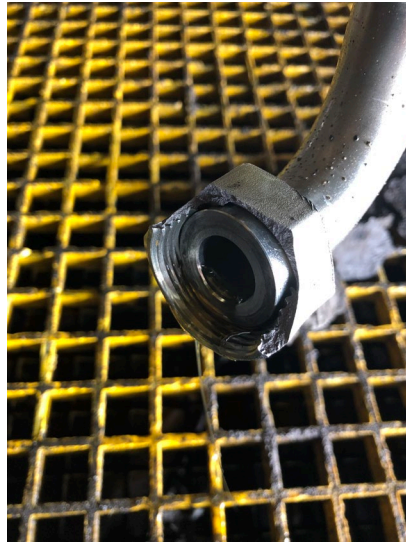
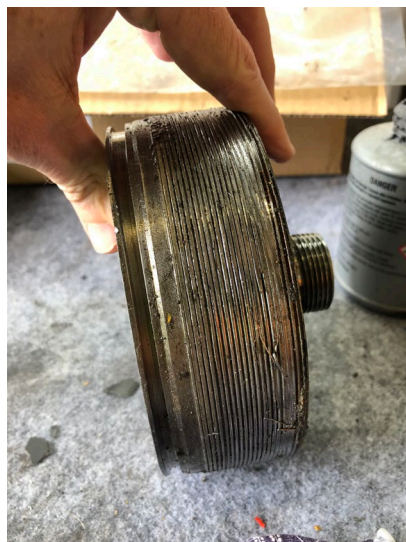
Dangerous incident
IncNot0043119
Open cut coal mine

During pressure checks on a refurbished steering accumulator on a haul truck, the centre accumulator failed. The piston and cap were ejected under pressure and mounts were damaged. The cap was found 3 m from the truck while the cylinder piston was found 20 m from the truck. Nobody was injured.

This incident is under investigation to determine the root cause and further information may be published later. This incident highlights the importance of considering component failure and having no-go zones in place when commissioning hydraulic systems.

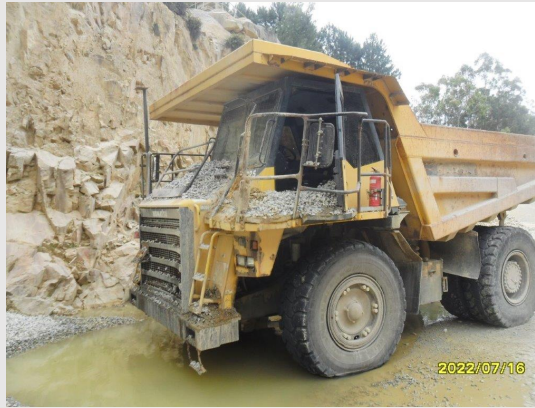
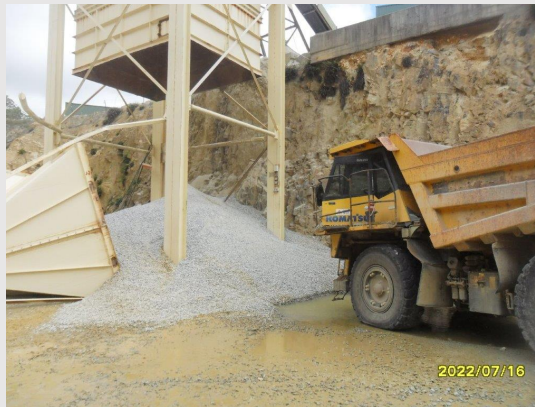
Dangerous incident
IncNot0043131
Construction
materials

While loading a dump truck from a silo, the driver noticed there was material coming out of the silo near the top of the cone. The driver closed the clam shells and drove out from under the bin. In order to open the clam shells to empty the bin, the truck driver positioned the truck to the bin to have access to the clam shell controls from the truck's platform. The driver then opened the clam shell slightly. As the truck driver returned to the cabin and started to reverse, the silo failed and material rilled

over the front of the truck smashing its windscreen. The operator was uninjured.

This incident is under investigation to determine the root cause and further information may be published later. Mine operators should review the adequacy of their structural integrity audits and ensure that remedial actions that have been identified as being required during such audits, are carried out in a timely manner.
