Weekly incident summary

Week ending 28 October 2022

Document control	
CM9 reference	DOC22/307493
Mine safety reference	ISR22-43
Date published	4 November 2022
Authorised by	Deputy Chief Inspector Office of the Chief Inspector

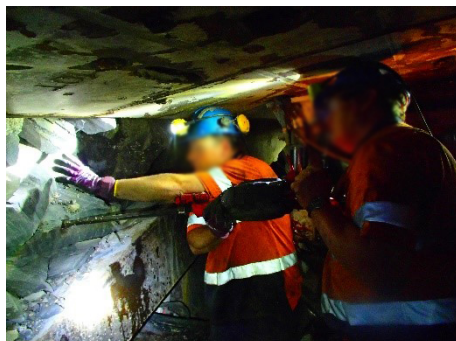
Incident type	Summary	Comments to industry
Dangerous incident IncNot0043302 Underground coal mine	<p>Two longwall roof supports rotated and were canopy tip down. To correct this, workers were drilling and shooting stone above the roof supports.</p> <p>Two workers were using a hand-held air drill, one behind the drill operating it and a second next to the drill holding it. The second worker saw a small rock fall into the work area and the other worker reached across the drill to deflect it. As he reached, his jumper became caught in the rotating steel. The worker suffered severe friction burns to his right forearm. The crew had to cut the jumper away to release the worker.</p>	<p>Workers must remain situationally aware when operating any type of equipment or plant.</p> <p>Training in how to operate hand-held drilling equipment should include the hazards of rotating drill steels and interaction with clothing and long hair.</p> <p>Drill operators should keep both hands on the operating drill at all times and ensure they remain clear of rotating components such as drill steels and chucks.</p>

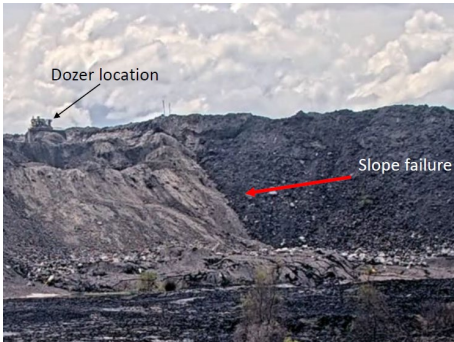
Incident type	Summary	Comments to industry
Dangerous incident IncNot0043318 Open cut coal mine Ground or strata failure	<p>A slump occurred at a tailings dam while a dozer was preparing the area for a remote dozer push. The preparation works included establishing a tip head at the dozer sighter peg line and filling in the void area prior to the sighter pegs.</p>

<p>The image shows a large, dark, rocky tailings dam. A dozer is visible on the top edge of the dam, with an arrow pointing to it labeled 'Dozer location'. A red arrow points to a section of the dam's slope that has failed, labeled 'Slope failure'.</p>	<p>Mine operators must have safe systems of work in place to inspect highwalls, low walls and dumps. These inspections must consider weathering effects, ground water and conditions that affect the stability.</p> <p>Operators working in the vicinity of geotechnical hazards should be trained and deemed competent to do so.</p> <p>Refer to: Safety Bulletin SB20-01 Failure of highwalls, low walls and dumps.</p>

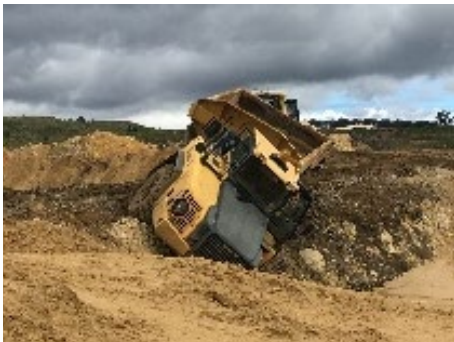
Dangerous incident IncNot0043322 Construction materials Ground or strata failure	<p>An articulated dump truck was driving along a newly constructed roadway when the roadway has failed. The truck cabin tipped approximately 45 degrees before coming to a stop. The worker was not injured.</p>

<p>The image shows a yellow articulated dump truck that has overturned on a newly constructed roadway. The truck is tilted at a steep angle, with its cabin and front end resting on the ground. The roadway appears to be made of loose soil or sand.</p>	<p>Mine supervisors should conduct frequent physical inspections of mine roadways to identify potential hazards that may pose a risk to plant operators.</p> <p>This is especially important during significant rainfall when the potential for slumping to occur increases.</p> <p>Roadway standards must be documented and include factors such as using competent material, compaction requirements and windrow specifications.</p>
