Weekly incident summary

Week ending 16 December 2022

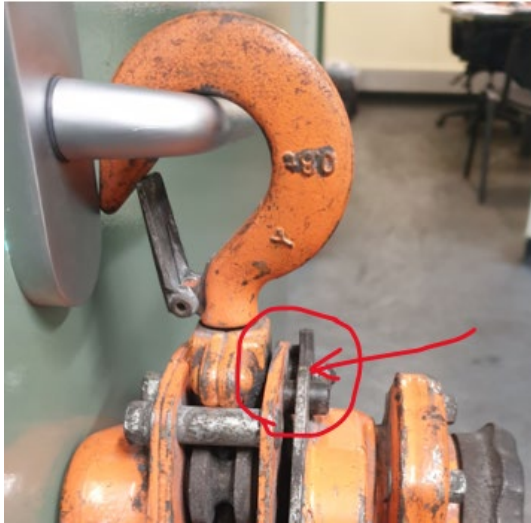
Incident type	Summary	Comments to industry
Dangerous incident IncNot0043705 Underground coal mine	<p>Two workers were changing rollers on a drift conveyor. The conveyor belt was lifted using 2 lever hoists and chain shorteners. While changing out the roller, the lifting gear failed, dropping the belt. One worker was hit on the shoulder and neck. The worker was cleared of injury after being assessed at hospital.</p> <p>The investigation identified that the lever block was not fully engaged.</p>

<p>Workers must be trained to use lifting equipment before carrying out lifting activities.</p> <p>Workers must inspect lifting equipment for damage, defects and debris that may affect the safe use of lifting equipment before starting a lifting task.</p> <p>Workers must be reminded of the risk associated with working under suspended loads and controls put in place to remove the risk.</p>

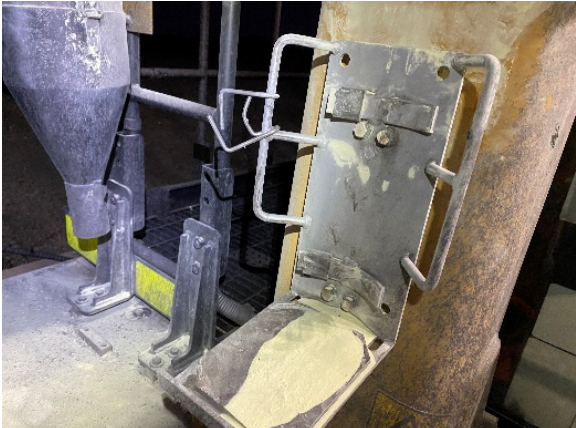
<p data-bbox="113 797 411 864">High potential incident</p> <p data-bbox="113 875 411 920">IncNot0043683</p> <p data-bbox="113 931 411 976">Open cut coal mine</p>	<p data-bbox="419 797 1038 1099">A dozer was operating when a loud noise was heard and the dozer was suddenly engulfed in a plume of white powder. The operator stopped and inspected the dozer. The 9 kg dry chemical powder fire extinguisher was missing from the mounting bracket on the roll over protection structure. The strap was on the hydraulic oil tank. The extinguisher was found ruptured, with a vertical split, 18 metres away.</p> <p data-bbox="419 1111 1038 1234">From initial inspections of the failed extinguisher, the heads of the bolts on the mounting bracket rubbed on the body of the fire extinguisher.</p>

<p data-bbox="1046 797 1477 965">Mine operators should revise routine fire extinguisher inspections to confirm clearance between extinguishers and any mounting hardware.</p> <p data-bbox="1046 976 1477 1133">Workers tasked with inspecting fire extinguishers must thoroughly inspect extinguishers for any sign of damage.</p>

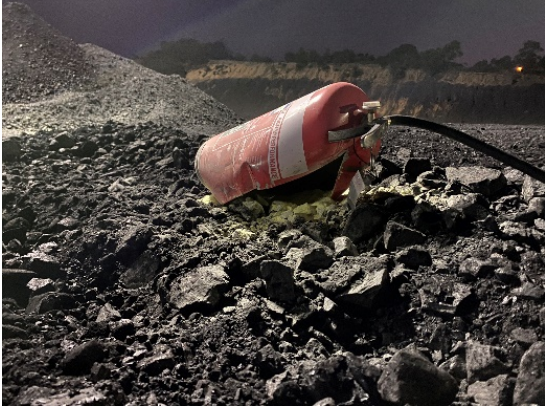
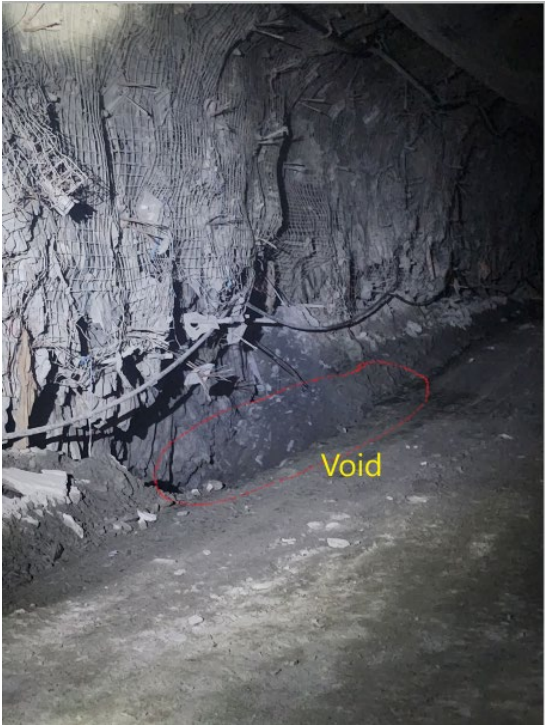
<p data-bbox="124 633 395 840">Dangerous incident IncNot0043673 Underground metals mine Ground or strata failure</p>

<p data-bbox="424 633 1023 913">A loader operator went into the wrong draw point and proceeded to start bogging out in an underground metalliferous mine. While attending a production drill on the level above, a fitter has observed a void in the floor of the drive. The fitter and the production driller retreated from the drive and informed the shift supervisor. The area was then barricaded, and geotechnical assessment planned.</p>

<p data-bbox="1054 633 1465 757">Mine operators should use higher order controls to prevent inadvertent bogging of rills such as physical barriers.</p>
