Weekly incident summary

Week ending 9 December 2022

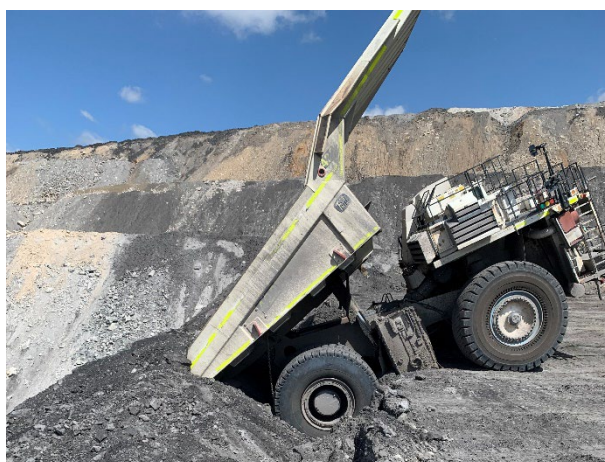
Incident type	Summary	Comments to industry
Dangerous incident IncNot0043667 Open cut coal Ground or strata failure	A haul truck was dumping material when the dump failed and the rear wheels of the truck sank. The body was half raised. Cracking was identified on the dump 14 hours earlier. The dump was cut down as per the mine's trigger action response plan (TARP). The mine was in the process of rebuilding the dump when the failure occurred.	When conditions warrant a change in TARPs and operating conditions, thorough assessments need to be made before returning to normal operations. Consider the suitability of material when building dumps and when determining if edge dumping or dumping short. All workers should be trained in the use and requirements of relevant TARPs.

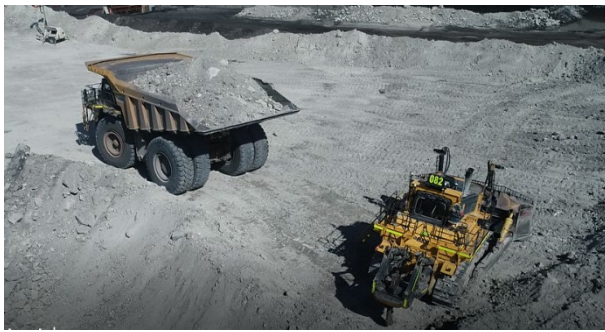
<p data-bbox="400 210 1023 293">A haul truck was reversing at a tip head where it reversed into a dozer, making contact with the rollover protective structure (ROPS).</p>

<p data-bbox="1023 210 1479 555">There continues to be too many incidents of this type occurring at open cut coal mines. Mine operators should review the hierarchy of controls for managing vehicle interactions at dumps. Segregation between dozers and trucks should be prioritised over administrative controls such as positive communications and procedures.</p>
<p data-bbox="113 701 400 784">Dangerous incident IncNot0043628</p> <p data-bbox="113 795 400 831">Open cut coal mine</p>	<p data-bbox="400 701 1023 831">During a shutdown, a boilermaker was setting up to air arc gouge in a scissor lift. As the scissor lift was raised, the positive lead was pulled apart.</p> <p data-bbox="400 842 1023 1126">While trying to reconnect the welding leads, the boilermaker pulled the insulation boot from the male part of the welding lead to attach vice grips and tried to rejoin the leads. The boilermaker then touched the scissor lift handrail with their hand and suffered an electric shock and burns. An ambulance officer gave the worker an ECG. The worker was cleared, but was taken to hospital to treat the burn on his hand.</p>
