Weekly incident summary

3 week period from 17 December 2022 to 6 January 2023

Document control	
CM9 reference	RDOC23/814
Mine safety reference	ISR23-01
Date published	13 January 2023

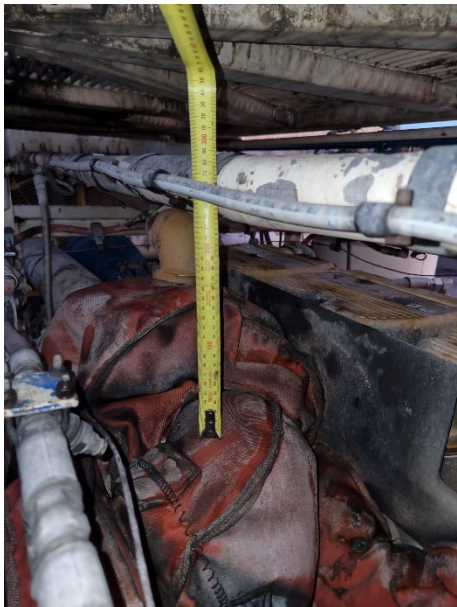
<p>A contractor commenced cleaning a drill rig engine bay with degreaser. The lagging became soaked with degreaser and when some was sprayed on a gap in the lagging it ignited. The contractor yelled out to another worker on the ground who immediately got into the water cart, moved it to the side of the drill rig and extinguished the fire using the water cart's cannon. The water cart was parked at the drill to assist in cleaning.</p>

<p>Where products are used near hot engine components such as cleaners and degreasers the ignition point should be assessed and compared with surface temperatures to manage the risk of fires. When selecting products, higher ignition point products should be used.</p>

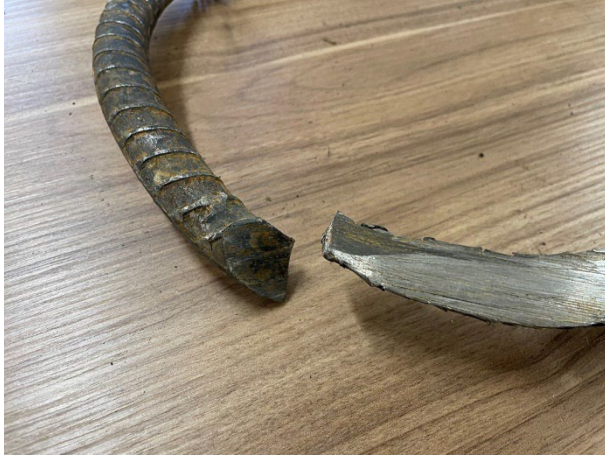
<p>An ignition of methane gas occurred on a longwall face. The flames self-extinguished after several seconds.</p> <p>The investigation identified the causal factors being a rib bolt jammed in the bottom race of the armoured face conveyor (AFC) as the ignition source and a floor break emitting methane gas in the immediate area.</p>

<p>This incident is a reminder to mines of the risk of methane emissions from lower seams impacting the work area.</p> <p>Mining supervisors must continually monitor and manage ventilation dead spots and layering of methane.</p> <p>The risk of frictional heating caused by metallic objects and the AFC must be considered in the risk assessment for longwall operations. Sources such as strata support, and poor housekeeping should be addressed.</p>

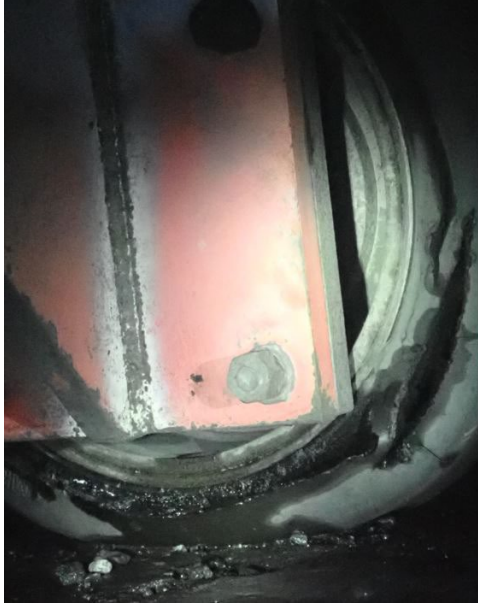
<p>High potential incident IncNot0043761 Underground coal Fire or explosion</p>	<p>A load haul dump (LHD) was towing a supply trailer into an underground coal mine. The operator of another vehicle saw a flame on one of the off-driver's side wheels, stopped the LHD and used an extinguisher to put out the fire. Inspections identified a delaminated tyre.</p>	<p>An uncontrolled tyre fire in an underground coal mine can have catastrophic consequences.</p> <p>Tyres should be inspected closely as part of pre-use inspections. Operators should receive training to assist them in identifying tyre defects.</p>

<p>The suitability of tyres for the duty cycle must be considered. Analysis should be reviewed when changes are made to payload, operating speeds, or cycle distances. Tyre data such as the Tonnes Kilometres Per Hour (TKPH) rating should be included in this review.</p>
<p data-bbox="124 831 373 1055">Dangerous incident IncNot0043703 Open cut coal Roads or other vehicle operating areas</p>

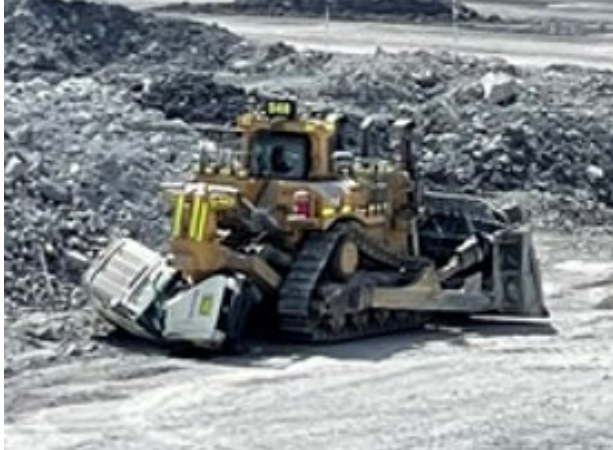
<p data-bbox="400 831 1007 1032">A worker was tasked with creating a park up area in a new work area at an open cut coal mine. The operator of a dozer reversed into and crushed the light vehicle they drove to the area. There were no other workers in the vehicle or working in the area at the time.</p>

<p data-bbox="1038 831 1461 999">Mines should review their park up procedures when workers are accessing parts of the mine without designated park up areas.</p> <p data-bbox="1038 1016 1461 1155">Operators must always remain vigilant and focused on the area surrounding the machinery they are operating.</p> <p data-bbox="1038 1173 1461 1379">Please refer to the Investigation report and animation video of the fatal incident that occurred in 2019 involving a dozer and light vehicle.</p>
