Weekly incident summary

Week ending 27 January 2023

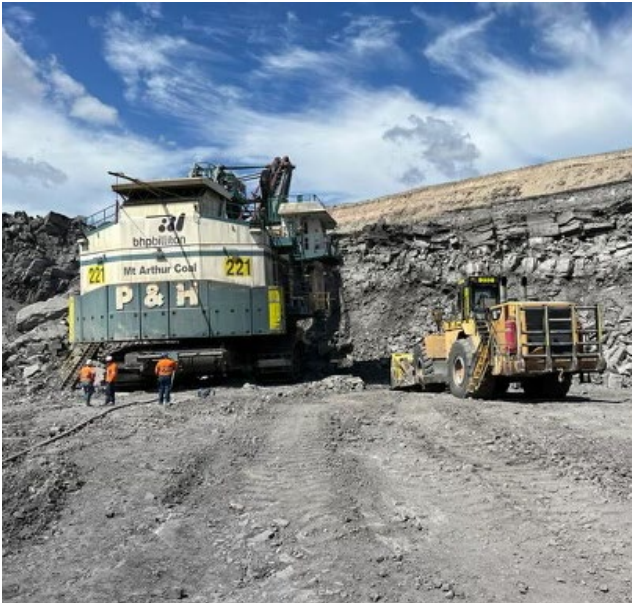
Incident type	Summary	Comments to industry
<p>Dangerous Incident</p> <p>IncNot0043933</p> <p>Open cut coal mine</p> <p>Roads or other vehicle operating areas</p>

<p>An electric rope shovel was loading a truck on the offside. A cat wheel dozer was hit with the shovel counterweight on the front left hand corner, striking the front walkway, handrail and cabin.</p>

<p>Collisions between mobile plant during clean-up activities are well-known and documented.</p> <p>It is recommended that when mine operators review their documented systems of work regarding working on or around excavation equipment, they consider the hierarchy of controls and the reliance on administrative controls (positive communications), which are susceptible to human factors.</p>

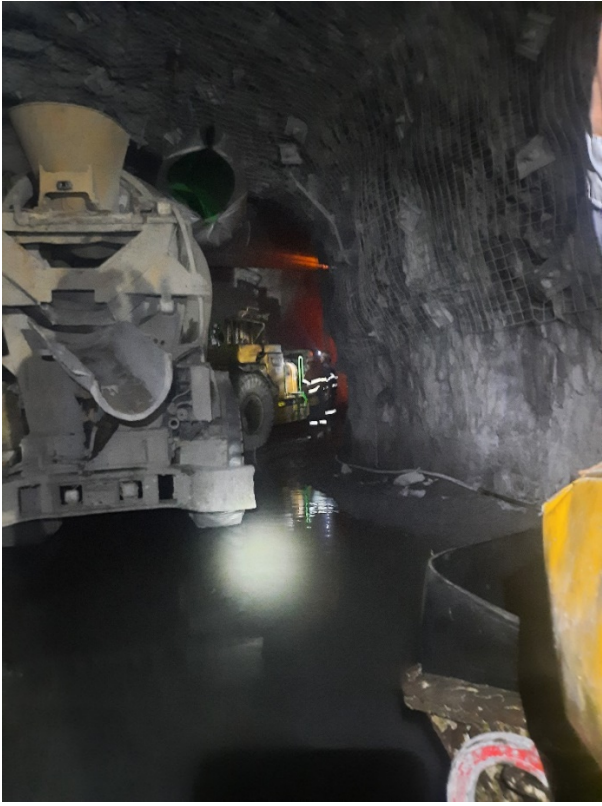
<p>Dangerous Incident IncNot0043970 Underground metals mine Fire or explosion</p>

<p>A shotcrete rig was set up to spray in an ore drive. As the agitator reversed into position behind the shotcrete rig, the shotcrete rig operator noticed a 200 mm high flame in the engine bay above the turbo. The shotcrete rig operator activated the emergency stop and the fire suppression system using the rear activation point on the agitator.</p> <p>The fire suppression system extinguished the flames and a hand-held fire extinguisher was also deployed as a precaution.</p>

<p>Mine operators must have systems in place to ensure that mobile plant is cleaned following a service to ensure that flammable substances are removed from potential heat sources.</p>
