Dangerous Incident – Dump slump 7th November 2022

Dangerous incident | IncNo0043383

Open cut coal mine

Ground or strata failure

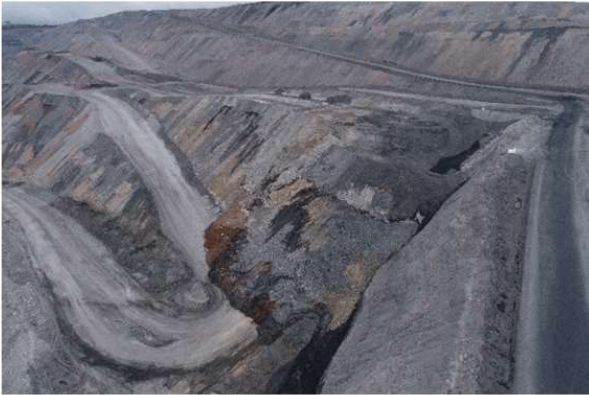
Summary: A dozer operator noticed minor cracking on a dump and notified their supervisor. The supervisor inspected the area and believed the cracks were associated with reject management at the front of the dump and only affected the current lift (7 m high). A hard barrier was established behind the area and the dozer operator was tasked with cutting down the dump. Later in the shift, the dozer operator noticed movement on the dump and began to reverse. The section of the dump the dozer was on slumped about 10 metres. The dozer was unable to exit the dump. The operator raised the emergency. A second dozer cut an access path for the first dozer to safely exit the area.

Recommendations to industry: When a hazard is identified, workers must not be placed at risk to remediate the hazard. The integrity of waste material and impacts on the mine design must be considered when dumping reject material in the mine.

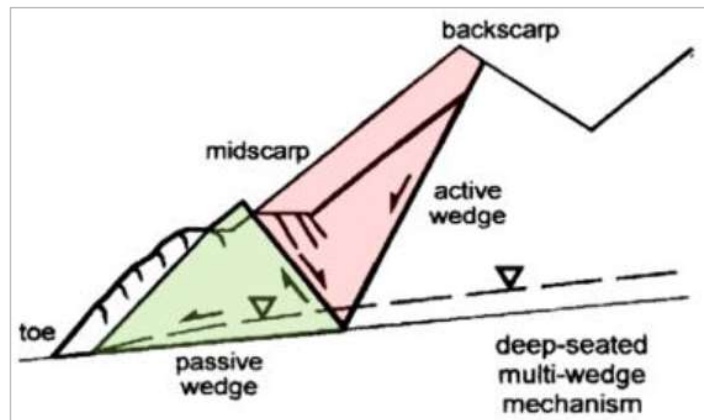
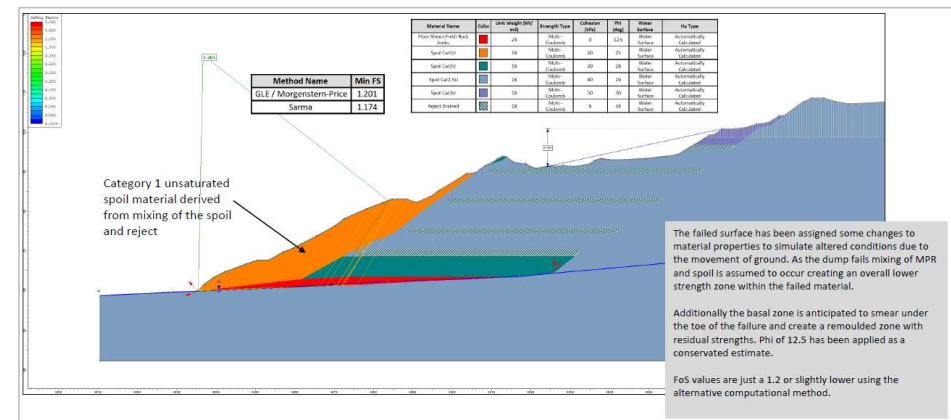
Contributing factors:

- A weak foundation layer in the base of the dump
- Contact between endwall (insitu) and reject has elevated pore pressures/weakened material strengths
- Hard-packed road + in-situ bench (the base of the dump) created differential contact and limited drainage
- Construction of the base of the dump was during very wet conditions
