Investigation Summary - Operator falls from dozer

Event - 1000493316

Investigation Summary - T913 Contacts Windrow OP1 Road

Event - 1000521330

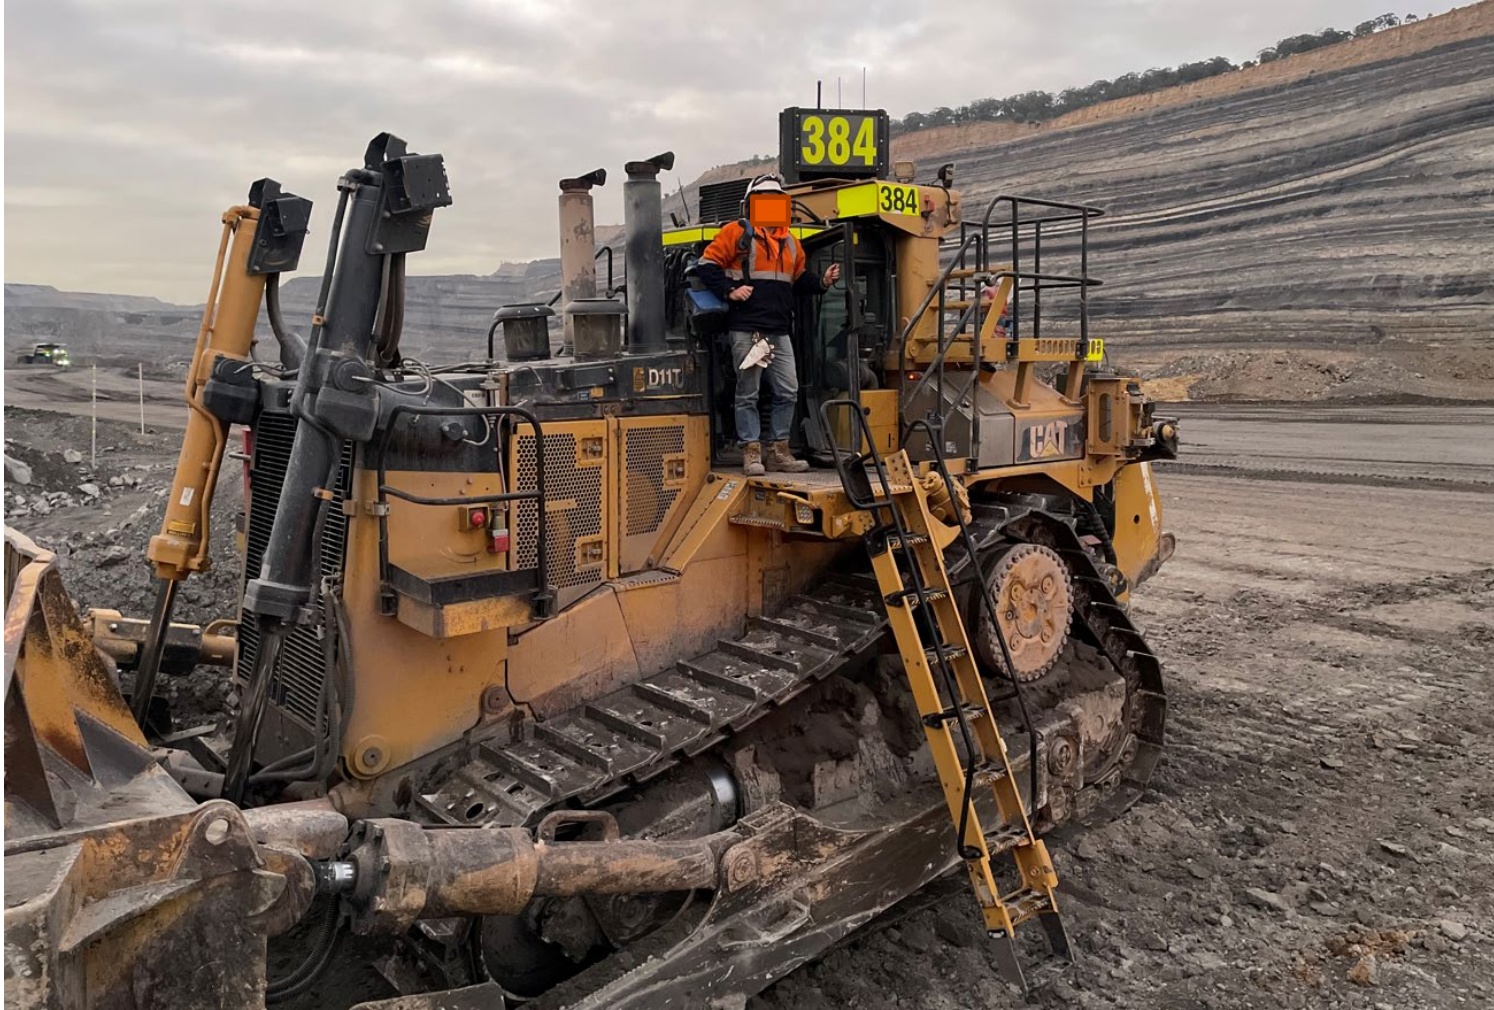
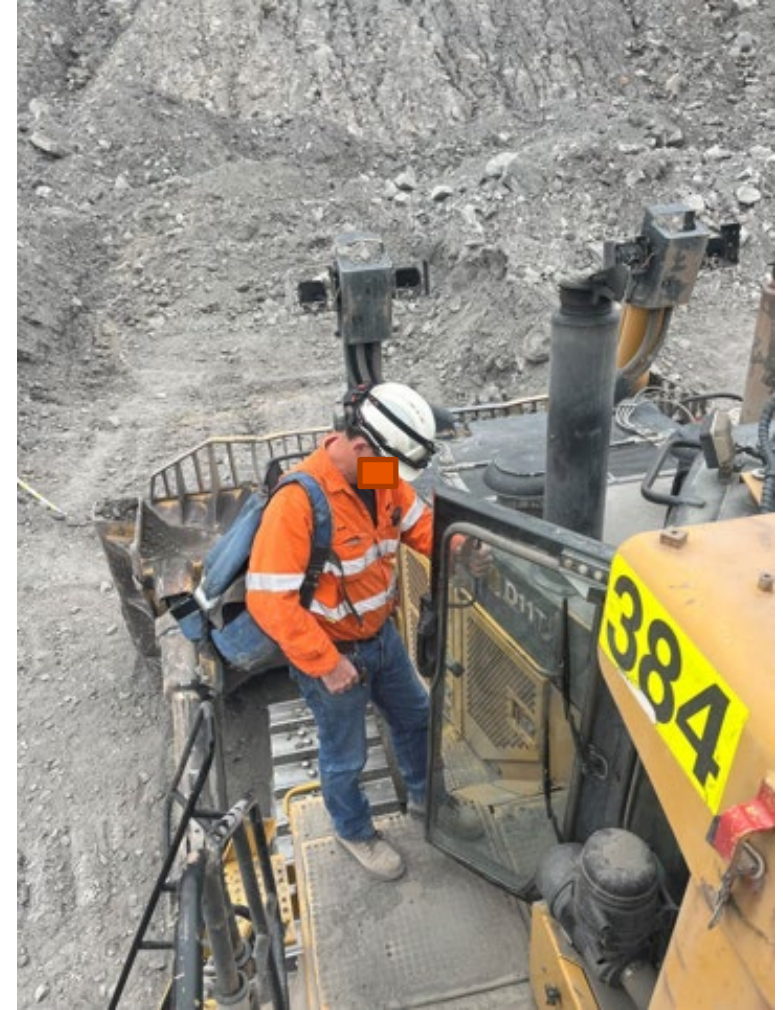
Operator of TRD384 right foot slipped / missed the small "L shaped" part of deck

- There was no barrier in place to prevent the fall from the platform. It is currently within appetite to wait for the implementation of fatal risk controls via the PCR / major equipment rebuild schedule.
- The absence of lighting on the night may have contributed to the workers awareness of the limits of the dozer platform in relation to their foot placement. The operator did not have a cap light, the dozer access lighting was not turned on by the operator.

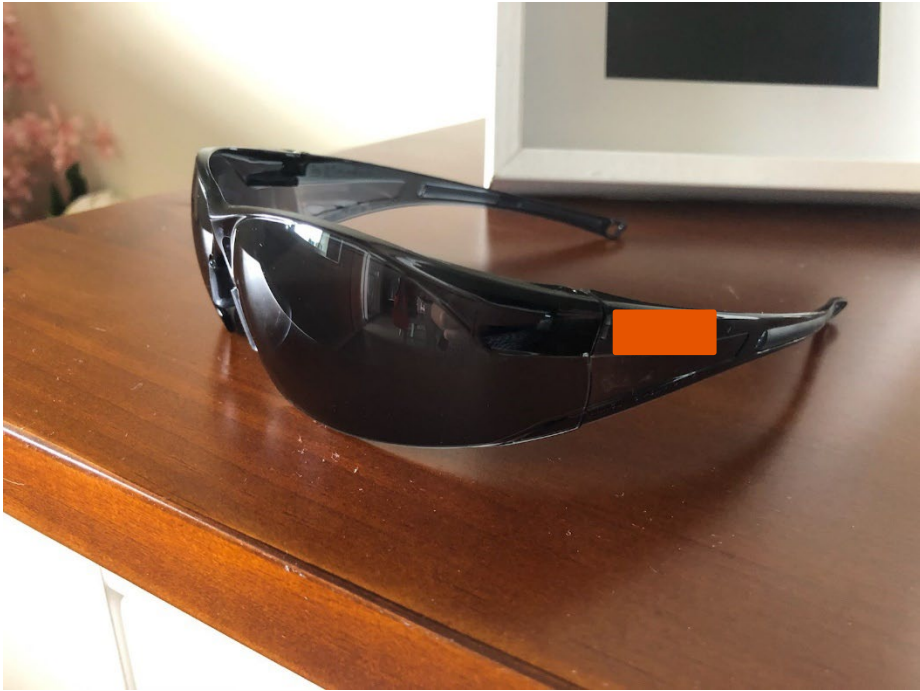
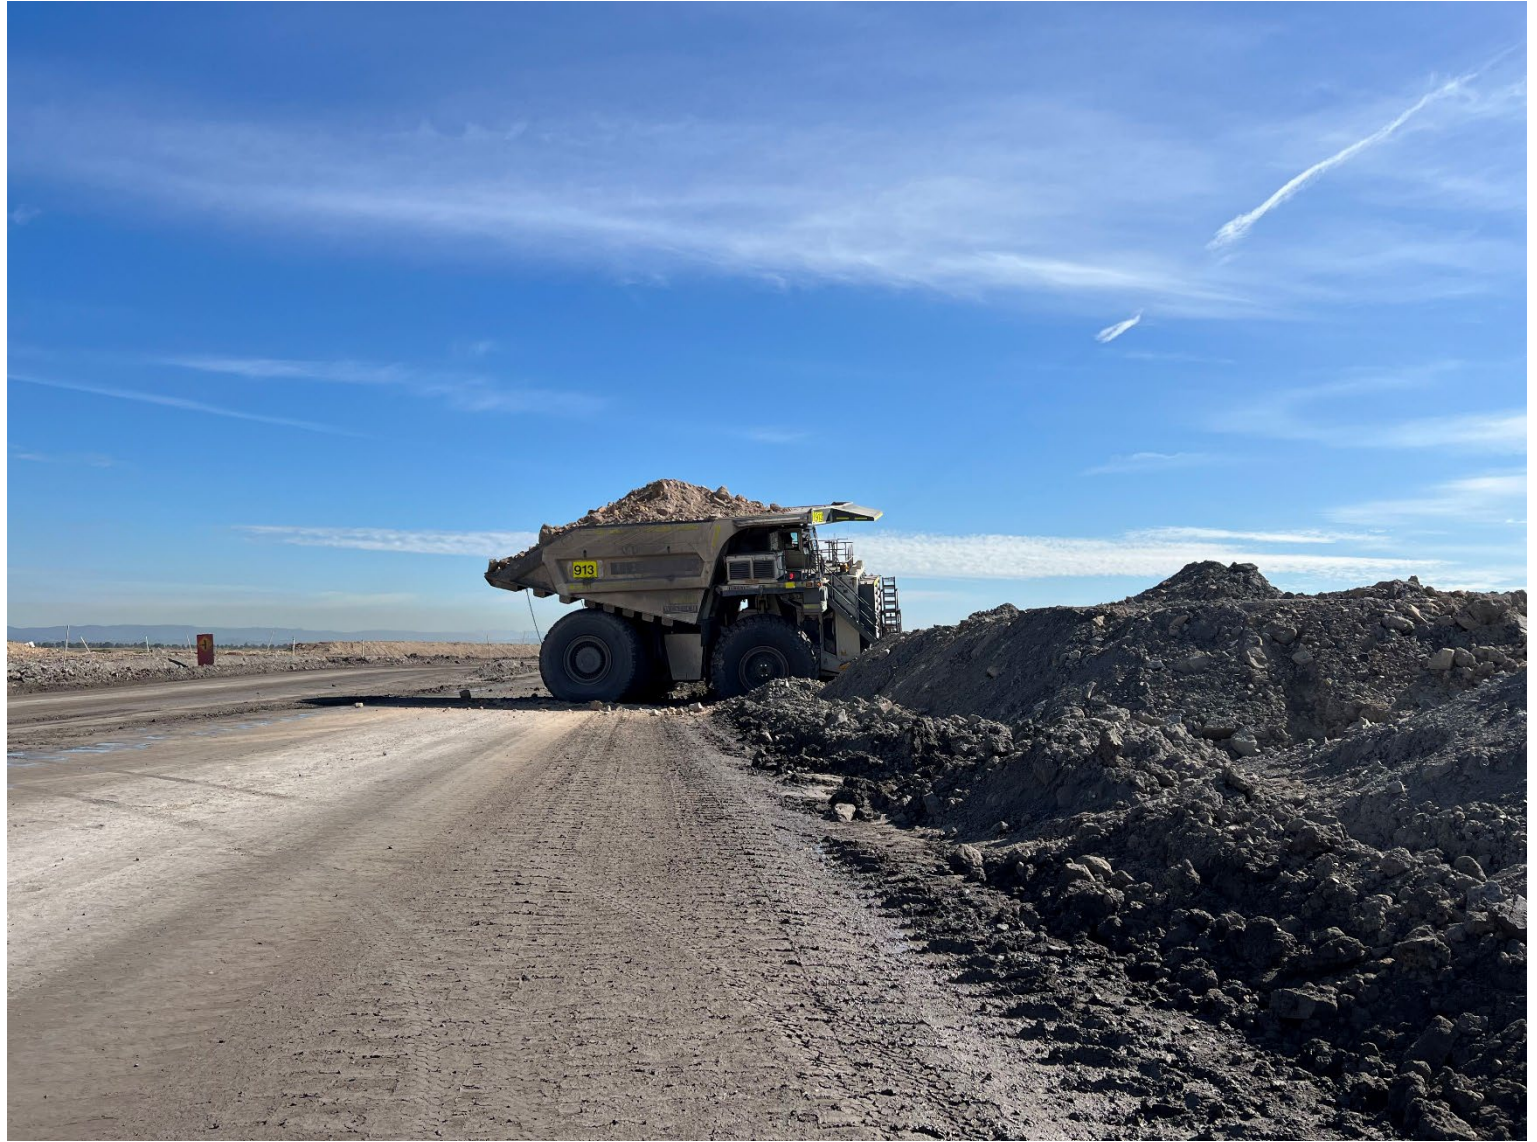
Short video of one of the microsleeep events.
Note dark glasses and IR reflection on lenses

- A safety alert issued to site by the OEM did not trigger a risk review or appropriate action to address the risk, this coupled with the OEM failing to appropriately address the issue lead to the routine use of incompatible glasses rendering the DSS system ineffective.
- Patterns of fatigue events with an individual operator did not trigger intervention, allowing that operator to continue duties with an increased risk of fatigue

- Appropriate review of industry and OEM safety alerts is required to trigger risk reviews when new or emerging risks are identified
- Chronic fatigue can be more difficult than acute fatigue to identify, additional tools may be required to assist in identifying chronic fatigue

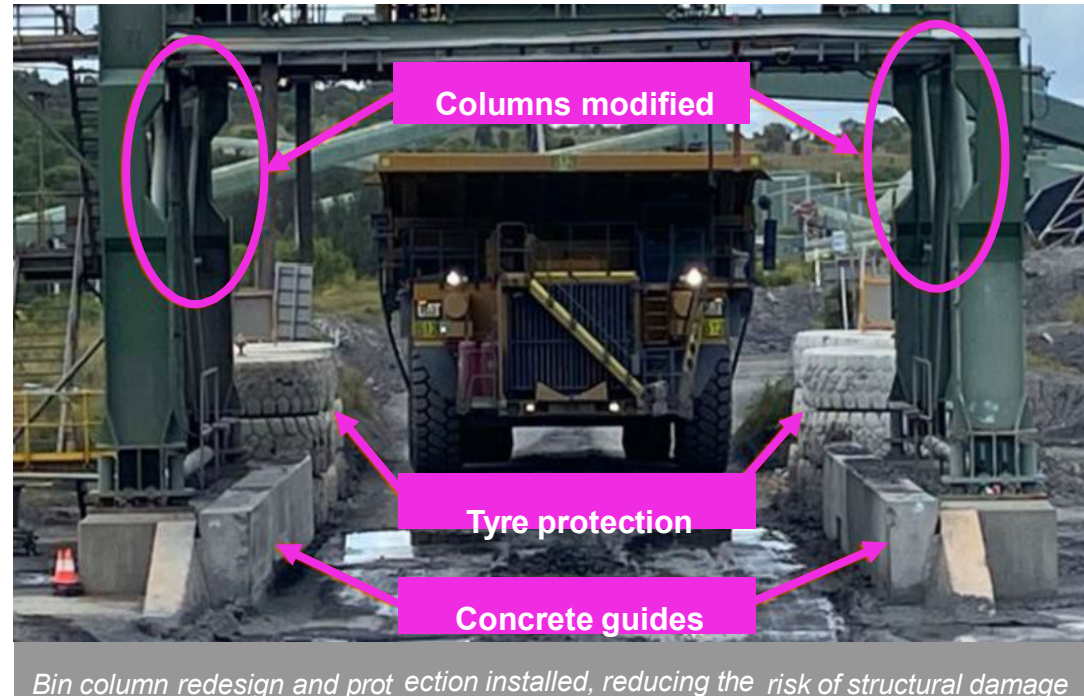
- There have been incidents where Caterpillar 789 haul trucks collided with the reject bin columns in the reject circuit at NSWEC, resulting in damage to the structure with potential to jeopardise the integrity of the reject bin and put haul truck operators at risk. The team had previously modified the reject circuit, within the NSWEC footprint constraint, to make it easier for operators to line up for the reject bin within the NSWEC footprint constraint, however incidents continued to occur.

- Modified the bin columns to increase clearance between the truck tray and bin structure
 - Stacked concrete filled tyres either side of the bin entry to protect the front bin columns

- Installed precast concrete guides to narrow the path when trucks are passing under the bin.
