Investigation information release

Frictional ignition of methane in underground coal mine

Location: Russell Vale Colliery

Investigation information release IIR23-05

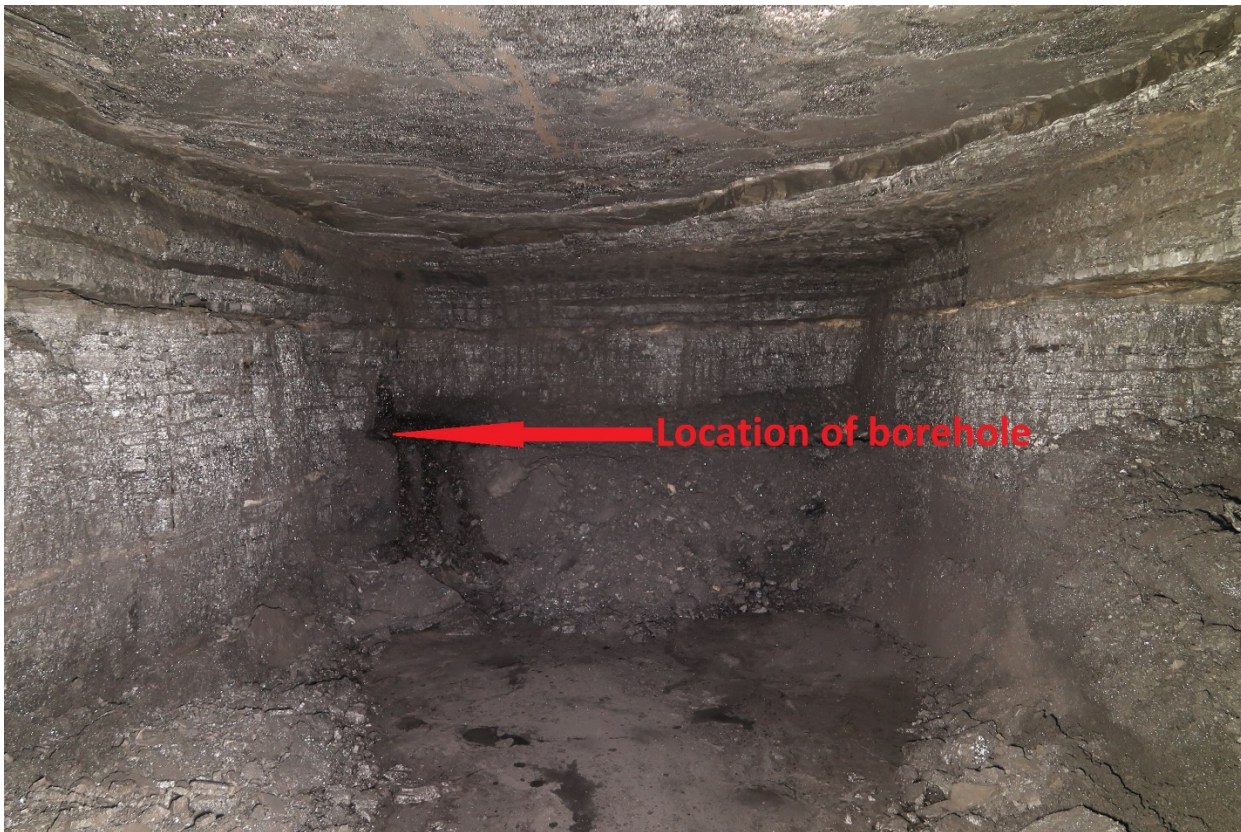
During the cutting process, the continuous miner exposed a borehole in the mid-section of the left rib adjacent to the face. Methane was released from the borehole and ignited. It was believed that the ignition source was rocky material coming into contact with the picks on the continuous miner's cutting drum. A large flame spread from the left side across the width of the heading, over the continuous miner and towards the workers. The cable hand and continuous miner operator immediately moved to the ground. The shuttle car operator moved the shuttle car outbye and both he and the cable hand left the heading.

Figure 1 - Location of incident and borehole

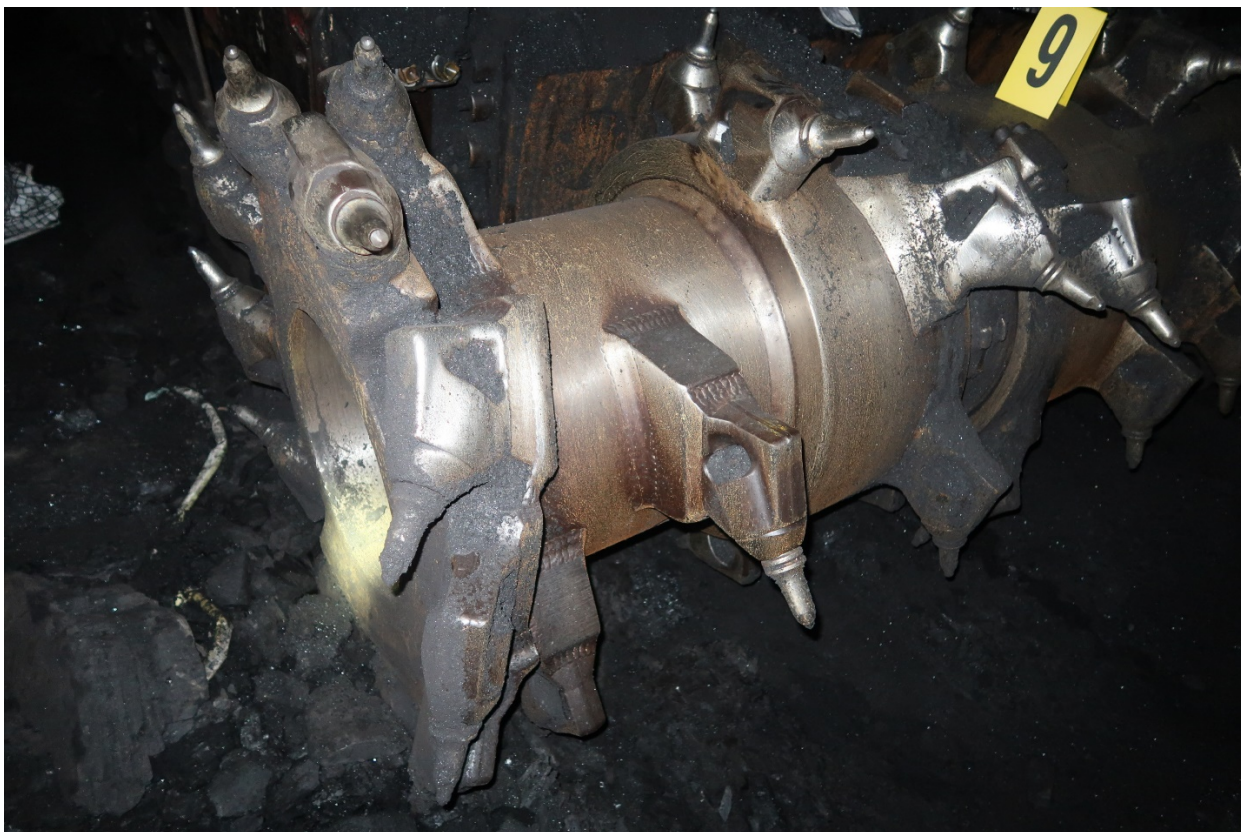
Figure 2 - Picks on the cutting drum of continuous miner, which are believed to have contacted a rock or similar material in the heading to provide an ignition source
