Quarterly safety report

January to March 2023

Title: Quarterly safety report – January to March 2023

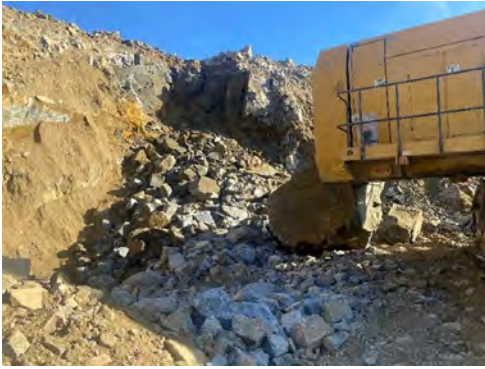
Summary: A large excavator was loading a mobile crusher on the pit floor when a 2-3 tonne stone fell from the face and hit the counterweight of the excavator. The operator was not injured.

Picture 1.
Material spalled from face.

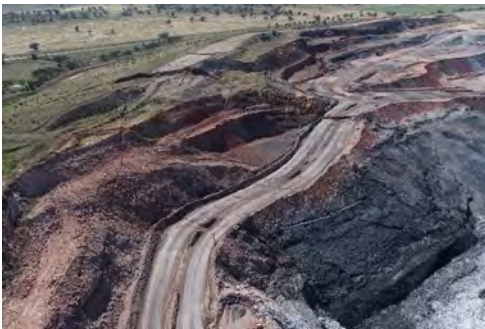
Summary: A significant failure of ground occurred at an end wall. No workers were in the vicinity at the time of the failure.

Picture 2.
End wall ground failure.

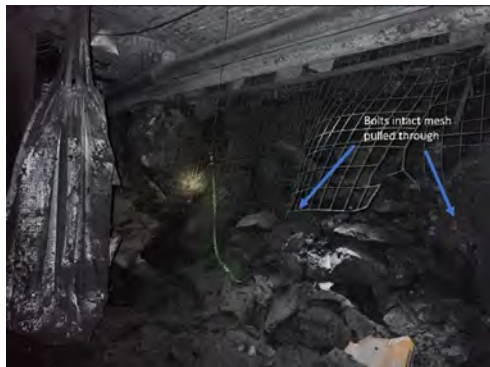
Summary: A deputy was advancing the spear duster in the tailgate of a longwall. A pressure bump occurred causing material to push the mesh past the rib bolt and plate. Material slid out knocking the worker into a swilly - a large, deep puddle. Larger material then slid out hitting the worker. The worker took some time to free himself from the coal and water. The worker was not injured, only suffering grazing on his arm.

Picture 3.
Rib material spalled following a pressure bump.

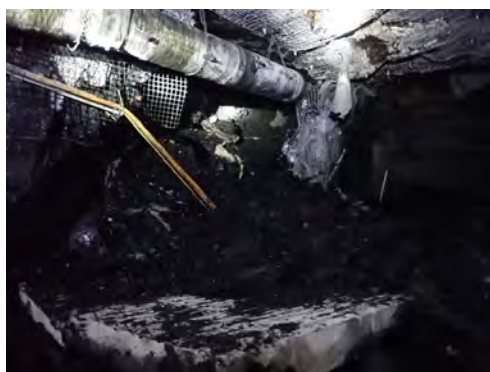
Summary: A rib slump occurred in an underground coal mine. The slump was 4 metres long, floor to roof in height and 2.5 metres into the rib. At the time of the failure, the crew was preparing to use the miner to grade through a large reverse fault. Two workers in the heading were alerted to the failure when they heard coal being sucked along the ventilation tube. There were no indicators of outburst or seismic activity.

Picture 4.
A rib slump.

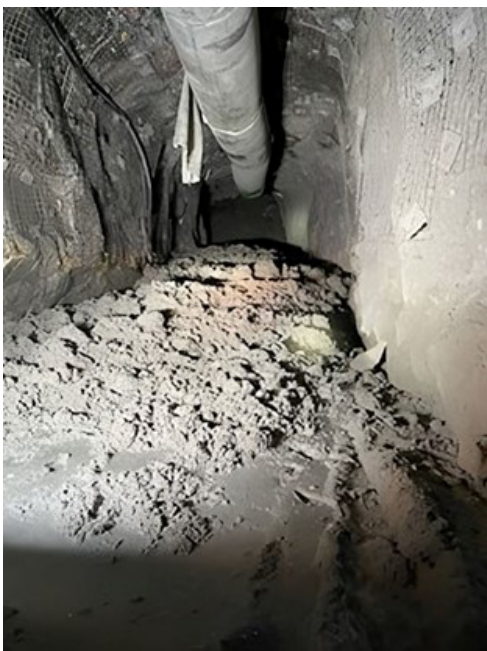
Summary: While loading from a draw point, an uncontrolled flow of material came from the draw point. The flow started slowly and flowed back into the drive.

Picture 5.
Material flowed uncontrolled into roadway.

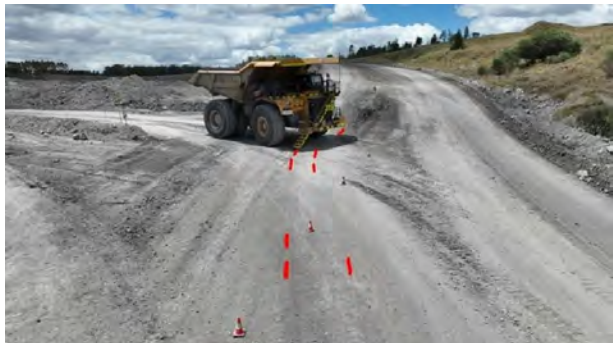
Summary: A haul truck was stopped at a give-way sign at an intersection. Another haul truck was approaching with a light vehicle in convoy. After the haul truck passed the intersection, the stationary truck began to move forward, turning right into the path of the light vehicle. The light vehicle operator was distracted while looking for the two-way approaching the intersection and when looking up had to take evasive action to avoid a collision. The proximity detection system alarmed.

Picture 9.
Intersection of near miss between light vehicle and haul truck.

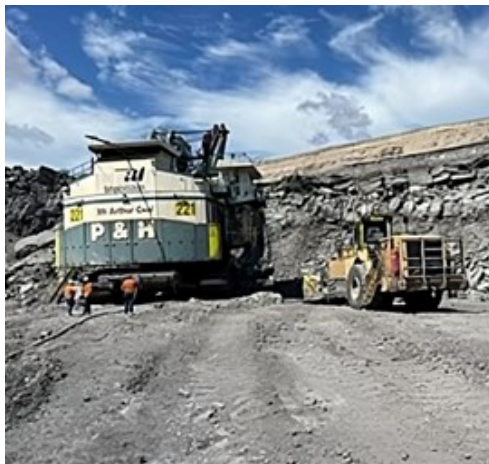
Summary: An electric rope shovel was loading a truck on the offside. A cat wheel dozer was hit with the shovel counterweight on the front left-hand corner, striking the front walkway, handrail and cabin.

Picture 11.
Location of shovel and dozer following collision.

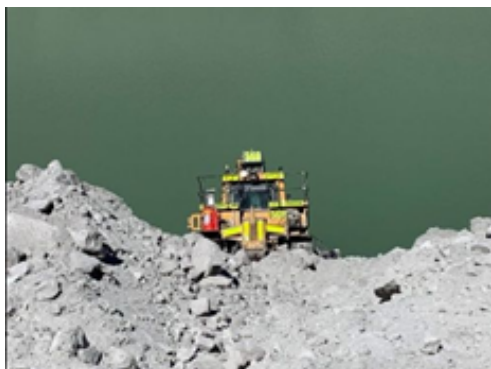
Summary: A dozer was cutting down a dump at a coal mine. As there was a water body below the dump, the trigger action response plan (TARP) required a double windrow and stand-off from the edge. The operator started dump edge cutting (slot push). The operator cut down to a point where the dozer was unable to reverse back up the slope. The operator decided to continue down the slope towards the water body. The dozer stopped when the blade made contact with the ground in the water. The water was about one metre deep. The worker was uninjured. The Emergency Response Team assisted the worker back up the slope.

Picture 20.
Location of dozer after it slid down the face towards a water body.

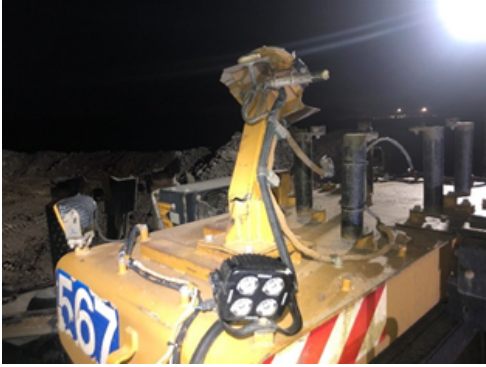
Summary: On night shift, a haul truck entered a dump and lost sight of a dozer when it was reversing. The truck was positioned between a lighting tower and the dozer, casting a shadow over the dozer. The truck did not feel any contact, so the operator drove out to re-set, reversed in and dumped. The dozer operator called to stop the truck. The worker was uninjured.

Picture 21.
Damage to dozer after being struck by haul truck

Comments to industry: Mine operators should review dump procedures and consider segregation or banded areas for dozers. Lighting plants must be positioned to avoid glare and shadowing work areas. When workers identify hazards for inadequacy with lighting in their work area, they should immediately report this to their supervisor.

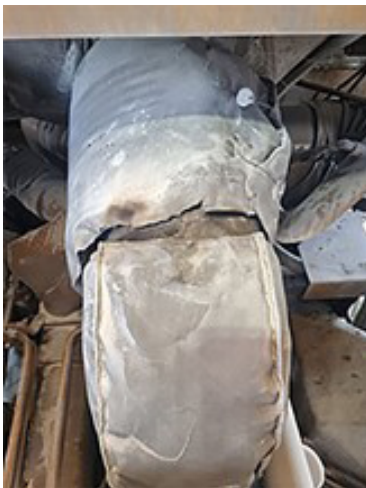
Summary: A dump truck was being driven into a crib hut parking area when it lost power. The operator called maintenance who instructed the operator to park the truck. A mechanical tradesman was entering the park up area at the same time and saw steam coming from the engine. As they approached the truck, there was the smell of coolant, and coolant could be seen dripping under the truck. After opening the covers, a flame was seen between the lagging on the turbo.

Picture 22.
Damaged lagging on the turbo.

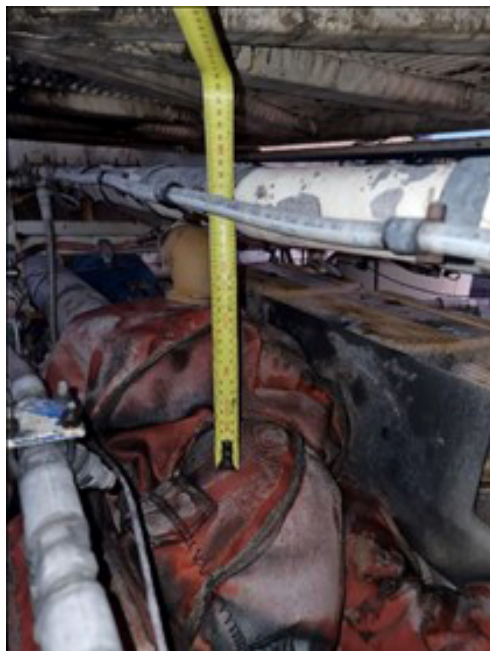
Summary: A contractor commenced cleaning a drill rig engine bay with degreaser. The lagging became soaked with degreaser and when some was sprayed on a gap in the lagging it ignited. The contractor yelled out to another worker on the ground who immediately got into the water cart, moved it to the side of the drill rig and extinguished the fire using the watercart’s cannon. The water cart was parked at the drill to assist in cleaning.

Picture 23.
Damaged lagging following the fire.

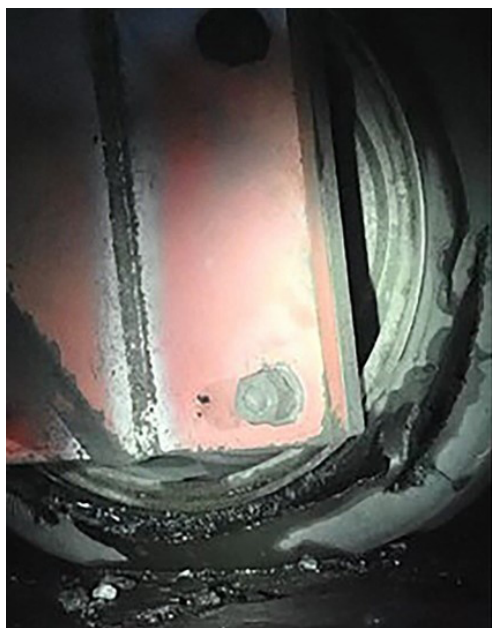
Summary: A load haul dump (LHD) was towing a supply trailer into an underground coal mine. The operator of another vehicle saw a flame on one of the off-driver's side wheels, stopped the LHD and used an extinguisher to put out the fire. Inspections identified a delaminated tyre.

Picture 25.
Delaminated tyre following the fire.

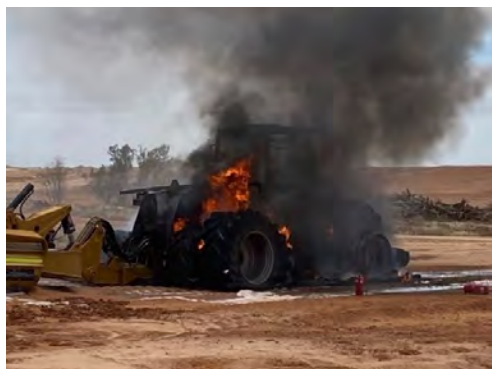
Summary: A large tractor was working on rehab carting topsoil. Fluid sprayed from the engine bay over the windscreen and shortly after flames appeared around the engine. The operator received minor burns to their wrist and was taken to hospital for assessment. Several nearby workers immediately rendered assistance and attempted to extinguish the fire. The workers were unable to directly raise the emergency and relied on another worker to relay the emergency message. The mine's emergency response team responded with a fire tender, and water carts were used to extinguish the fire. The tractor was destroyed.

Picture 26.
Tractor during the fire.

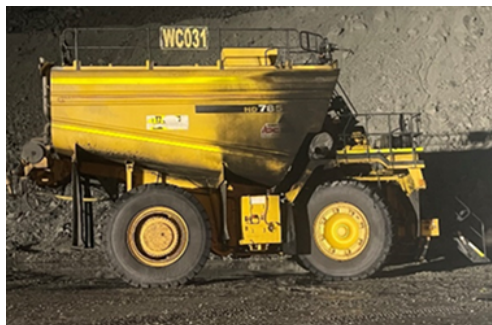
Summary: The operator of a water cart noticed a strange smell and returned to the workshop. An inspection did not identify any issues. The truck left the workshop heading to a dump when the operator noticed a loss of power and saw smoke in the rear mirrors. The truck was immediately parked up. Flames then started coming from the engine bay around the front of the truck. The fire was extinguished by other water carts. The operator complained of breathing issues and was taken to hospital. After being assessed, the worker was released and returned to the mine to complete their shift.

Picture 28.
Smoke and soot damage to watercart.

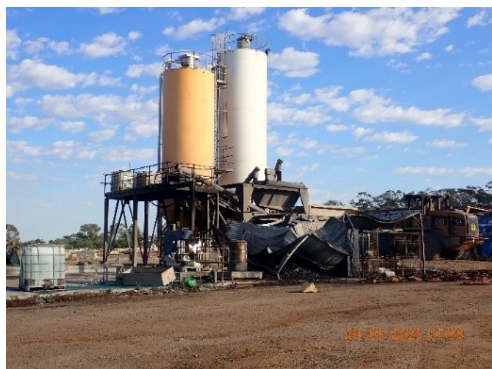
Summary: A fire started in a shed at a batch plant at an underground metalliferous mine. The mine evacuated all personnel on the surface, as there was the potential for the smoke to enter the decline. Those workers underground went to refuge chambers. Emergency services were called, and the fire was extinguished. Chemicals that were stored in the area contributed to the fuel load of the fire.

Picture 29.
Shed following the fire.

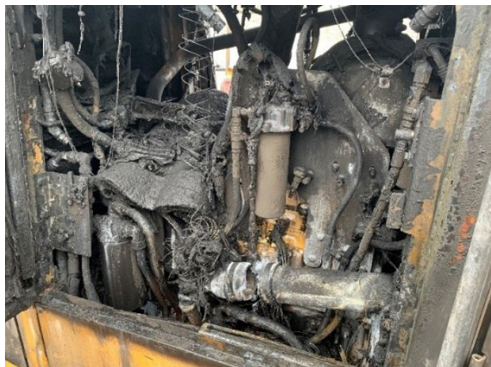
Summary: A Caterpillar 16M grader was parked-up for refuelling by a service cart. The service cart operator attached and activated the dry break fuel connector. The fuel gun immediately shut off. The operator activated the fuel dispense for a second time. Fuel was immediately sprayed out of the overflow area. The fuel ignited on the hot engine components. The fire suppression system on the machine was automatically activated. Two workers unsuccessfully tried to extinguish the fire with hand-held extinguishers. The fire was finally extinguished by water carts.

Picture 30.
Damaged engine components following the fire.

Comments to industry: Refuelling systems must be engineered and matched with the fuel tank, breather, and delivery systems. Confirm that overflow piping and breathers direct fuel away from ignition points.

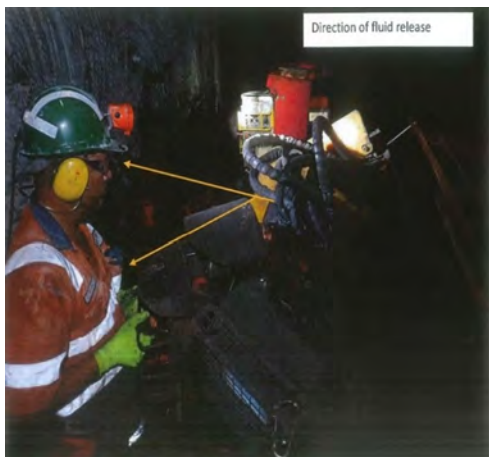
Summary: A worker was operating a rib bolter on a continuous miner when a hose failed. The worker was hit on the forehead and arm with hydraulic oil. The worker was assessed at hospital and cleared of injury.

Picture 33.
A recreation of the scene of the incident.

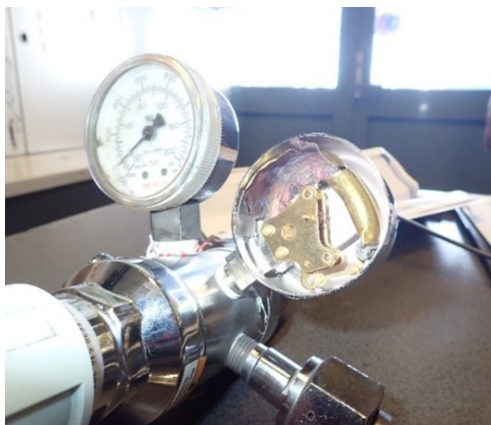
Summary: A control room operator changed a pressure gauge on a regulator fitted to a nitrogen bottle. When pressure was applied, the gauge failed and burst. A piece that was ejected grazed the worker’s jaw. The bottle contained nitrogen at 200 bar. The installed gauge was rated to 200psi (14 bar).

Picture 35.
Burst pressure gauge.

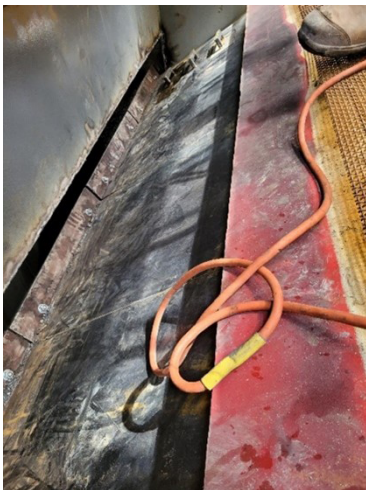
Summary: A contract boilermaker felt a tingle while using a portable 240-volt welder. He was using the welder during muggy conditions and attributed the shock to sweat. He was taken to hospital for an ECG and cleared of injury.

Picture 37.
Area welder was working in at the time of the electric shock.
