# Safety Bulletin

## Rockfall injuries to workers increase in underground mines

## Safety Bulletin SB23-06

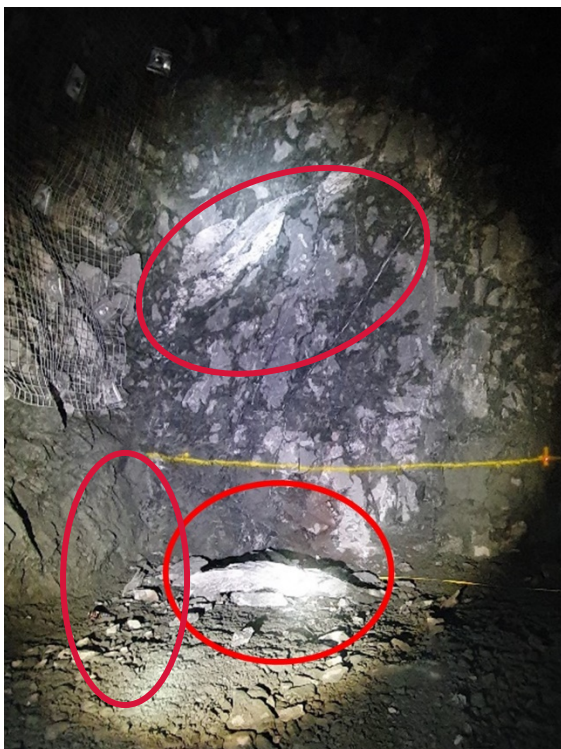
A Jumbo drill rig operator was marking up a development face in preparation to drill the next advance of the drive on 2 April 2023. While marking up, a rock fell from the left-hand side of the face and hit the operator on the back of the head. The operator was admitted to hospital and required 25 scalp stitches. The rock was estimated to be 400 kg.

Figure 1: Incident scene showing the approximate location of the slab that fell (top circle), the approximate location of the operator who was hit (circle on left) and the slab of rock that fell from the face (circle on right).

- review the risk assessments for ground and/or strata failure to identify engineering controls or higher to control material falling from the face of development headings
- implement engineering controls, including ground support to faces: mesh, thin skin liners (TSL) or shotcrete with bolts.

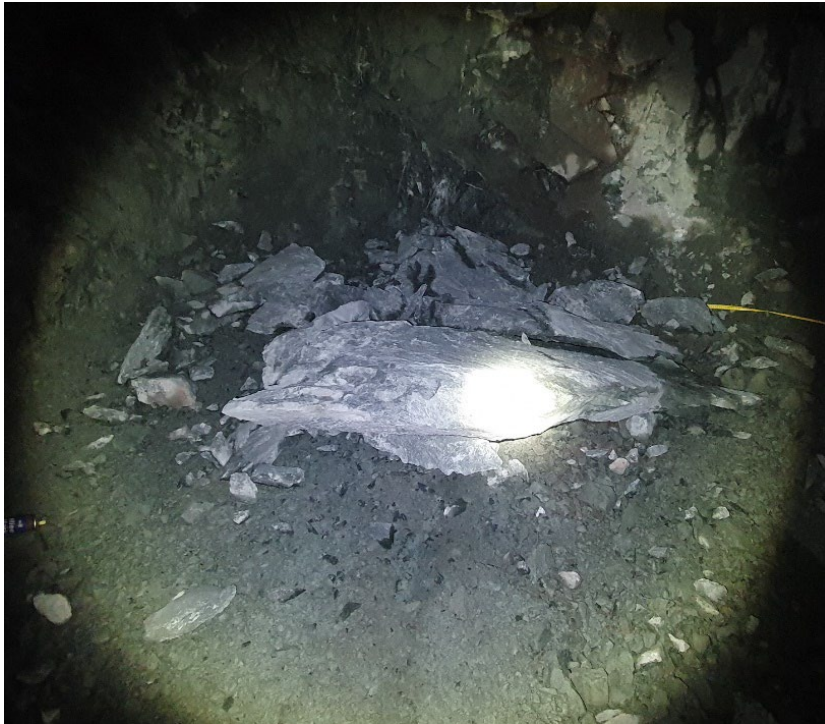
Figure 2: The slab of rock that hit the Jumbo operator
