# Weekly incident summary

## Week ending 26 May 2023

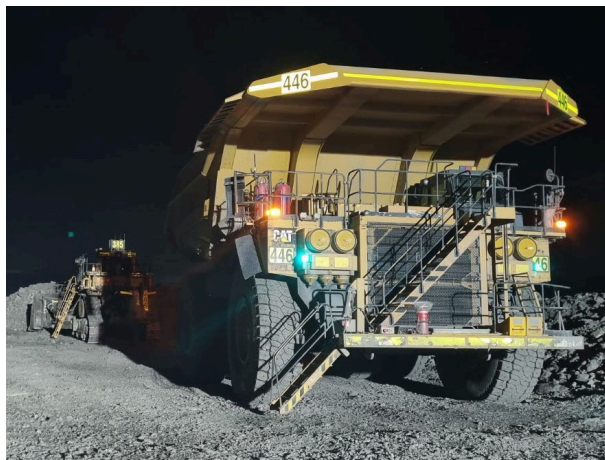
Incident type	Summary	Comments to industry
Dangerous Incident IncNot0044759 Open cut coal mine Roads or other vehicle operating areas	A haul truck entered a dump and was in position to start tipping off. The dozer operator called the truck and instructed it to reposition. The truck driver called up stating where they were going to dump. No response was given. As the truck was reversing, the position 6 (right rear) tyre hit the ripper box of the dozer. There were no injuries or damage.	To achieve positive communication, a clear direct message must be given. Additionally, the person receiving the message must actively reply with a clear understanding of the message.  Supervisors should be continually monitoring pos coms compliance during every radio call on their shift.  Work Health and Safety Regulation 2017 clauses <u>35</u> & <u>36</u> requires higher order risk controls be implemented and administrative controls such as pos coms, only be used when no higher order controls can be implemented. Controls such as equipment segregation and proximity awareness systems should be implemented before pos coms are consider.

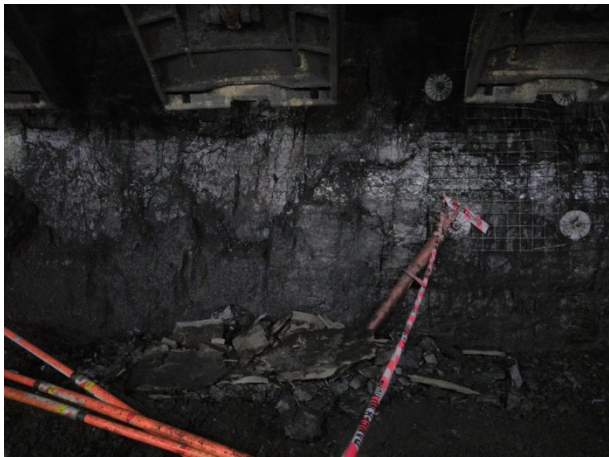
Incident type	Summary	Comments to industry
<p data-bbox="113 199 395 257">Dangerous Incident IncNot0044734</p> <p data-bbox="113 293 395 374">Underground coal mine</p> <p data-bbox="113 387 395 468">Ground or strata failure</p>

<p data-bbox="403 199 1027 521">A night shift crew on a longwall had started installing roof and face bolts to set up for shearer maintenance. A worker on day shift was setting up to continue to support the face. As the worker was reaching out to recover an air leg left under unsupported ground bolter, a piece of mudstone fell from the roof. The falling mudstone delaminated and hit the operator on the head, shoulder and arm. The piece of mudstone was about 0.7 m x 0.4 m x 0.1 m.</p>

<p data-bbox="1035 199 1479 495">Workers must always be alert to the hazard of unsupported ground. When working near the edge of installed support, workers must remain vigilant of their position relative to the installed support. Equipment should not be left or stored under unsupported ground.</p>

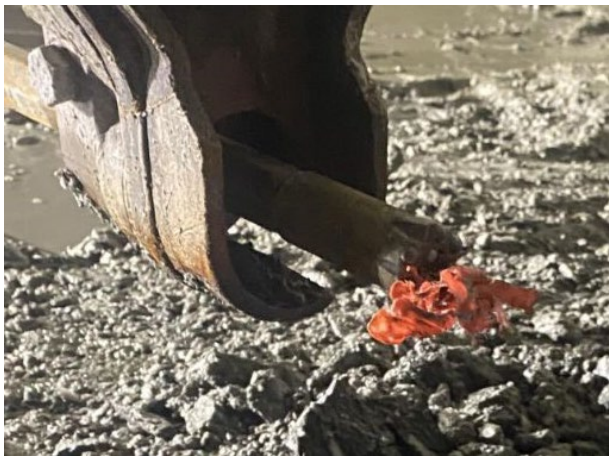
<p data-bbox="113 1171 395 1252">Dangerous Incident IncNot0044730</p> <p data-bbox="113 1265 395 1346">Underground metals mine</p>	<p data-bbox="403 1171 1027 1426">A Jumbo operator was drilling a lifter hole in a development drive. The drill steel was 2 m into the face when a previously drilled hole was intersected. The drill steel impacted a booster, which initiated. The operator heard a bang, but no fly rock or fume was noticed. When the drill steel was removed remnants of the explosives were found on the drill bit.</p>

<p data-bbox="1035 1171 1479 1337">Mine operators should have a process where drill holes are checked, and any misfires are cleared, before the next pattern is marked and drilled.</p>
