Weekly incident summary

Week ending 9 June 2023

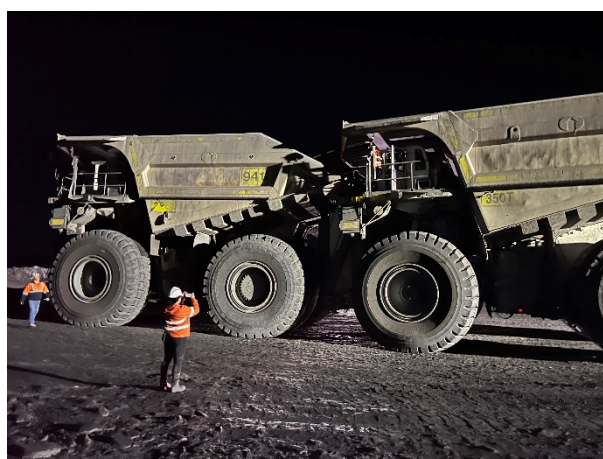
Incident type	Summary	Comments to industry
Dangerous Incident IncNot0044848 Open cut coal mine Roads or other vehicle operating areas	A haul truck was parked in a queue. A second haul truck approached and came to a stop. The truck then started moving forward and collided with the first truck (nose-to-tail collision). The worker in the second truck was uninjured but could not exit the truck due to damage to the ladder.	Workers have a duty to take reasonable care for themselves and others while in the workplace. This includes staying alert, being aware of their surroundings, and maintaining control of the plant and machinery they operate. Workers are also reminded that as part of their duty, they must comply with reasonable instructions and procedures of the workplace. Following parking procedures and fatigue management policies is considered reasonable. Fatigue policies require workers to arrive at work rested and ready for a full shift and reporting fatigue events as they occur.

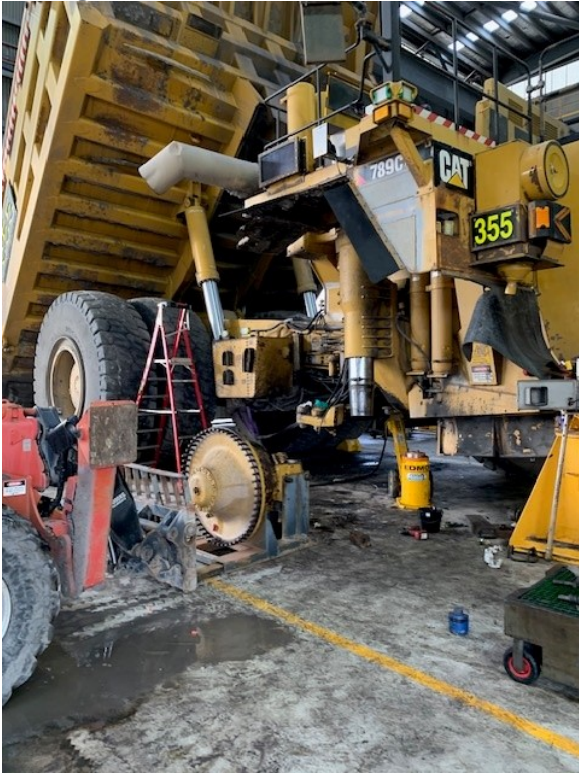
Incident type	Summary	Comments to industry
<p>Dangerous Incident IncNot0044814 Open cut coal mine</p>	<p>Workers were changing out a front wheel hub assembly on a haul truck in a workshop. While removing the hub from the taper, the assembly unexpectedly moved. The assembly was fixed to a frame that was sitting on the tynes of a telehandler. The tynes dropped when the load moved. A worker in close proximity was hit in the face. The worker suffered minor grazing.</p> <p>Photog</p>

<p>When removing components that may release instantaneously (such as those on a taper), controls must be in place to protect workers from the sudden release of energy. This may include using a boss and retaining bolts, timber packing, restraining slings or stops. If forklifts and telehandlers are used, the impact of pneumatic tyres and boom extension should be considered when assessing movement of the load.</p>

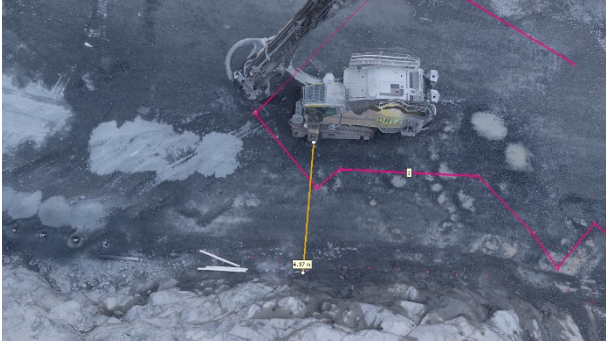
<p>A dozer was working on a main ramp directly above a drill working below. The dozer dislodged some material that fell about 55 metres to the working level below. It is estimated that 100 kg of material fell. The material broke up and 2 of the rocks hit a blast hole drill rig working below. One rock landed on top of a car body of the machine and the other hit the rear window of the operator's cabin, smashing the glass. The worker was off the drill at the time of the impact and was standing about 30 metres away from the drill. Nobody was injured.</p>	<p>Catch bunds should be in place wherever possible.</p> <p>When work is being carried out above other work areas, no-go zones should be established considering the type of work, height between work areas and suitable stand-off distances.</p> <p>When working against high walls and faces, no work should occur directly above.</p> <p>Autonomous drill rigs remove the workers from the risk of falling objects when working near highwalls and faces.</p>
