Weekly incident summary

Week ending 30 June 2023

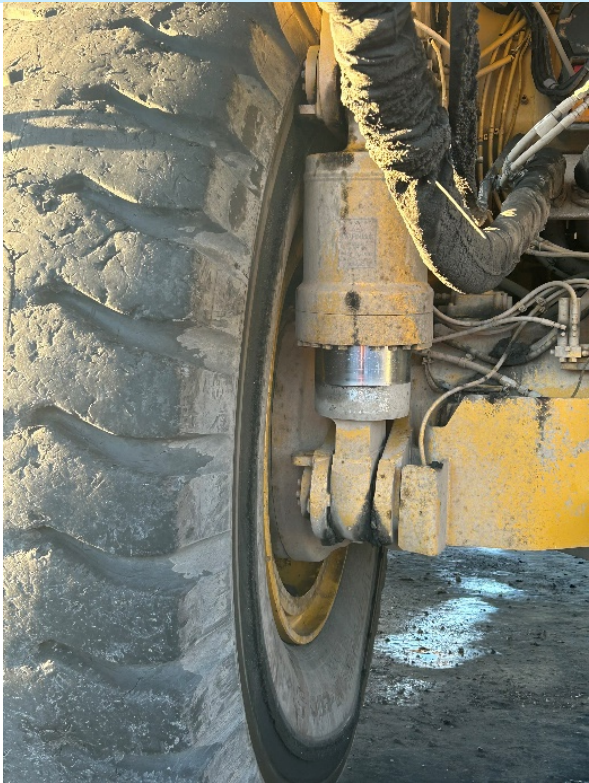
Incident type	Summary	Comments to industry
Dangerous incident IncNot0044974 Open cut coal mine Fire or explosion	<p>A watercart was fitted with 3 new rims and was sent for a short drive before retorquing the wheels. After a while, the operator noticed a strange smell that became worse. The operator saw smoke coming from the rear of the truck.</p> <p>The operator saw another water cart and called to ask the operator to look at the rear of the truck. At the same time, the operator noticed spots of flames in a line on the haul road behind the truck.</p> <p>The second water cart operator saw flames about one metre high on the inside of position 4 wheel. They used the cannon to extinguish the fire. An emergency was called, and the watercart continued to cool the tyres.</p>	<p>When changing to a different component supplier or to a different model component, a change management process must be undertaken. This must include checks to confirm compatibility with the equipment that is being fitted and for suitability for the task and duty.</p>

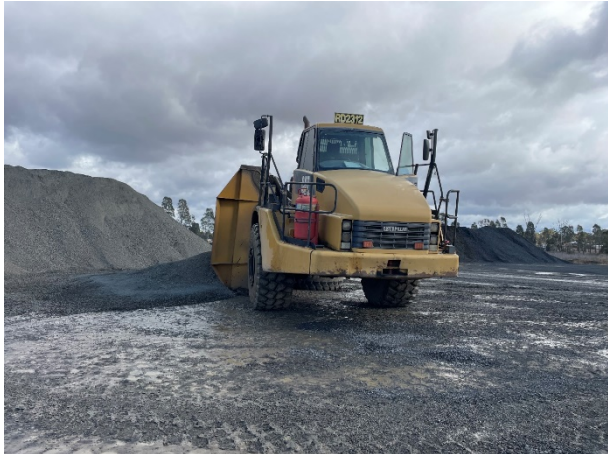
<p data-bbox="124 1003 373 1084">Dangerous Incident IncNot0044966</p> <p data-bbox="124 1099 292 1162">Construction materials</p> <p data-bbox="124 1178 346 1272">Roads or other vehicle operating areas</p>

<p data-bbox="416 1003 1023 1162">An articulated truck was approaching a stockpile. As the operator started to turn the truck to line up with the stockpile, an alarm started to sound. The tub then rolled. The worker was uninjured.</p>

<p data-bbox="1050 1003 1465 1162">When operating articulated equipment workers must drive at appropriate speeds, particularly when negotiating corners and turning the machine around.</p>
<p data-bbox="124 1659 373 1740">Dangerous Incident IncNot0044937</p> <p data-bbox="124 1756 368 1787">Open cut coal mine</p>	<p data-bbox="416 1659 1011 1883">A hoist drum shaft was being removed during a dragline shutdown. As the 15-tonne shaft was moved out of the drum, the support legs on the custom-designed-and-built frame failed. As the shaft fell, it hit and damaged scaffold. Four workers were on the scaffold and were uninjured.</p>	<p data-bbox="1050 1659 1442 1787">Tools such as jibs and frames must be designed to withstand the expected loads with an appropriate factor of safety.</p> <p data-bbox="1050 1803 1453 1928">Designs should undergo engineering analysis to validate their suitability for the task intended.</p>
