Quarterly safety report

April to June 2023

Published by NSW Resources Regulator
Title: Quarterly safety report – April to June 2023
First published: August 2023
Authorised by: Executive Director, NSW Resources Regulator
CM9 reference: RDOC23/151558

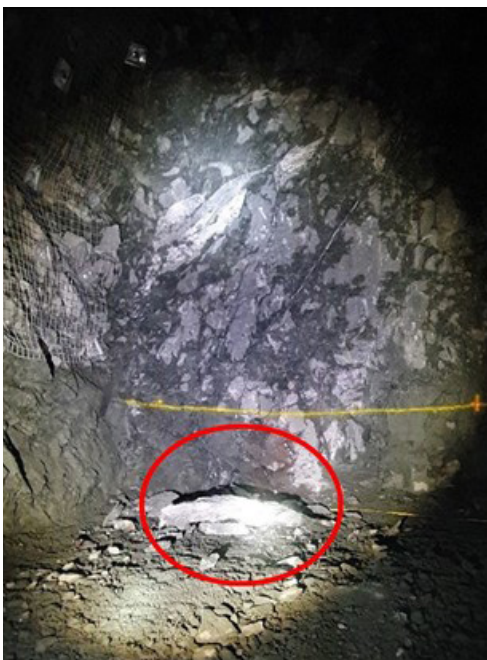
Picture 1.
The piece of stone that struck the Jumbo operator

Dangerous incident | IncNot0044412 – Worker hit by falling stone

Summary: A Jumbo operator and an offsider were marking up a development face. A piece of stone fell from the face and struck the Jumbo operator on the back of the head and shoulder. The offsider helped get the Jumbo operator back from the face and rendered first aid. The injured worker was transported to hospital via ambulance where the laceration was stitched, and scans cleared the worker of any fractures.

Comments to industry: Mine operators should review their risk assessments and principal hazard management plans for ground and strata to ensure that controls are identified and implemented to prevent rocks falling from development faces that could cause serious injury or kill mine workers. Controls should be focussed on the engineering level or higher. The use of engineering controls to manage the risks at a development face are widely used across the underground hard rock industry.

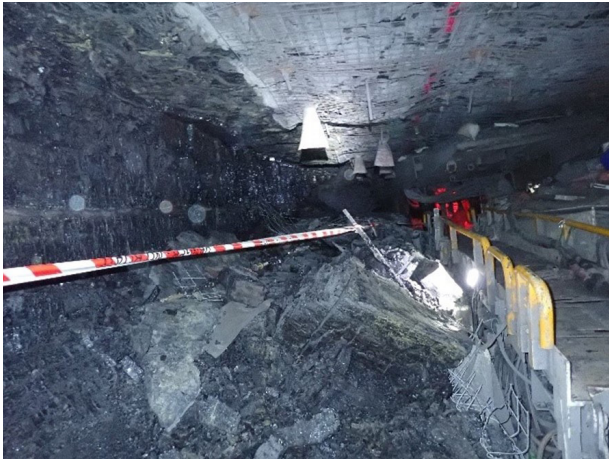
Picture 2.
The scene following the incident

Summary: A fall of rib occurred adjacent to a crusher. The fall was about 13 metres long, 2 metres high and a metre deep. The mine operator had recognised that changes were required to strata support requirements but failed to upgrade the support in this area before the longwall retreated.

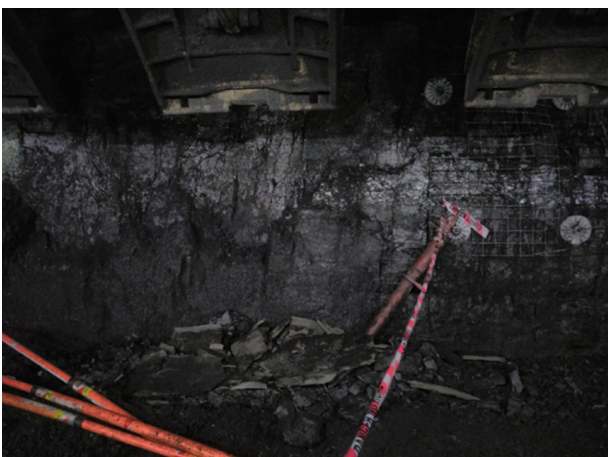
Picture 6.
The scene following the incident

Summary: A night shift crew on a longwall had started installing roof and face bolts to set up for shearer maintenance. A worker on day shift was setting up to continue to support the face. As the worker was reaching out to recover an air leg left under unsupported ground bolter, a piece of mudstone fell from the roof. The falling mudstone delaminated and hit the operator on the head, shoulder and arm. The piece of mudstone was about 0.7 m x 0.4 m x 0.1 m. The worker suffered a graze on the wrist and shoulder, was sent for scans and cleared of any further injuries.

Comments to industry: Workers must always be alert to the hazard of unsupported ground. When working near the edge of installed support, workers must remain vigilant of their position relative to the installed support. Equipment should not be left or stored under unsupported ground.

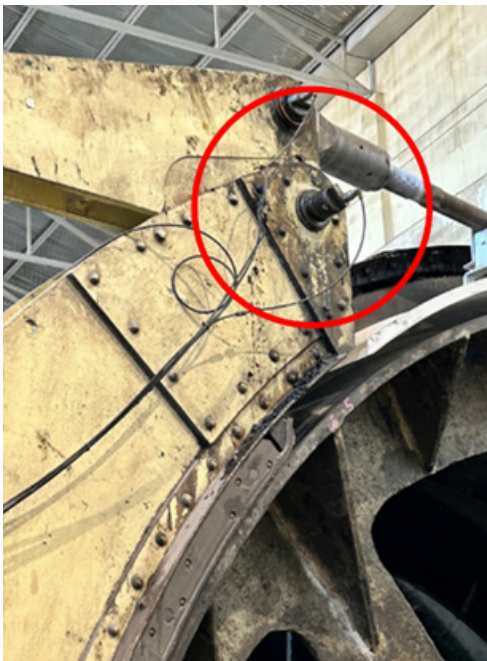
Picture 9.
The exposed upper brake calliper pin on a man-riding shaft winder

Dangerous incident | IncNot0044421 – Loose pin on winder brake calliper

Summary: During a walk-around inspection of a man-riding shaft winder, it was noticed that an upper brake calliper pin had worked its way out about half the length of the pin. The split pin and retaining washer were missing. The opposite side calliper was still intact.

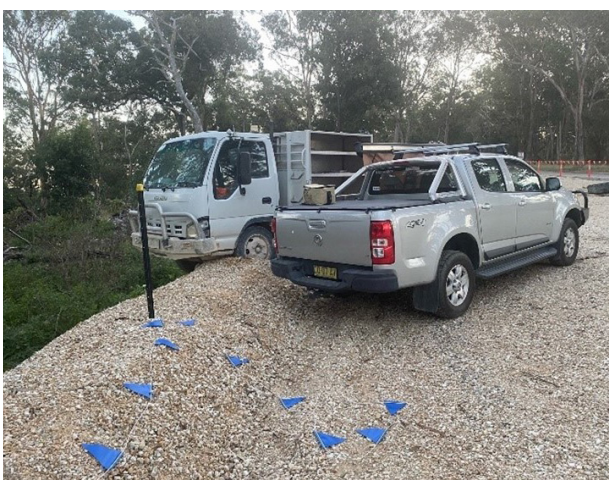
Picture 10.
The scene following the incident

Dangerous incident | IncNot0043703 – Dozer crushed light vehicle

Summary: A man was driving a light-rigid truck and parked in a car park in front of their private vehicle. The truck driver left the truck, which started to roll forward. The driver unsuccessfully tried to get back into the truck and as he tried to jump away, he slipped and the outside rear wheel ran over his ankle. The truck rolled forward hitting his own vehicle and stopped on a bund. He was cleared of any fractures and only suffered minor grazing.

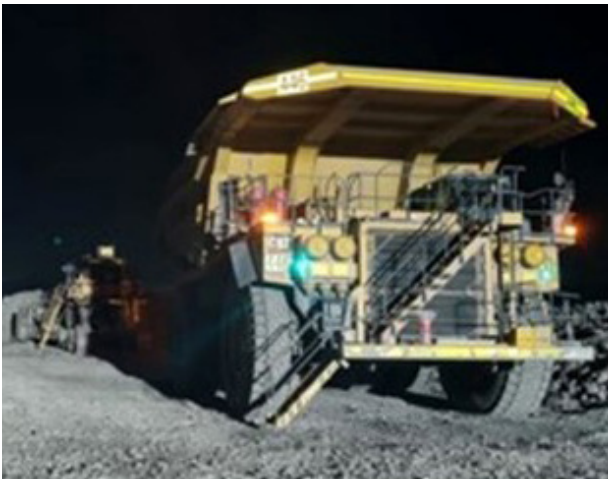
Picture 12.
The scene following the incident

Summary: A haul truck entered a dump and was in position to start tipping off. The dozer operator called the truck and instructed it to reposition. The truck driver called up stating where they were going to dump. No response was given. As the truck was reversing, the position 6 (right rear) tyre hit the ripper box of the dozer. There were no injuries or damage.

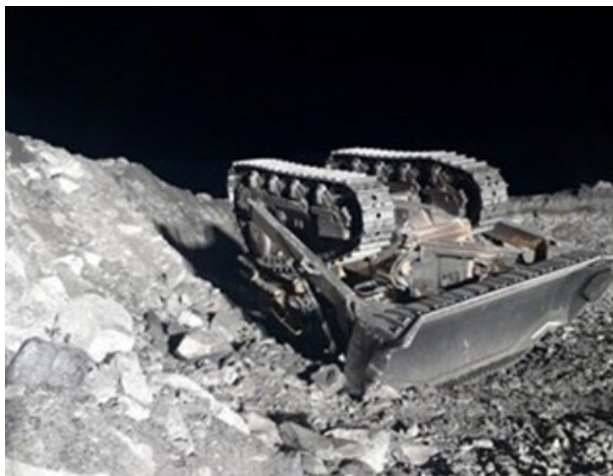
Picture 13.
The scene following the incident

Summary: A dozer operator was preparing coal on a shared workbench. The operator was aware of the edge of the bench as the dozer trammed forward. The operator felt a track slump. The operator then tried to reverse but the edge gave way, resulting in the dozer rolling onto its roof. The bench was about 4 metres high, and conditions were reported as dusty.

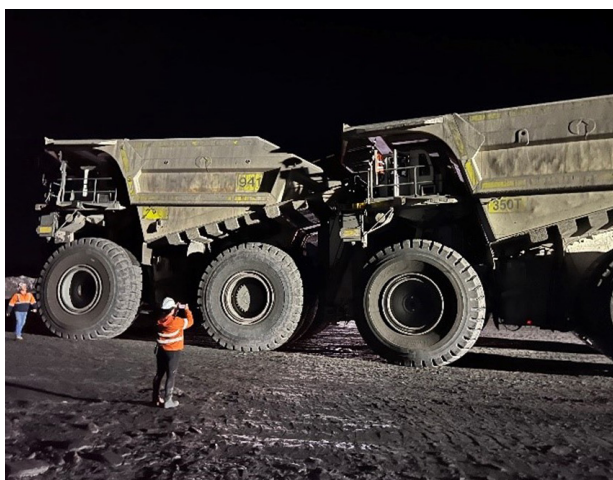
Picture 14.
The scene following the incident

Summary: A haul truck was parked in a queue. A second haul truck approached and came to a stop. The truck then started moving forward and collided with the first truck (nose-to-tail collision). The worker in the second truck was uninjured but could not exit the truck due to damage to the ladder.

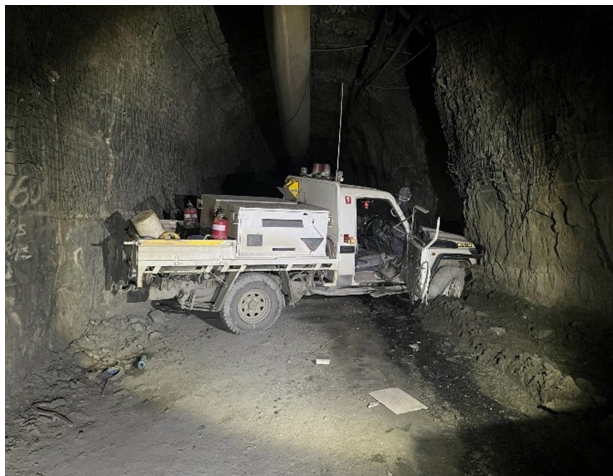
Picture 15.
The vehicle wedged across the drive

Summary: A shotfirer was returning some leftover packaged explosives to an underground magazine. The vehicle had 27 plugs of 700 mm packaged explosives onboard. The worker parked outside the underground magazine and left the vehicle to open the gate. The vehicle started to roll backwards. The worker tried to get back in the vehicle but tripped and fell. The vehicle ended up travelling about 80 metres before hitting a wall and becoming wedged across the drive. The explosives were recovered and stored in the magazine and the scene was preserved.

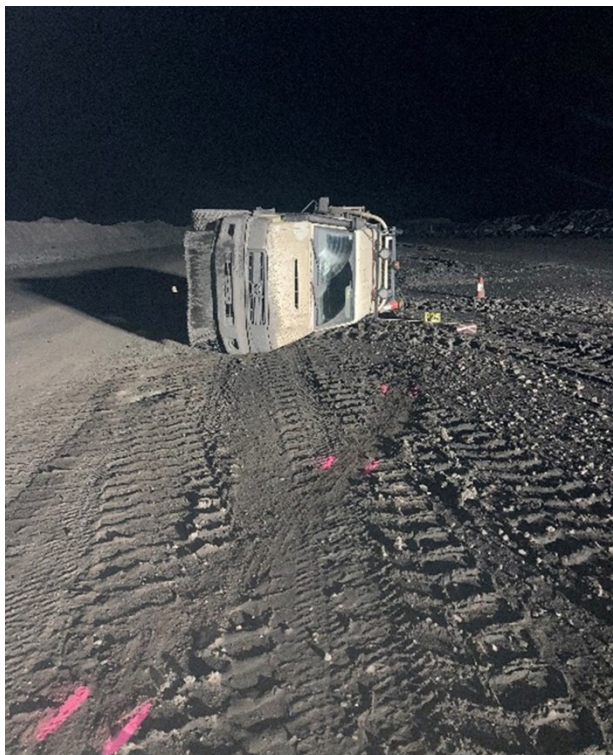
Picture 17.
The rolled vehicle following the incident

Summary: At the end of day shift, 3 workers were driving back to a muster area. The vehicle hit a soft spot in the haul road, causing the vehicle to slide. As the driver tried to correct the slide, the vehicle went from a wet section of the haul road to a dry section. The vehicle rolled. No workers were injured.

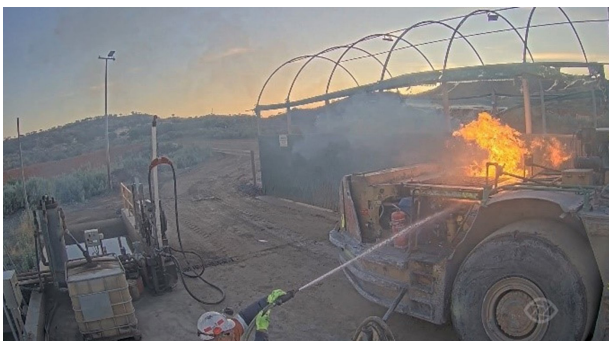
Picture 20.
The worker using a hose to extinguish the fire

Summary: A loader was being refuelled at a surface fuel bay when a fire started. The worker immediately shut off the fuel. The automatic fire suppression system activated, and the worker used a hose to extinguish the fire. Inspectors identified a 50 kg fire extinguisher trolley that was overdue for inspection and a fire hydrant in the fuel bay inaccessible due to poor housekeeping. The mine is investigating the cause of the fire.

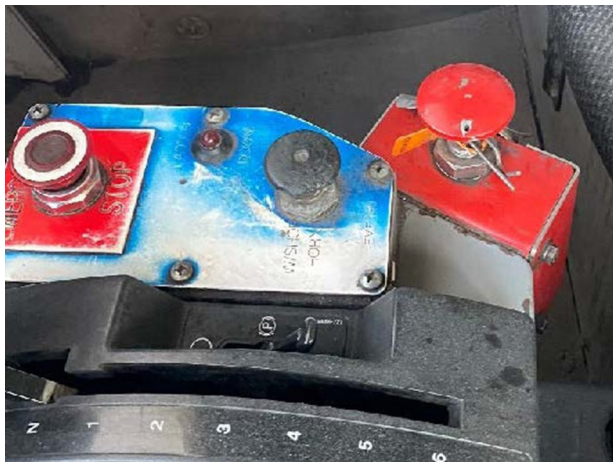
Picture 21.
The fire suppression system manual activation button

Dangerous incident | IncNot0044568 – Worker fails to activate fire suppression system

Summary: A haul truck was being operated on a ramp when the engine failed. The operator saw smoke and flames coming from the engine bay and immediately stopped the truck. The operator could not manually activate the fire suppression system because the operator couldn't remove the retaining pin. The operator exited the truck. The fire suppression system automatically activated. Water carts and the emergency rescue teams attended the incident and extinguished the fire.

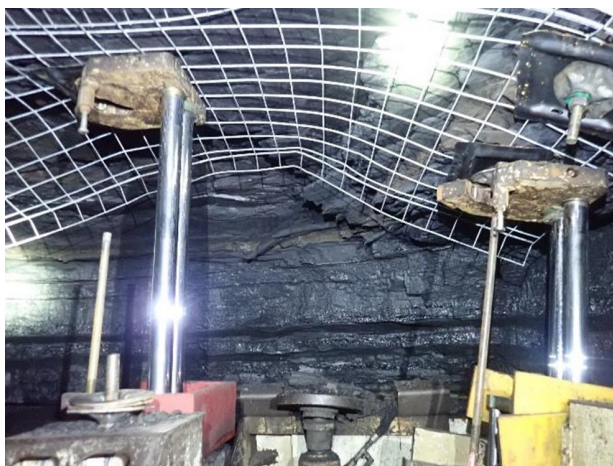
Picture 22.
The scene following the incident

Summary: Workers on a continuous miner were installing roof bolts. There was a small roof cavity across the face area. When a red-hot blocked drill steel was withdrawn from the hole, methane ignited and a flame spread across the face area to the opposite rib above the heads of the workers on the continuous miner. An inspector attended the mine and identified good ventilation, Venturi pumps in place and monitoring devices present. However, the bolt was being installed in a cavity about 0.4 metres deep. The investigation identified that the drill steel was broken, which caused the drill tip to heat when using the auto feed function on the drill rig.

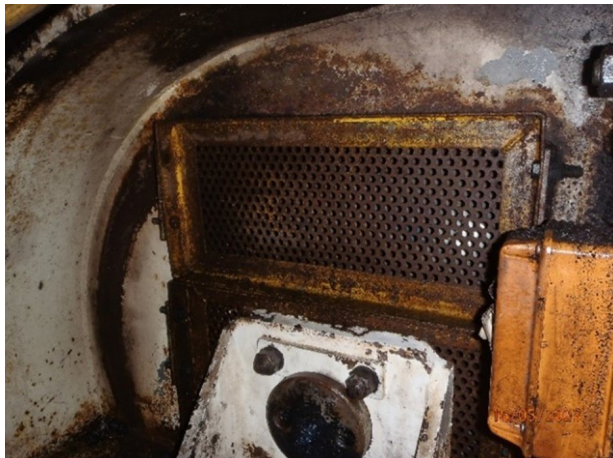
Picture 23.
The scene following the incident

Summary: A crew was driving into a mine and noticed smoke while passing a transfer. Smouldering coal was found behind the guard of the boot end. The crew stopped the belt, removed the guard and started hosing down. The conveyor was restarted to wash out additional material. The conveyor was stopped and the area cooled and the scene was preserved. A fire watch was put in place.

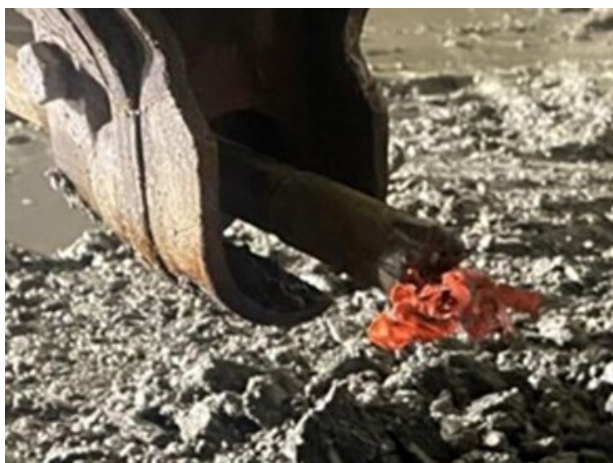
Picture 24.
The drill bit following the incident

Summary: A Jumbo operator was drilling a lifter hole in a development drive. The drill steel was 2 m into the face when a previously drilled hole was intersected. The drill steel impacted a booster, which initiated. The operator heard a bang, but no fly rock or fume was noticed. When the drill steel was removed remnants of the explosives were found on the drill bit.

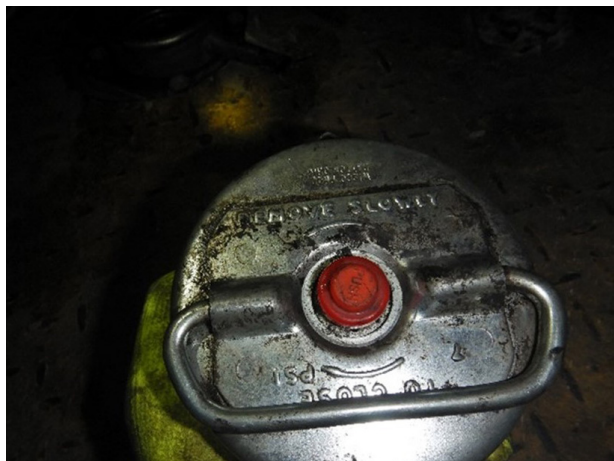
Picture 25.
The header tank of the load haul dump

Dangerous incident | IncNot0044771 – Worker burnt with hot coolant

Summary: A worker was driving a load haul dump (LHD) that overheated on the main travelling road. The operator removed the header tank cap and was sprayed with hot coolant. The worker was taken to the surface and then to hospital where he was transferred to a specialist burns unit. The worker was treated for superficial burns to the arm, chest and thigh.

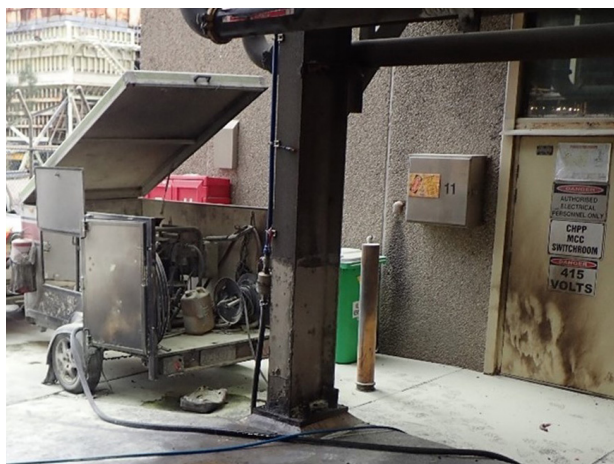
Picture 26.
The scene following the incident

Dangerous incident | IncNot0044923 – Worker suffers burns while refuelling with petrol

Summary: A contractor was using a petrol-powered pressure cleaner in a coal handling preparation plant. Midway through the day, the worker attempted to refuel the unit. A fire erupted. The worker was seen rolling on the ground before getting up and removing their jacket. The worker was treated on site before being transferred to hospital.

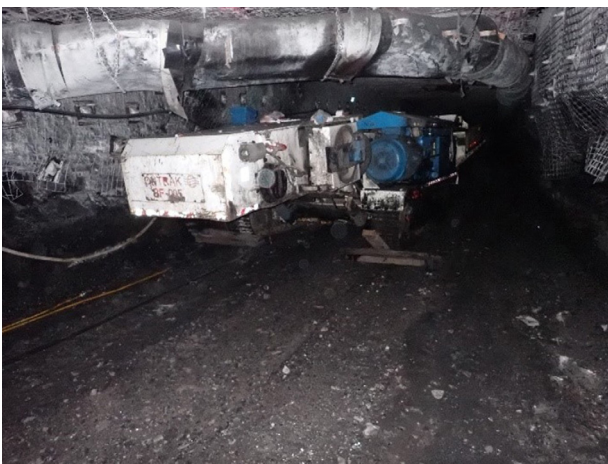
Picture 28.
The scene following the incident

Dangerous incident | IncNot0044657 – Feeder breaker runs away

Summary: A feeder breaker was being trammed up a grade in a development panel by a trainee operator and trainer. The feeder breaker rode up onto a rock on the ground that started to crack and break. The trainee operator stopped trammimg. When the trainee started trammimg again, the breaker feeder moved down the hill towards the workers. The feeder breaker rolled about 4 metres before it stopped. The trainee dropped the pendant. The cable was caught under the tracks and the power tripped.

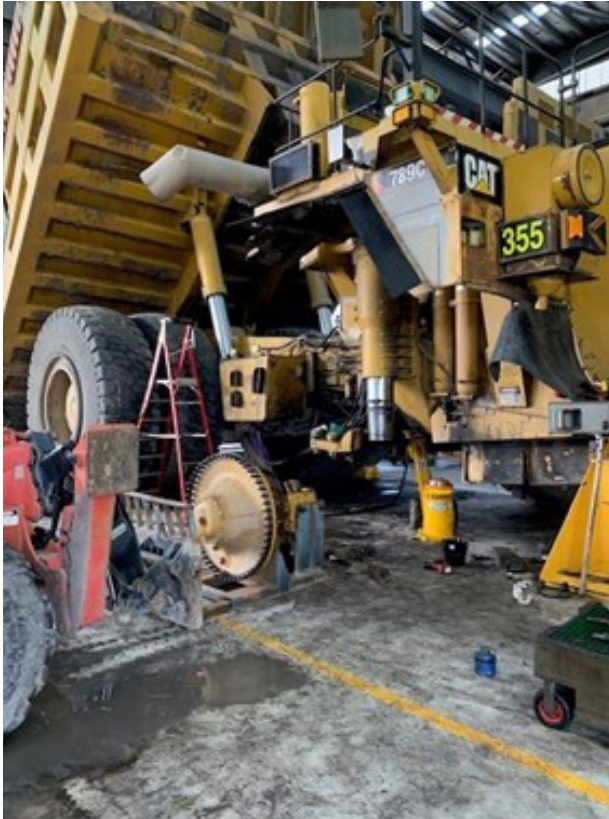
Picture 29.
The scene following the incident

Summary: Workers were changing out a front wheel hub assembly on a haul truck in a workshop. While removing the hub from the taper, the assembly unexpectedly moved. The assembly was fixed to a frame that was sitting on the tynes of a telehandler. The tynes dropped when the load moved. A worker in close proximity was hit in the face. The worker suffered minor grazing.

Comments to industry: When removing components that may release instantaneously (such as those on a taper), controls must be in place to protect workers from the sudden release of energy. This may include using a boss and retaining bolts, timber packing, restraining slings or stops. If forklifts and telehandlers are used, the impact of pneumatic tyres and boom extension should be considered when assessing movement of the load.
