Weekly incident summary

Week ending 11 Aug 2023

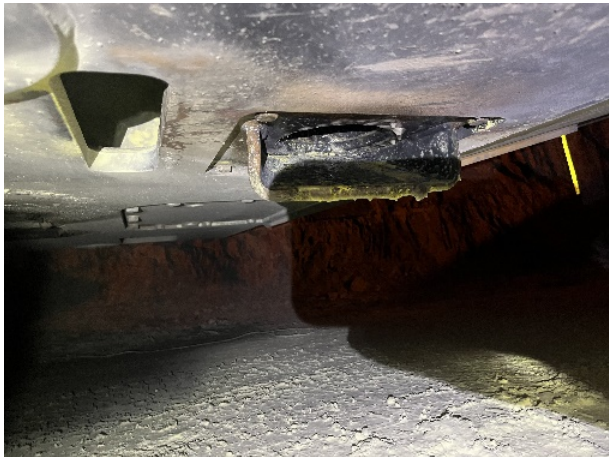
Incident type	Summary	Comments to industry
Dangerous incident IncNot0045182 Underground metals Fire or explosion

While refilling the tank on a water cart, the operator could smell something burning and found a small fire around the exhaust system. The operator extinguished the fire with a hand-held extinguisher. Diesel residue was found below the fuel filters above the DPF unit on the water cart Damaged gaskets and loose bolts were found on the exhaust unit.

Mine operators should ensure stringent monitoring and quality control of maintenance and repair activities. Refer to: MDG15 Guideline for mobile and transportable plant for use at mines (other than underground coal mines) AS 5062 <i>Fire protection for mobile and transportable equipment</i> provides further guidance for mines. For more resources, refer to our webpage: Fires on mobile plant safety

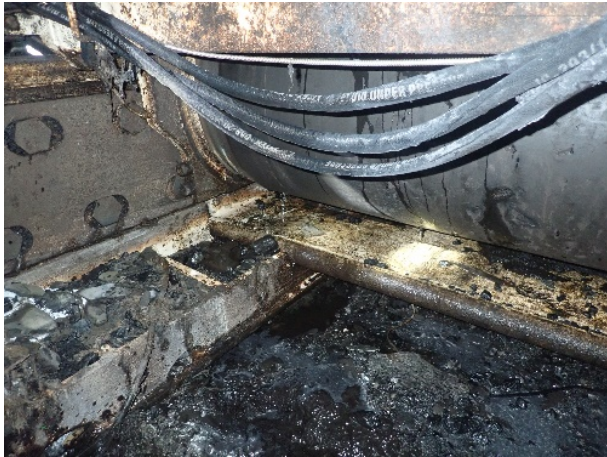
Incident type	Summary	Comments to industry
<p>Dangerous incident IncNot0045225</p> <p>Underground coal mine</p> <p>Fire or explosion</p>

<p>Longwall operators smelt burning and found a 30 cm flame on the side of the conveyor boot-end pulley.</p> <p>The belt was stopped, and water was applied to the pulley. The flame reignited once the water was taken off. Water was reapplied, the flame extinguished, and the water left running on the pulley with a spotter in attendance.</p> <p>The heat source of the fire was identified as a bearing failure.</p> <p>The temperature probes installed were discovered to be 290 mm long compared with a specified length of 450 mm contributing to the lack of warning of failure.</p>

<p>Where condition monitoring is used as a risk control for hazards such as fire, a commissioning process must be in place to ensure the systems are effective. Warning and trip points should be reviewed to ensure adequate detection prior to a failure occurring.</p>
