# Weekly incident summary

## Week ending 28 July 2023

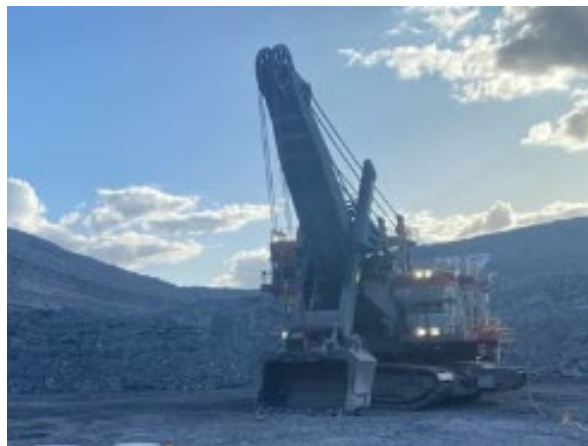
Incident type	Summary	Comments to industry
Dangerous incident IncNot0045101 Open cut coal mine	<p>The joystick control on an electric shovel failed to respond as the machine was swinging. As the machine was slewing left, the operator tried to stop the machine by pushing the joystick to the right. It did not respond. The operator was able to hoist the bucket while in motion to avoid hitting a dump truck.</p> <p>The shovel was walked back from the face and parked up. The bench was cleaned up before the scene was preserved.</p>	<p>The cause of this incident is being investigated. Further information may be published later.</p> <p>Workers and supervisor must be trained in the required response to incidents. This includes when escalation to management is needed and when the incident scene must be preserved.</p> <p><u>Work Health and Safety Act 2011 39 Duty to preserve incident sites</u> details the legislative requirements regarding scene preservation.</p>
