Weekly incident summary

Week ending 15 September 2023

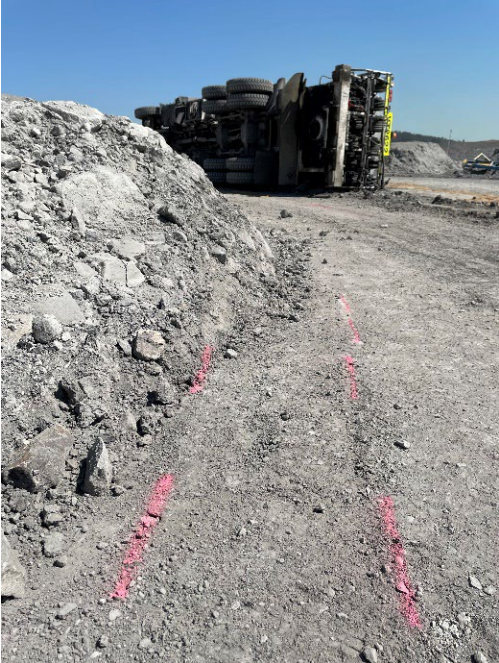
Dangerous incident IncNot0045399 Open cut coal mine Roads or other vehicle operating areas	<p>A service cart tipped onto its side when negotiating a bend near a haul road intersection. The truck was turning onto a light vehicle road from an old haul road when the truck drove onto the lower part of the windrow causing it to overturn.</p> <p>The operator self-evacuated.</p>	<p>Vehicle operators need to remain situationally aware when changing from one designated road type to another and drive to the conditions.</p> <p>Mine operators should ensure that traffic procedures account for</p>

<p>The incident occurred during daylight hours. The road was dry and flat, and visibility was clear.</p>

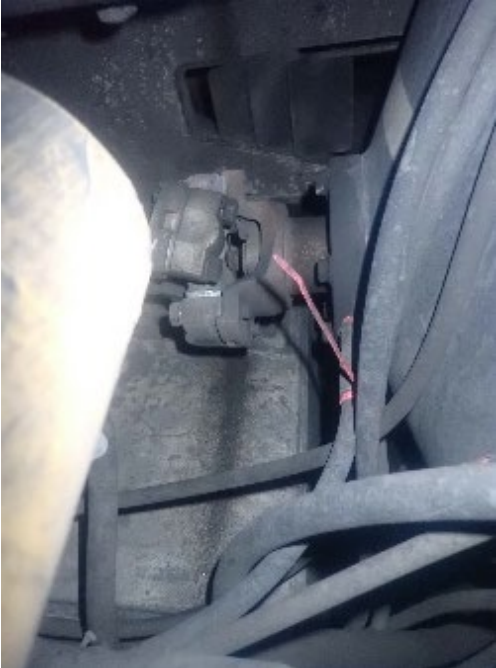
<p>medium-sized vehicles traveling on roads intended for light vehicles.</p>
<p>Dangerous incident IncNot0045403 Underground coal Fire or explosion</p>  	<p>A load haul dump (LHD) with an empty roof support trailer was travelling outbye when the operator smelled smoke and saw flames under the engine, within the engine bay.</p> <p>The investigation identified a failed universal joint.</p>

<p>Maintenance procedures must ensure that universal joints are included in maintenance schedules.</p>
