# Safety Alert

Date: November 2023

## Unintended initiation of unidentified (misfired) explosives during excavation

## Safety Alert SA23-04

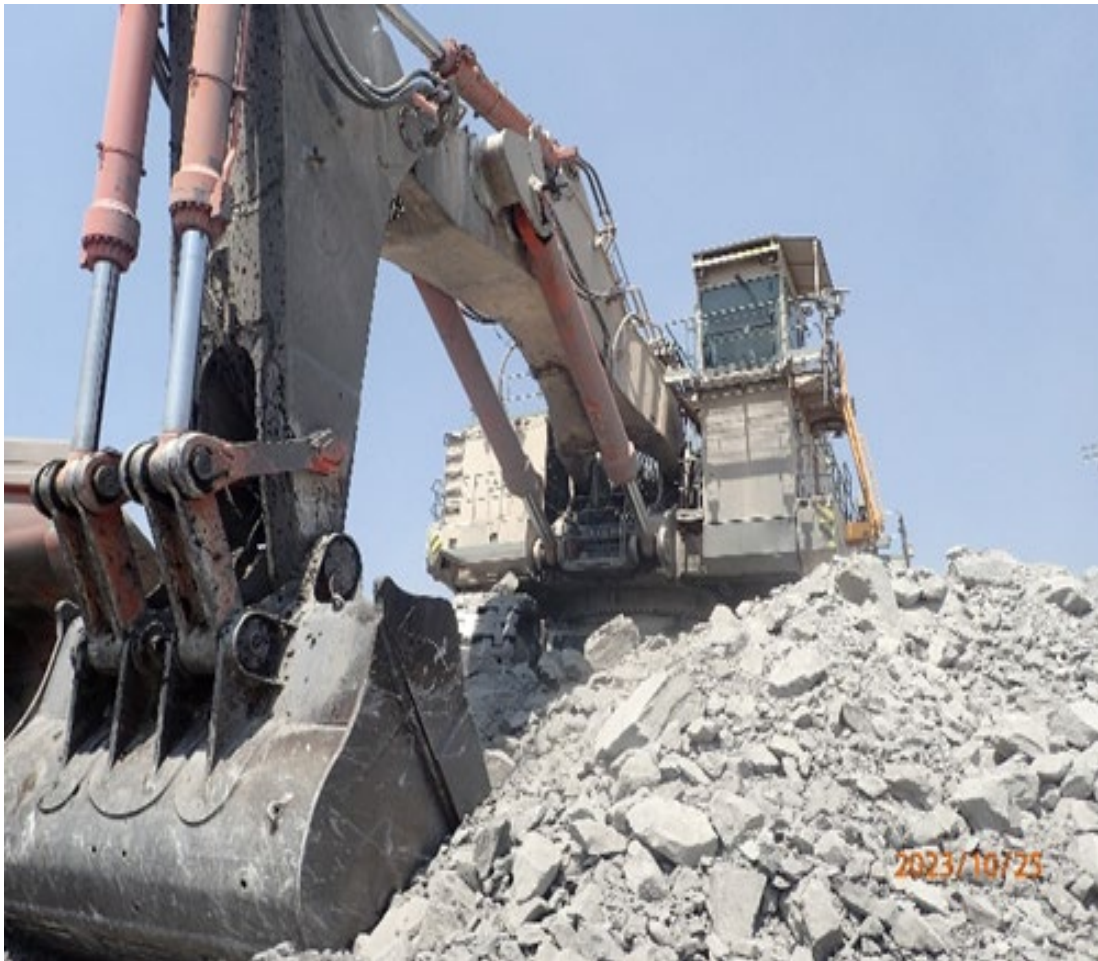
Figure 1: Excavator in position at time of incident

An excavator was excavating blasted waste material at an open cut coal mine during night shift when an unplanned initiation of explosives occurred.

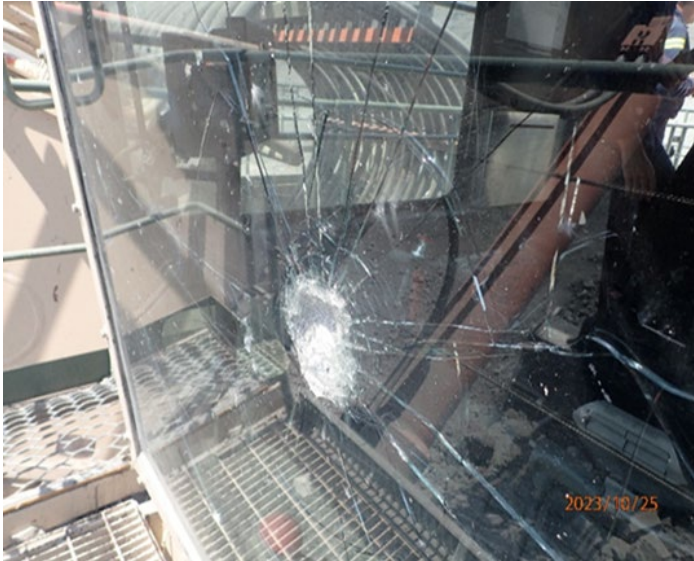
Figure 2: Flyrock impact damage to excavator windscreen

Multiple pieces of flyrock hit the windscreen and body of the excavator, damaging the windscreen. The operator's cabin was not breached.

- ensure equipment used for excavating blasted ground is suitable and able to withstand flyrock, over-pressure or other potential consequences of inadvertently initiated explosives, for example the use of hardened/laminated glass for operator cabins

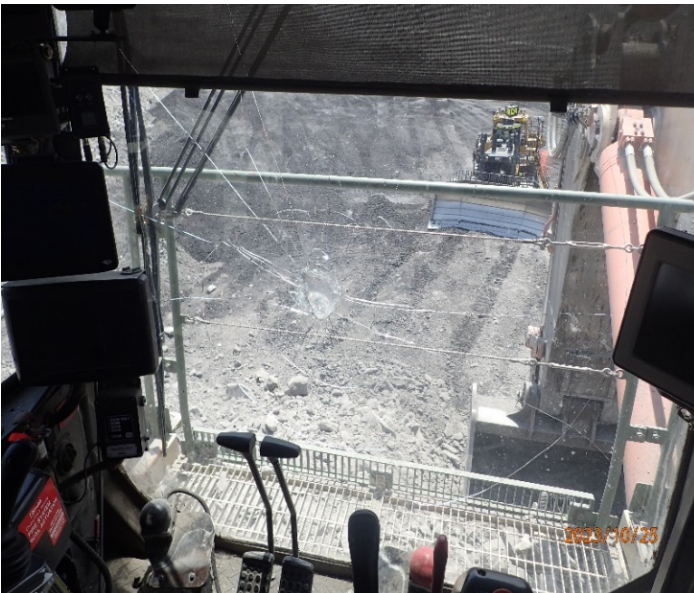
Figure 3: Inside the excavator cabin showing flyrock impact to windscreen and the position of the dozer after the incident

Flyrock was scattered up to 63 metres from the dig face, damaging a side mirror of a truck being loaded and hitting a dozer that was cleaning the floor at the time of the incident.
