Safety Alert

Date: October 2023

Conveyor tail pulley fire

Safety Alert SA23-03

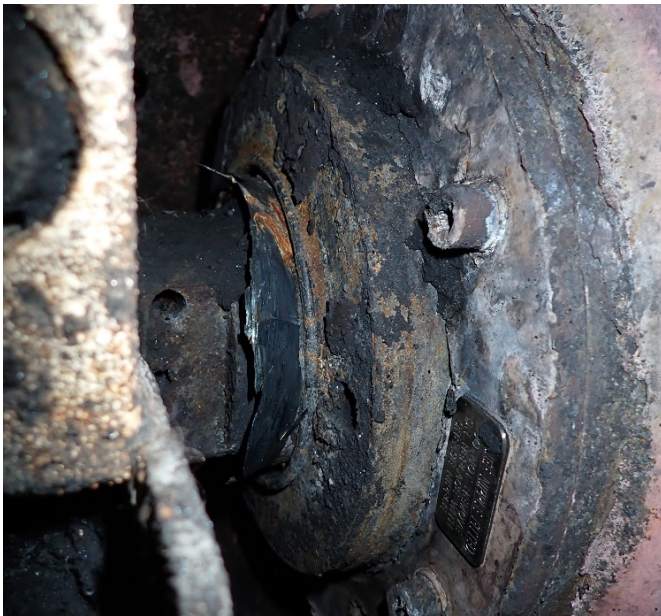
Underground mine workers investigating a burning smell discovered a fire on a longwall conveyor tail pulley. Workers tried unsuccessfully to extinguish 300 mm high flames with water hoses and fire extinguishers while the conveyor was running. The fire reignited when the cool water was removed. The conveyor was stopped, and the fire was extinguished. The conveyor was isolated, water applied to the tail pulley shaft area, and a fire watch was posted pending investigation.

Figure 1: Failed tail pulley bearing

The mine determined the fire was caused by a failed tail pulley bearing. The 2 tail pulley bearings were monitored by resistance temperature detectors (RTDs). Tail pulley bearing temperature trending was available through the mine's monitoring system.

The grease used in the bearing had a melting point of 180°C and a flash point of 230°C.

- ensure temperature monitoring systems are fitted in accordance with the equipment designs to achieve highest level of accuracy and sensitivity
- provide guidance on establishing and implementing setpoints for over-temperature alarms and tripping functions.

- establish systems to verify that devices provided to manage fire risks detect, alarm and trip in accordance with equipment specifications.
- ensure that monitoring systems are installed and operated to manage fire risk as described in the mine's safety management system.
- ensure monitoring data is readily available to enable the identification of emerging hazards.

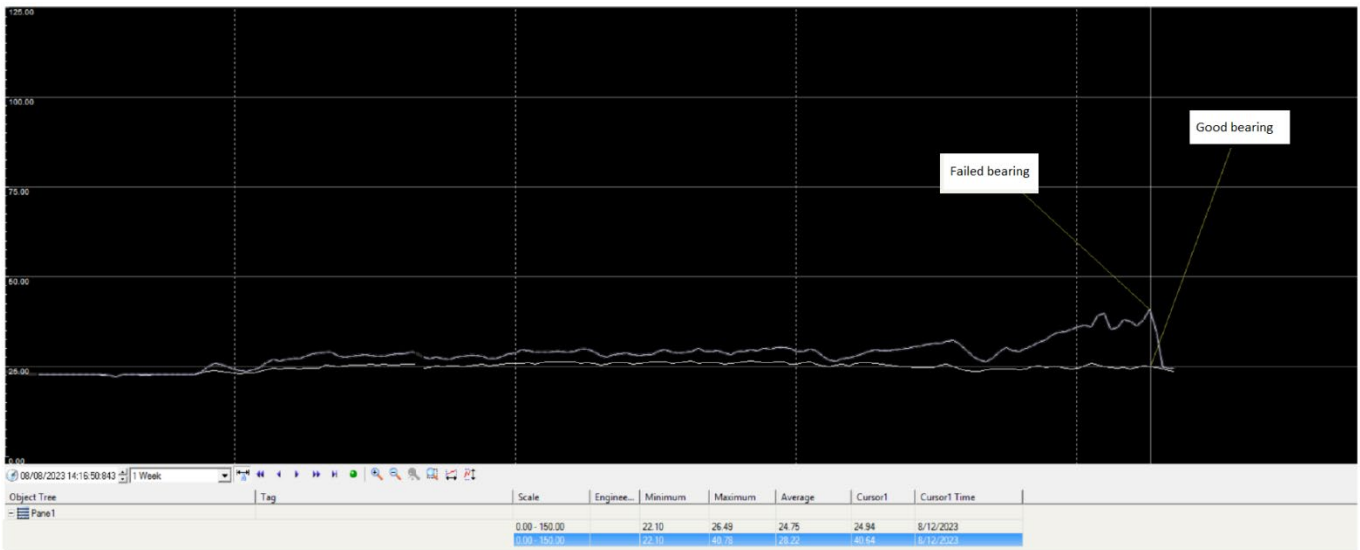
The recorded temperature of the bearing involved in the incident rose to about 41°C compared with the recorded temperature of the opposite pulley bearing that remained relatively steady about 25°C. The monitoring system was set to alarm when bearing temperature reached 65°C.

1. The design length of the RTDs monitoring the tail pulley bearing temperatures was 450 mm. The RTDs installed in the tail pulley assembly were only 290 mm, meaning that the measured temperature may not have reflected the actual bearing temperature.
2. The tail pulley bearing temperatures were monitored independently. Differential temperature monitoring of pulley bearings was the established standard at the mine but was not in place for the longwall tail pulley.

Monitoring records for the tail pulley involved in the incident revealed bearing temperature divergence began several days before the incident. An alarm setting of 10°C differential temperature (for example), would have provided several hours warning of the failure.

Figure 2: Bearing temperature monitoring for the week prior to the incident
