Safety Alert

Date: December 2023

Potential heating of acetylene cylinder raises potential for underground explosion

Safety Alert SA23-06

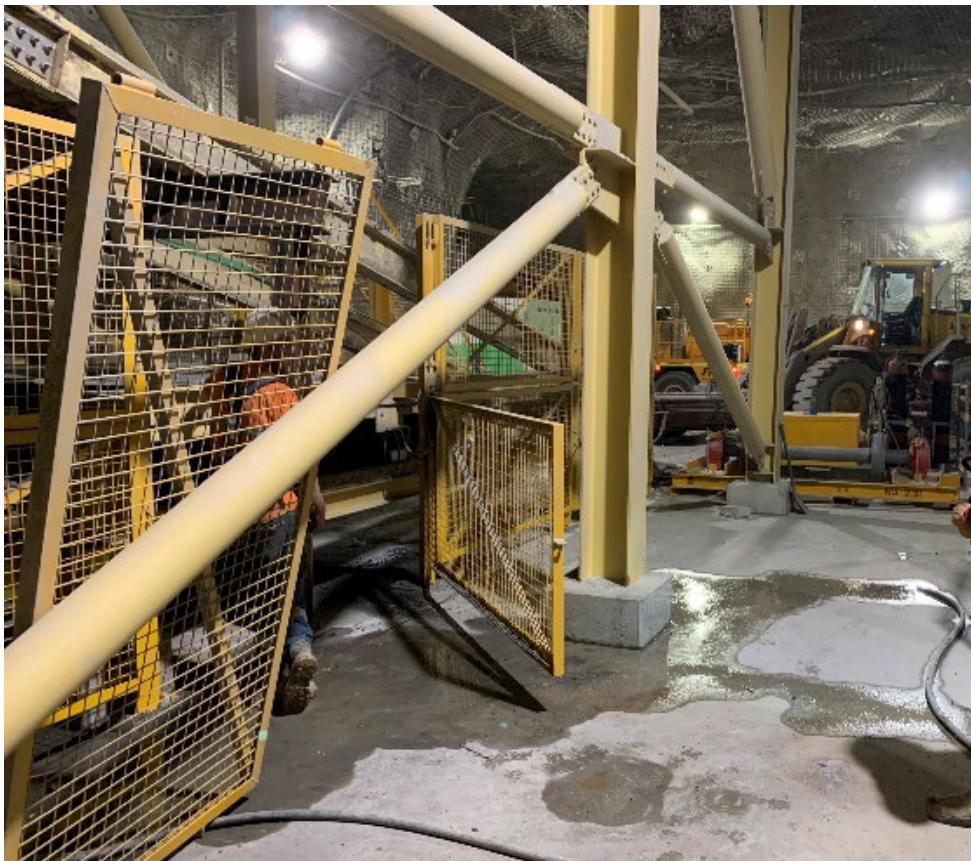
After initial cooling of the cylinder, mine workers loaded it on the back of a light vehicle and transported it to the surface without adequate considerations to the hazards.

Figure 1: Approximate position of workers with oxy/acetylene in stillage in the background

The workers loaded the cylinder on the back of a light vehicle and transported it to the surface, where it was quarantined. (Note this is not recommended practice when dealing with an acetylene incident).

1. An emergency response was not called.
2. The acetylene cylinder safe use standard stand-off time was not complied with.

- Ensure appropriate handling and storage of cylinders (both in use and off use) in purpose-built stillage in clean and ideally dry conditions.
- Ensure an emergency response plan covers a hazardous materials incident response, including gas cylinders and the subsequent explosion risk. The response plan should outline the steps to be taken in the event of a gas incident. Implementation should include training for response personnel and awareness and familiarity with this plan across all areas and workers where gases are used.

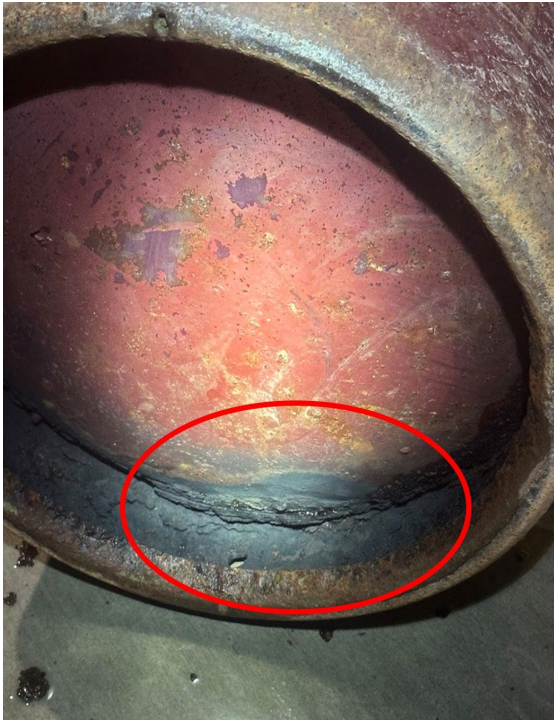
While conducting hot work, an orange glow was seen to be coming from the bottom of an acetylene cylinder.

Figure 2: Underside of acetylene cylinder with heat affected area

A visual inspection of the underside of the cylinder identified what appeared to be localised corrosion at the heat-affected area, and this may have contributed to a possible leak.

1. All acetylene cylinders on site were inspected for structural integrity and corrosion.
2. Warehouse staff began an immediate review of the Quality Assurance (QA)/Quality Control (QC) process with the vendor.

- Inspect all stock of acetylene cylinders across sites to ensure there is no corrosion and the structural integrity around the base of cylinders is free of visual mechanical defects.

- Contact the suppliers of gases and verifying the QA/QC process, including inspecting and testing cylinders, marking and stamping from testing authorities and labelling of those cylinders is known.
