Safety Bulletin

Methane gas incidents occurred in NSW coal mines

Safety Bulletin SB23-10

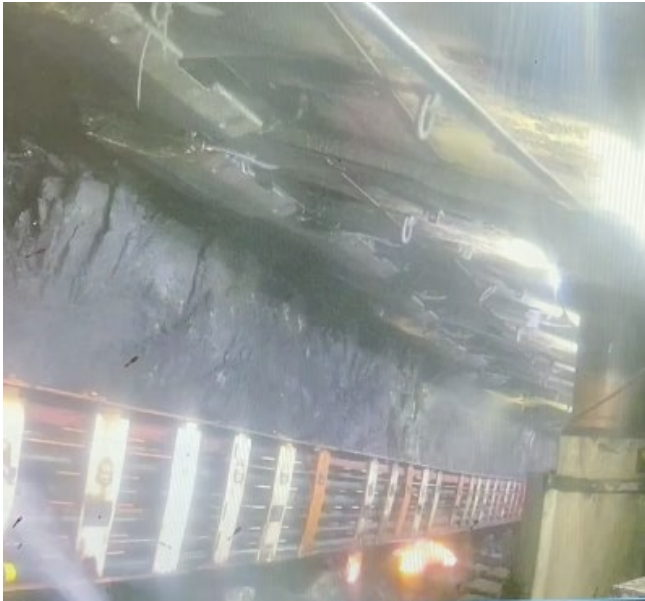
- A steel roof bolt was caught in the return raceway of a longwall armoured face conveyor that had a build-up of methane in the race way because of an uneven grade and floor break.

Figure 1 - Frictional ignition on an operation longwall

Mine operators should review the adequacy of their controls against frictional ignition and remedial controls if an ignition occurs, within their safety and health management system. This review should include but not be limited to:

- frictional ignition management plans
- management of in situ gas content
- gas drainage requirements
- cutting sequences
- face ventilation requirements
- pre-use checks regarding picks and sprays
- stone dusting requirements
- gas drainage hole intersection procedures
- frictional ignition trigger action response plans (TARPs).
