Weekly incident summary

Week ending 1 December 2023

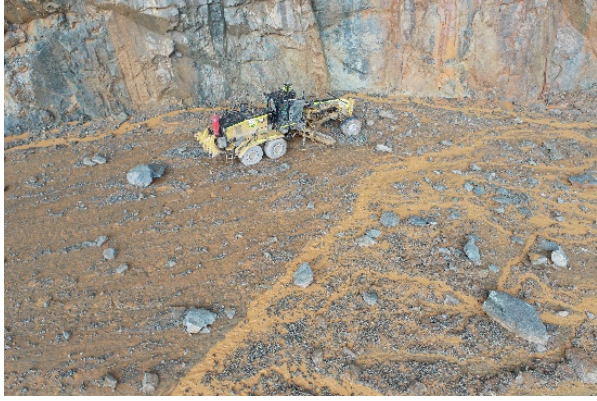
Dangerous incident IncNot0045905 Open cut metals mine	A wedge failure occurred from about 114 m up a high wall with some material falling onto the main ramp. Most of the material was caught by the berms and broken up during the failure. About 2 tonnes of rock landed on the main pit	Mine operators should review the frequency of assessments of highwall stability and confirm appropriate triggers are included to increase frequency of

<p data-bbox="403 219 1002 291">ramp with some hitting a grader. The grader operator was not injured.</p> <p data-bbox="403 309 1002 459">At the time of the event, the pit was closed to normal operations due to rainfall in the preceding 24 hours and was in the initial stages of being reopened to resume mining operations.</p>

<p data-bbox="1010 219 1479 291">assessments arising from events such as rain events.</p> <p data-bbox="1010 309 1479 459">Mine operators should also ensure water egress is minimised to highwall crests to reduce the potential of a failure occurring.</p> <p data-bbox="1010 477 1479 600">Refer to Safety Bulletin: <u>SB20-01 Failure of highwalls, low walls and dumps.</u></p>
<p data-bbox="113 902 395 985">Dangerous incident IncNot0045907</p> <p data-bbox="113 1010 395 1160">Open cut coal Roads or other vehicle operating areas</p>

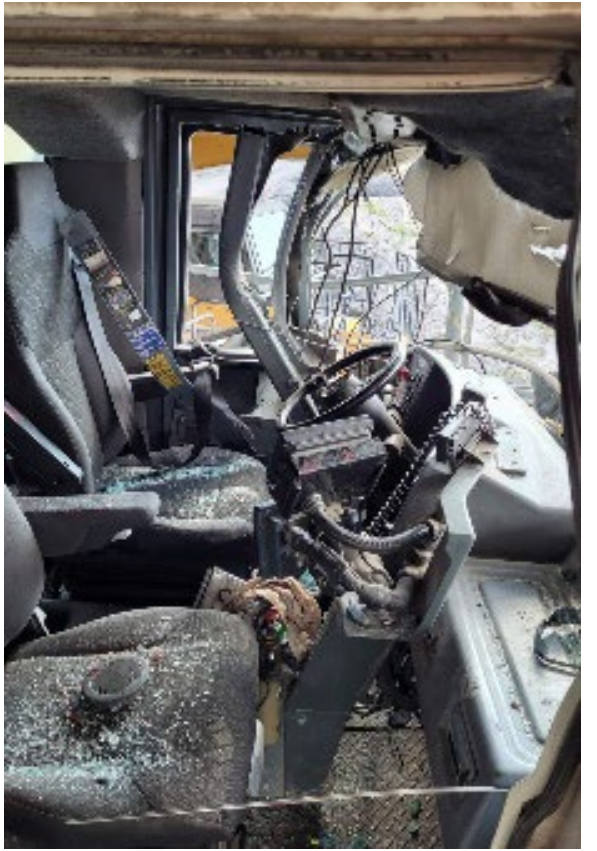
<p data-bbox="403 902 1002 1010">Two empty haul trucks turned in front of each other with the collision causing the headboard of one to damage the cabin of the other.</p> <p data-bbox="403 1028 1002 1099">One operator suffered hand fractures and a head laceration that required 52 stitches.</p>

<p data-bbox="1010 902 1479 1010">This incident is under investigation and further information may be published later.</p> <p data-bbox="1010 1028 1479 1323">Following a recent awareness campaign on vehicle interactions the Regulator published a video that can be used for training purposes and toolbox talks. Mine operators are encouraged to use this resource. You can watch the video on <u>YouTube</u>.</p>
