Investigation information release

Two workers injured when truck tyre explodes

Incident date: 8 February 2024

Location: Clovass Quarry, Clovass NSW

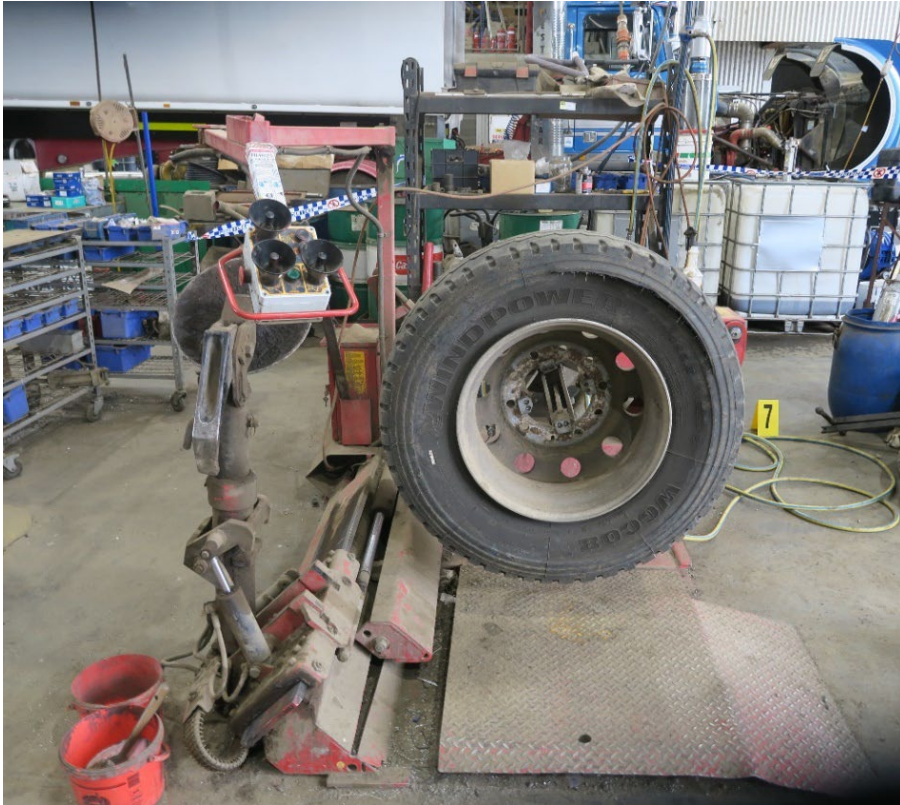
Figure 1: Front view of tyre and wheel assembly fitted to the tyre-fitting machine after the incident

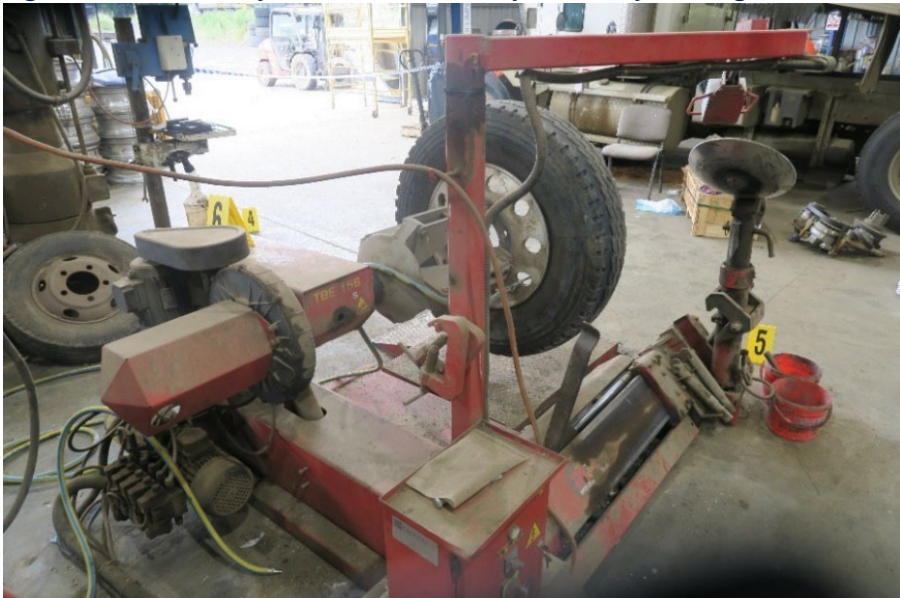
Figure 2: Rear view of tyre and wheel assembly fitted to tyre-fitting machine after the incident

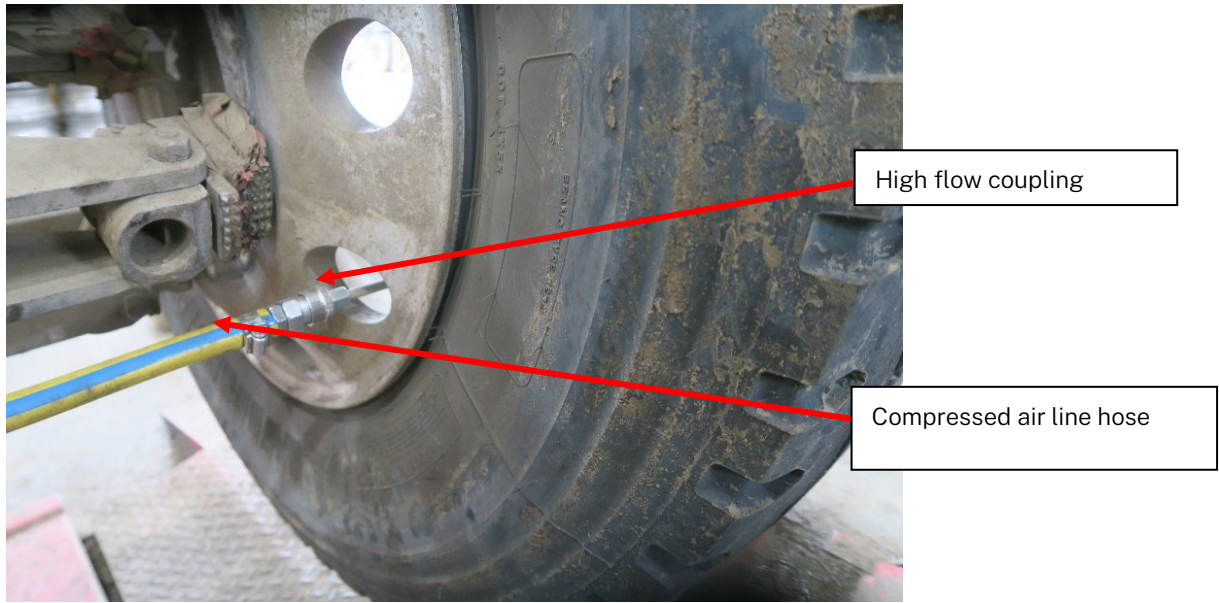
Figure 3: Compressed air line hose and high-flow coupling fitted to the tyre and wheel assembly

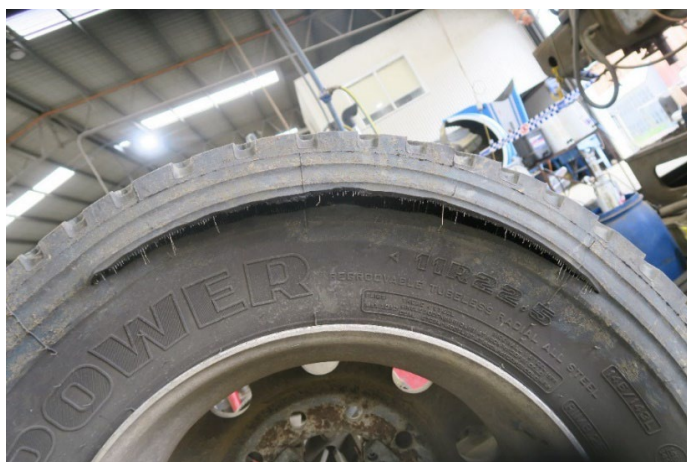
The workshop's compressed air line system continued to pump air into, and inflate, the tyre. Shortly after, there was a loud bang and the 2 workers at the front of the tyre were hit with debris and explosive air pressure. The air pressure knocked one worker to the floor and tore off his shirt. He was later found to have suffered perforated ear drums, hearing loss, cuts and bruises. The other worker was hit directly in the face with debris and later found to have suffered an eye injury.

Inspection of the tyre after the incident identified a rupture of its side wall (as shown in Figure 4).

Figure 4: Front view of tyre showing side wall failure

- develop and implement a safe system of work for inspecting, repairing and maintaining tyres that, among other things, take into account that a damaged tyre may be prone to failure during inspection
- ensure procedures for detecting tyre leaks incorporate, where reasonably practicable, appropriate controls including:
 - conducting an inspection of a tyre to confirm its integrity before inflation
 - restricting tyre inflation air pressures for the purpose of confirming bead seating/lock ring engagement on multi-piece wheel assemblies and leak detection
 - restraining tyres using safety cages or similar devices while they are being inflated
 - positioning workers clear of potential trajectory paths of a failed tyre with clear exclusion zones identified
