Quarterly safety report

October to December 2023

Title: Quarterly safety report – October to December 2023

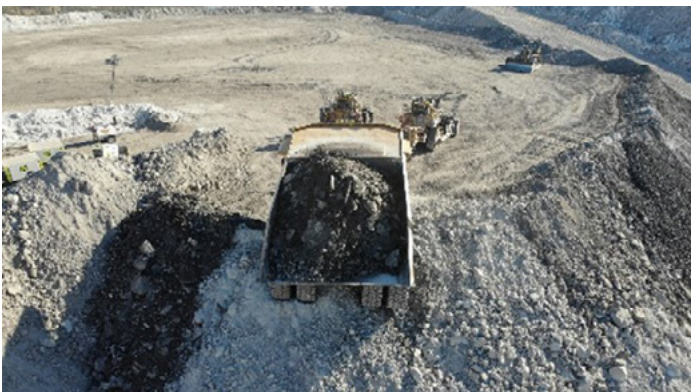
Picture 1.
Dump truck following the incident.

Summary: A rear dump truck reversed into a tip area to tip its load. The truck backed up to and through a dump windrow with both sets of dual tyres, causing the truck to become stuck on the dump edge with its belly on the ground and duals over the edge.

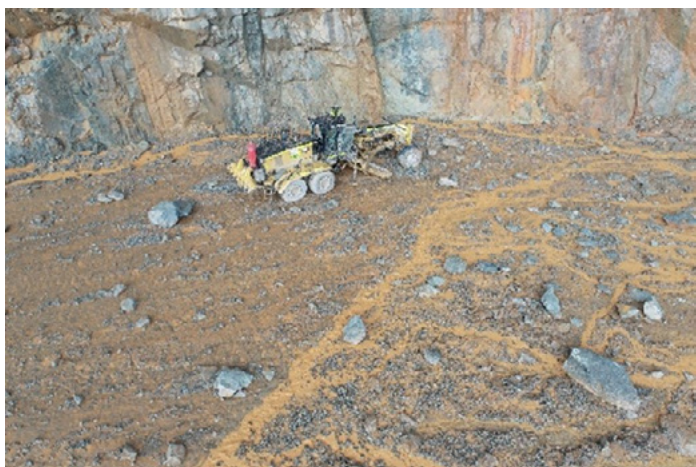
Picture 2.
The scene following the incident.

Dangerous incident | IncNot0045905 – Wedge failure caused material fall and hit grader

Summary: A wedge failure occurred from about 114 m up a high wall with some material falling onto the main ramp. Most of the material was caught by the berms and broken up during the failure. About 2 tonnes of rock landed on the main pit ramp with some hitting a grader. The grader operator was not injured. At the time of the event, the pit was closed to normal operations due to rainfall in the preceding 24 hours and was in the initial stages of being reopened to resume mining operations.

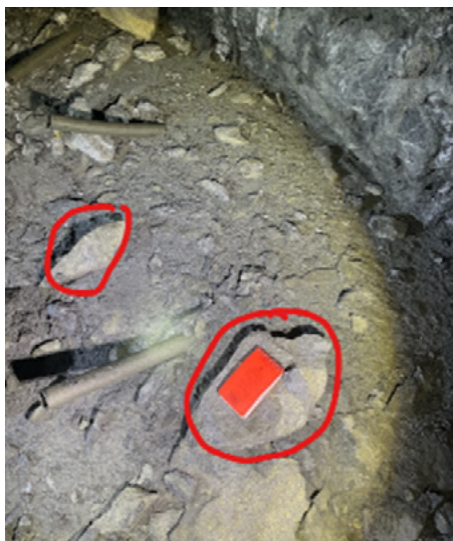
Picture 3.
Rock that fell during the incident.

Summary: While preparing for a shot underground, a piece of rock about 300 x 200 x 100 mm fell off the face and hit a worker on the right shoulder and back, knocking him over.

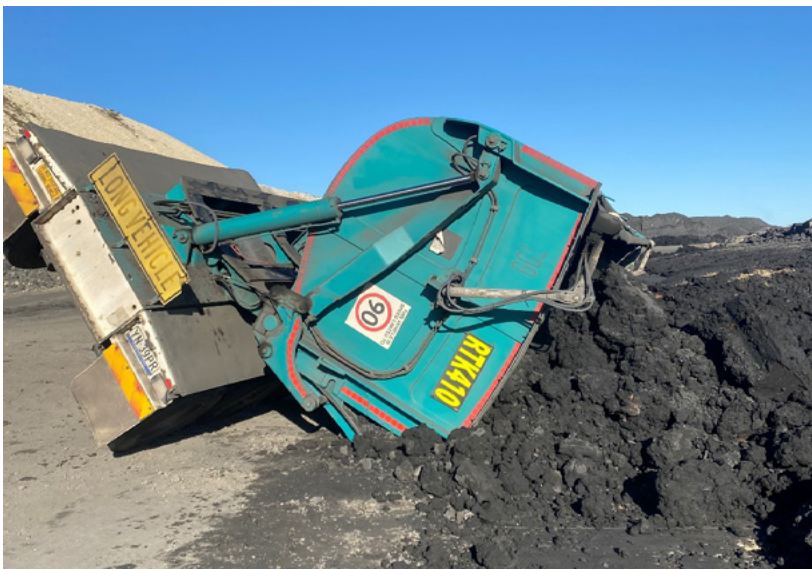
Picture 4.
Haul truck following the incident.

Dangerous incident | IncNot0045600 – Haul truck rolled while unloading reject material

Summary: The rear trailer of an A-double combination rolled while being unloaded. The truck was being used to haul reject material.

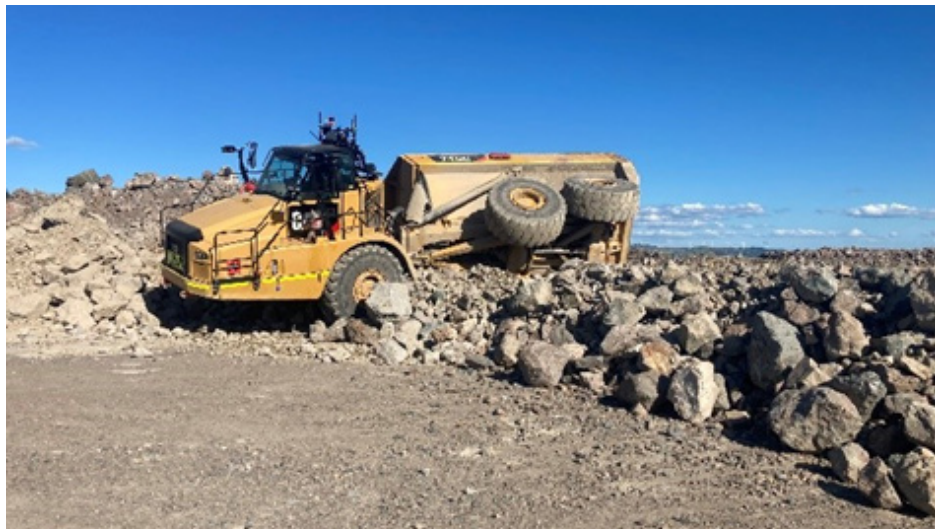
Picture 5.
Dump truck following the incident.

Summary: A worker was driving an articulated dump truck when they reached for a drink bottle. The truck hit a windrow, rode over the windrow and the tub rolled.

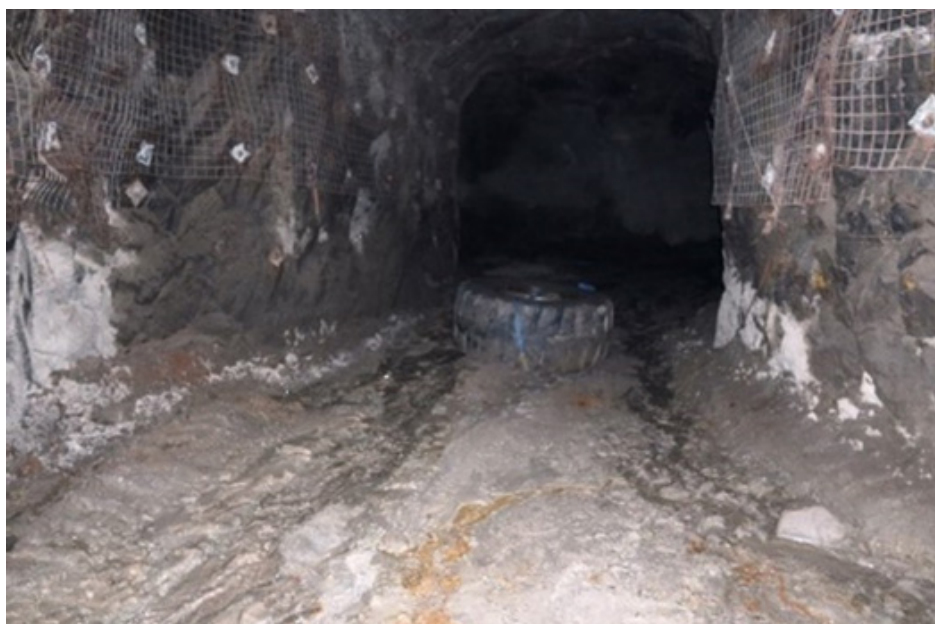
Picture 6.
Truck tyre where it stopped.

Summary: A truck tyre was being transported underground on the forks of an integrated tool carrier. While driving down the decline, the tyre came off the forks and rolled down the decline striking the rear of a popping rig that was tramping down the decline. The tyre continued rolling before stopping 500 m from where it dislodged from the forks.

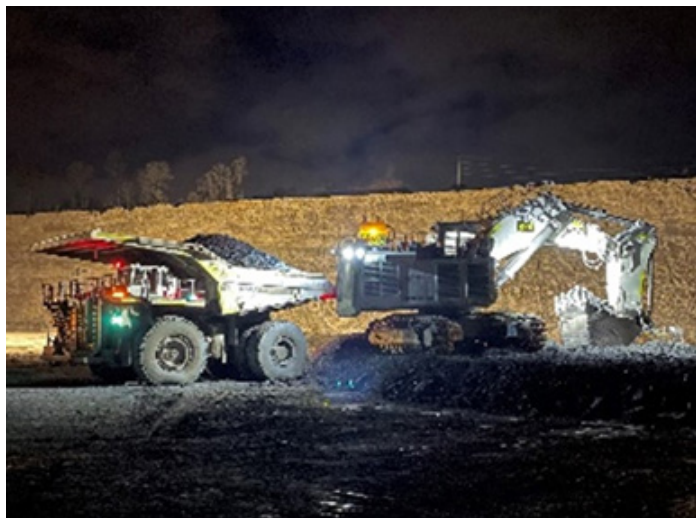
Picture 7.
Haul truck and excavator following the incident.

Summary: A haul truck was loaded by an excavator and kicked out. The truck driver did not hear the horn. Before the truck drove away the excavator started to reposition. In the process, the excavator counterweight hit the dovetail of the tray. No workers were injured.

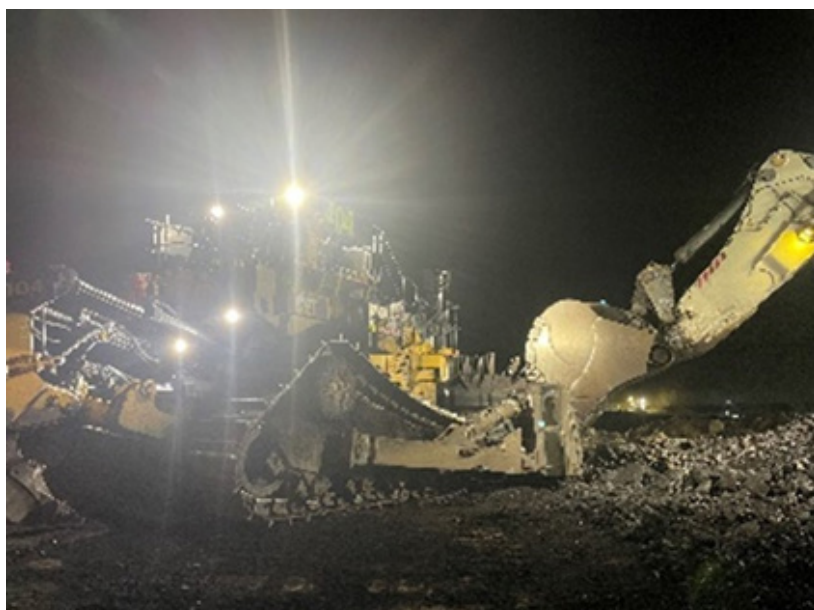
Picture 8.
Dozer following the incident.

Summary: A dozer was hit by an excavator bucket while the excavator was slewing for a bucket of coal. The dozer was too close to the swing radius of the excavator and when activating the steer clutch went the wrong way.

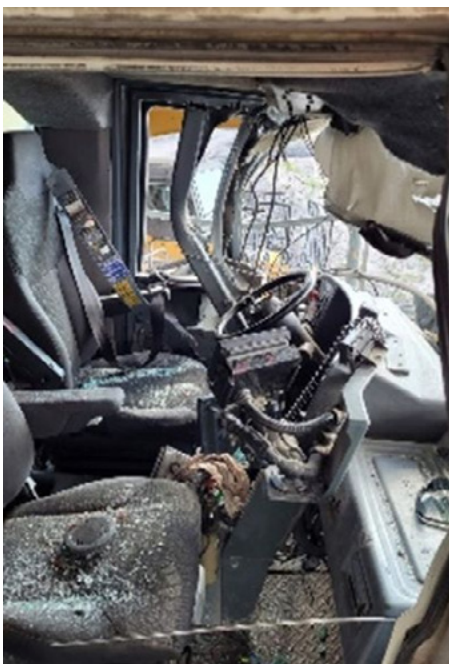
Picture 9.
Cabin of haul truck following the incident.

Summary: Two empty haul trucks turned in front of each other with the collision causing the headboard of one to damage the cabin of the other. One operator suffered hand fractures and a head laceration that required 52 stitches.

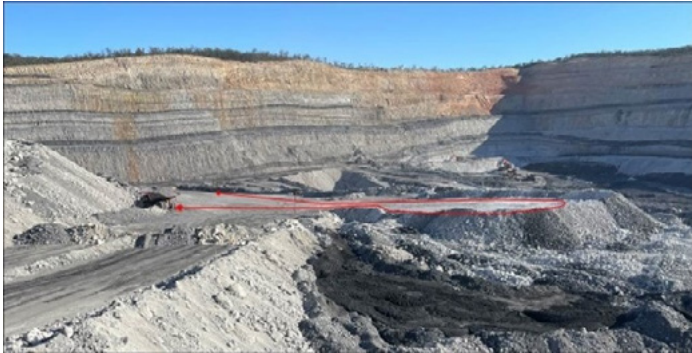
Picture 10.
Scene of the incident.

Summary: The operator of a dump truck turned at the tip head to get into a position to reverse. The operator turned too wide and drove position 1 tyre up onto the windrow at the side of the ramp regrade, exposing the operator and truck to a 3.5 m drop off. The operator continued to drive along the windrow, with position 3 and 4 tyres also mounting the windrow. The operator drove forwards off the windrow back onto the ramp. The operator said they were unable to stop the truck using the brakes, so decided to steer the truck about 90 m across the ramp, on a 9% grade, into the windrow on the edge of the road to stop the truck. The operator was not injured. Initial investigation suggested there was no issue with the braking system.

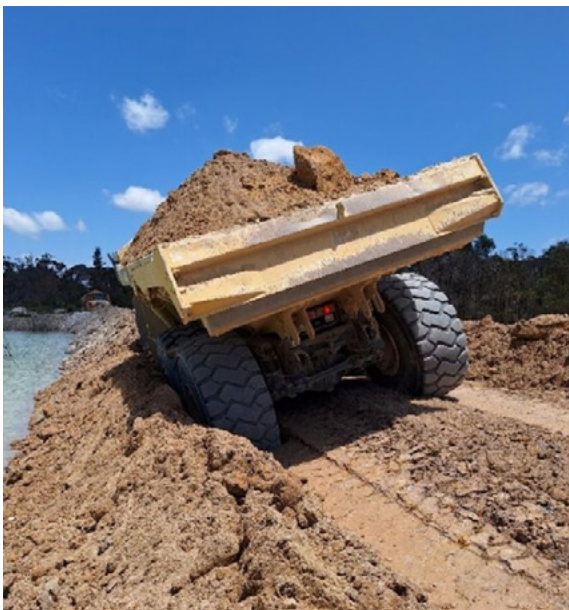
Picture 11.
Dump truck following the incident.

Summary: A loaded articulated dump truck became bogged while tipping overburden along a dam wall. The driver failed to hear positive communication from the dozer operator and continued to reverse with the left hand side of the truck sinking. The truck was not able to be removed under its own tractive effort.

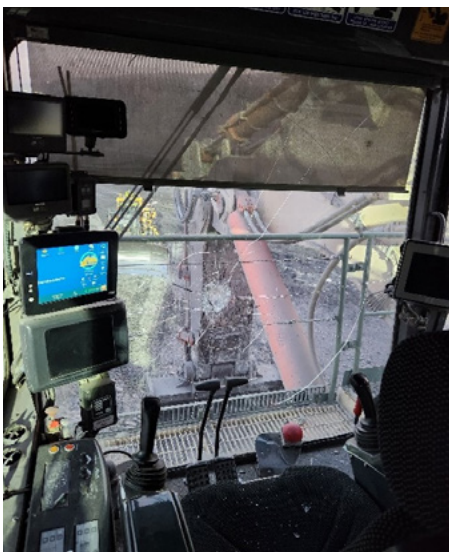
Picture 12. Excavator following the incident.

Dangerous incident | IncNot45666 – Unintended initiation of explosives on excavator

Summary: An excavator caused an unintended initiation of explosives while filling an excavator bucket with overburden. Flyrock from the explosion hit the windscreen of the excavator resulting in laminated glass inside the operator’s cabin. No rock penetrated the glass. An adjacent haul truck sustained damage to the side mirror and some debris on the walkway. A nearby dozer also had flyrock material impact the machine. The haul truck and dozer were about 5–10 m from the bucket when the incident occurred. There were no injuries suffered by any of the operators.

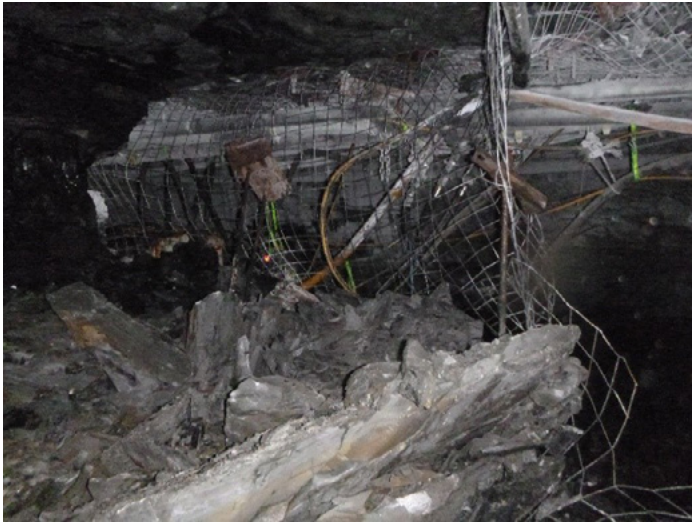
Picture 13.
Scene of the incident.

Summary: A load haul dump was cleaning out a cut through to access a seal for repairs. Two workers were inspecting the cut through when they noticed a change in rib conditions. The workers moved to the opposite side of the roadway. Soon after, the rib slumped.

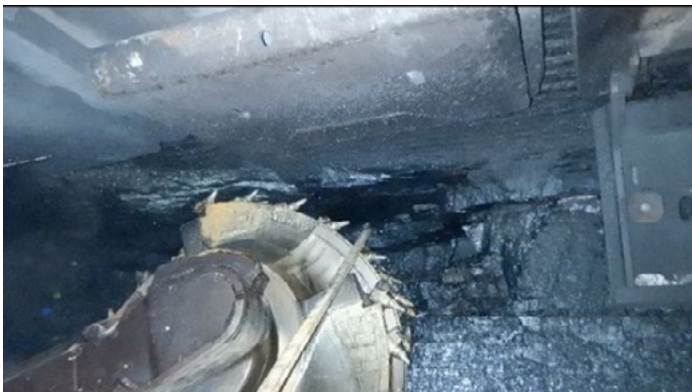
Picture 14.
Scene of the incident.

Summary: A frictional ignition event occurred during production on a long wall when workers were heading back to the main gate cutting the roof. There were frictional ignition checks and 16 picks were changed. The event lasted about 60 seconds and was extinguished with 2 frictional ignition hoses.

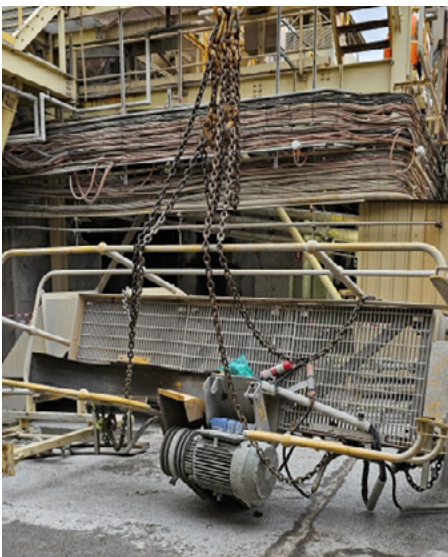
Picture 15.
Scene of the incident.

Dangerous incident | IncNot0045537 – Unplanned movement of screen

Summary: While in the process of lifting a screen with a motor attached, the dogman climbed onto the screen to adjust the lifting chains and radioed the crane operator to take the weight. The screen lifted on one side and, with only one corner touching the ground, tipped on an angle of 45 degrees. It proceeded to rotate 180 degrees. The crane operator lowered the screen and the dogman climbed to the ground.

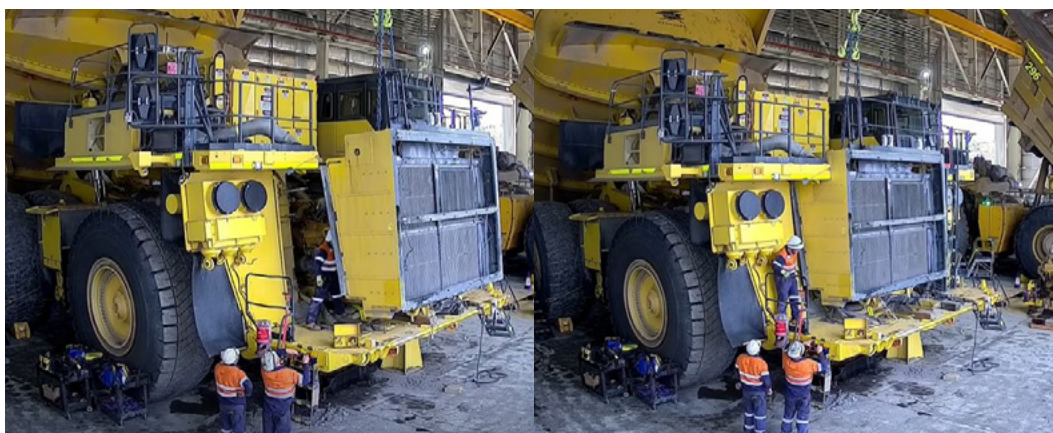
Pictures 16 and 17.
Scene of the incident.

Summary: Two workers were in the engine bay of a haul truck adjusting chains while installing an engine module. The module moved unexpectedly. The workers had to jump clear to avoid being hit or crushed. Both workers were uninjured. The incident was not immediately reported to the supervisor.

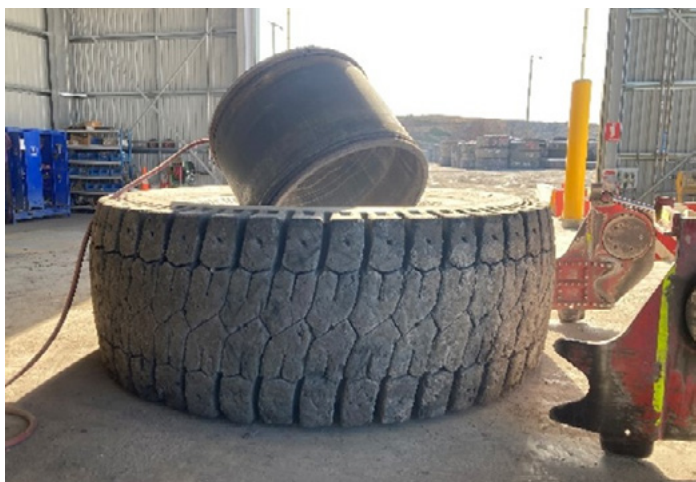
Picture 18.
Tyre and rim involved in the incident.

Summary: The rim of a haul truck tyre ejected from the tyre while the tyre was on the ground being inflated. The tyre was being inflated after having the rim O-ring seals replaced. The rim weighing about 2.5 tonnes was ejected about 300 mm above the tyre. The technician was about 5 m from the tyre when the rim ejected. The technician was having some difficulty trying to get the tyre to seal, possibly due to a leaking O-ring. The pressure was reported to be just above 10 psi at the time.

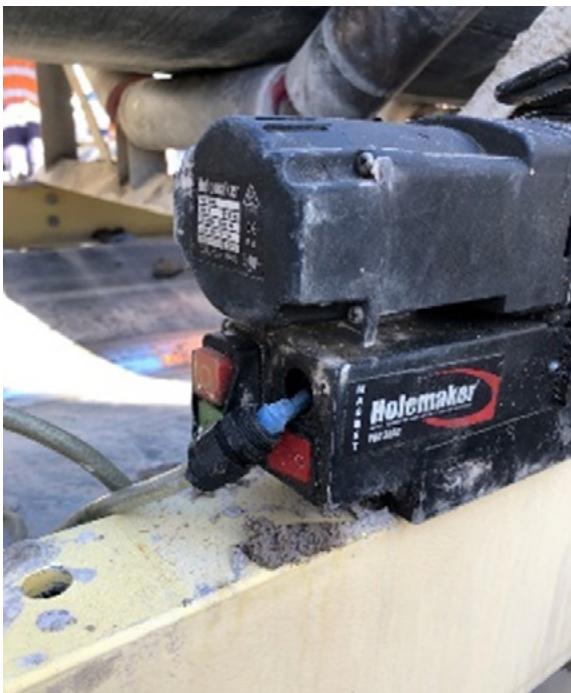
Picture 19.
Equipment involved in the incident.

Dangerous incident | IncNot46027 – Electric shock to worker using electric rotor broach

Summary: A worker suffered an electric shock while installing a new skirting system to a conveyor using an electric rotor broach to drill holes. A gland on the portable drill was pulled out and allowed ingress of moisture to internal electrical components.
