# Weekly incident summary

## Week ending 12 April 2024

Document control	
CM9 reference	DOC24/77888
Mine safety reference	ISR24-15
Date published	19 April 2024
Authorised by	Director Technical Operations Mine Safety Office of the Chief Inspector

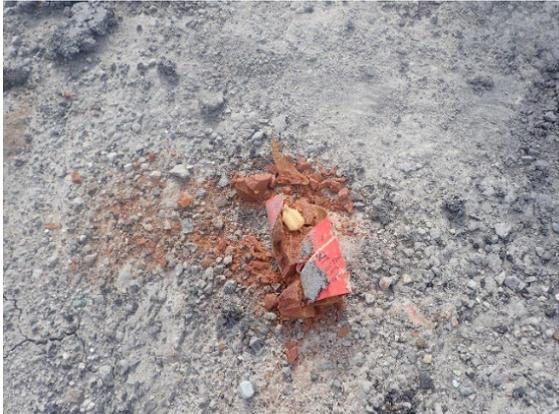
Incident type	Summary	Comments to industry
Dangerous incident IncNot0046674 Open cut coal mine	<p>A worker operating a front end loader ran over 3 boosters while cleaning up on a shot.</p> <p>The operator was taken through the task before starting by the blast supervisor, and was given instructions to stay away from explosives on the ground.</p>

<p>Workers have a legislative duty to care for their own health and safety and that of others (Section 28 of the <i>Work Health and Safety Act 2011</i>).</p> <p>One of the duties is to cooperate with any reasonable policy or procedure. Failure to comply with a duty is an offence and penalties apply.</p> <p>The traffic management plan for a shot floor should clearly identify travel routes so that trucks do not inadvertently drive along the incorrect path. Drivers should know the travel routes before entering the shot floor. To help the drivers, demarcation of usable tracks should be clearly identified by using visible cues such as cones or signs.</p>

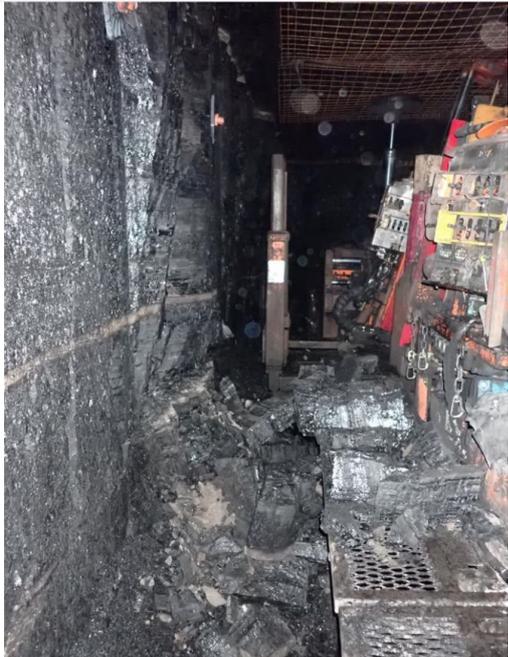
<p data-bbox="392 398 954 577">Following completion of rib support, a wedge of rib failed from between installed support. The wedge toppled onto the platform of a continuous miner in the vicinity of the rib bolting control box.</p> <p data-bbox="392 600 930 741">The rib support was installed in accordance with the approved support plan. Noticeable jointing was evident on inspection after the incident.</p>

<p data-bbox="999 219 1453 360">Mine operators should ensure effective supervision and auditing of compliance with documented traffic management plans.</p> <p data-bbox="1015 398 1477 651">Underground mine operators should review the adequacy of their strata monitoring arrangements and associated trigger action response plans (TARPs) to ensure that workers are not exposed to unacceptable risks associated with strata failure.</p>

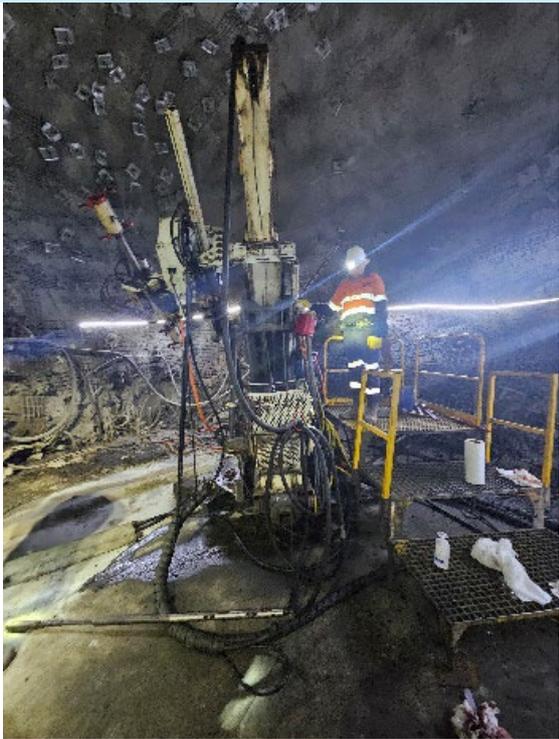
<p data-bbox="113 1458 296 1487">Serious injury</p> <p data-bbox="113 1509 328 1538">IncNot0046703</p> <p data-bbox="113 1561 296 1628">Underground metals mine</p>	<p data-bbox="392 1458 970 1673">A driller's offsider on a diamond drilling rig was hit in the face by an object that ejected from the drill rig. The offsider was climbing the stairs to access the drilling platform. The object was suspected to be the drill's overshot (~1800 mm and 5-10 kg).</p> <p data-bbox="392 1695 946 1800">The overshot was stored in the drilling frame and made contact with the drilling head, causing it to fall and hit the offsider.</p> <p data-bbox="392 1823 943 1928">The impact from the object caused the offsider to fall about 1.5 m from the stairs of the drill platform below.</p> <p data-bbox="392 1951 943 2024">The offsider was unconscious on the ground after the fall and suffered serious injuries.</p>	<p data-bbox="999 1458 1430 1563">This incident is under investigation and an investigation report will be published at a later date.</p>

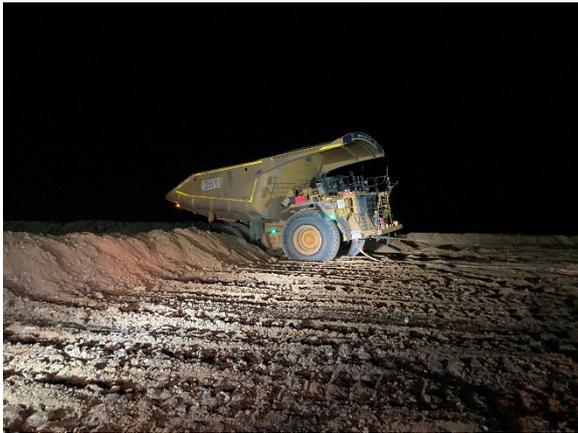
<p>While reversing to the tip face to dump a load, the operator failed to stop on time and the position 5 and 6 tyres breached the windrow. The operator remained in the cab while the truck was pulled forward off the windrow.</p>

<p>Windrow design, construction and maintenance is a critical factor in dump safety. Mine operators should:</p> <ul style="list-style-type: none"> <li>design and construct windrows adequately to be a control for the hazard at the operation, paying specific attention to set-back distances, heights and material used</li> <li>regularly inspect and maintain windrows through open cut examiner inspections and operator inspections.</li> </ul> <p>Refer to Safety bulletin:  <a href="#"><u>SB18-11 Windrow management and demarcation</u></a></p>
