Weekly incident summary

Week ending 16 August 2024

Summarised incidents

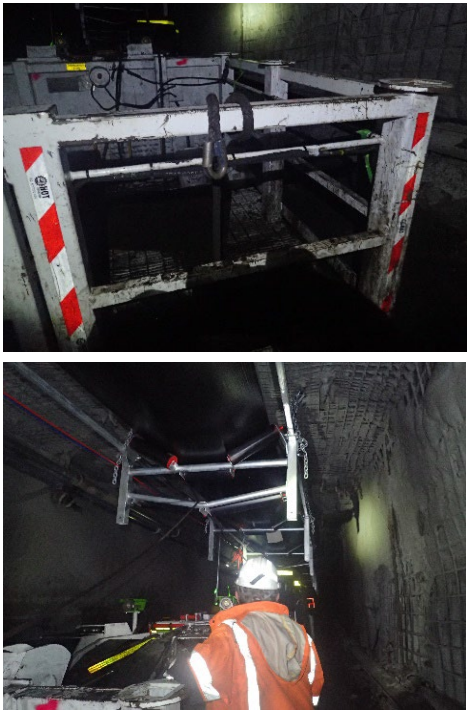
| Incident type | Summary | Comments to industry |
|--|--|---|
| Dangerous incident IncNot0047422 Underground coal mine | <p>While installing a conveyor belt, workers were pulling a belt winch rope over a belt structure.</p> <p>The rope, with a steel eyelet attached, was wound around the handrail of a man basket on an Eimco to assist with pulling. A knot formed in the winch rope and got caught in the V-shape return frame causing high tension on the rope.</p> <p>The rope subsequently uncoiled at speed from the basket handrail and travelled past 2 workers in the basket and the Eimco operator. The rope recoiled about 50 m past the Eimco before it stopped.</p> <p>The steel eyelet flew past the heads of 2 workers, missing them by about 300 mm.</p> | <p>This and other recent incidents of rope and sling failures while under tension are the subject of investigation and further information will be published later.</p> <p>Mine operators are reminded of the need to undertake proper risk analysis before undertaking pulling tasks.</p> <p>Workers should not be in the line of fire in the event of rope or sling failures.</p> |

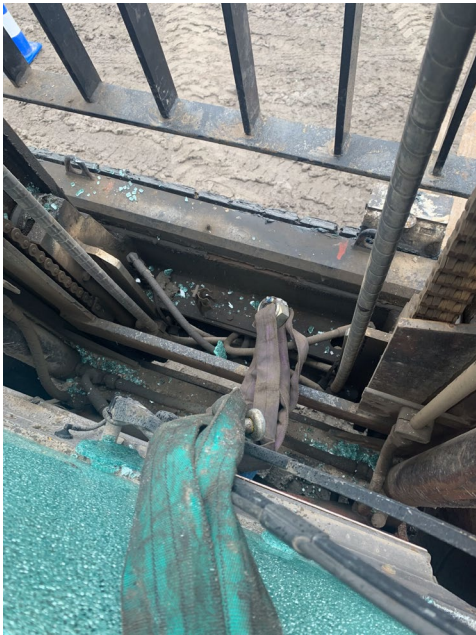
| Incident type | Summary | Comments to industry |
|---|--|---|
| <p data-bbox="124 972 368 1099">Dangerous incident IncNot0047473 Open cut coal mine</p> | <p data-bbox="419 972 906 1272">Workers who were removing track pins from an excavator welded a nut (M28-30) to a pin, and used a sling attached to a forklift to try to pull out the pin. The weld failed and the nut and steel shackle on the sling flew through the front window of the forklift and out the back window, hitting the operator.</p> | <p data-bbox="943 972 1241 1010">Refer to incident above.</p> |

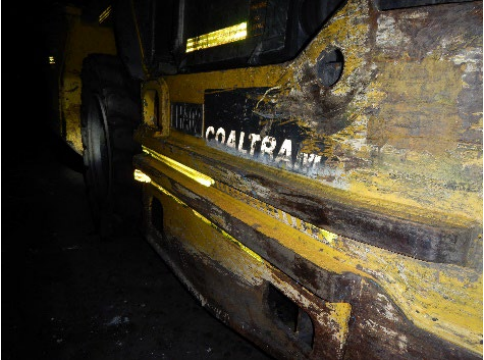
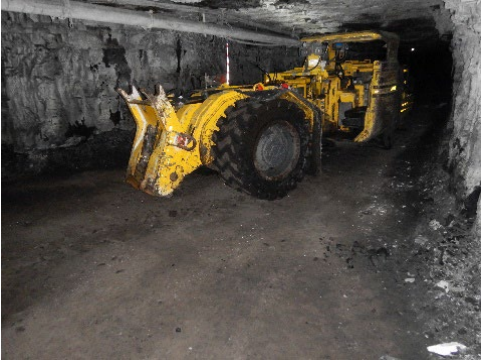
| Incident type | Summary | Comments to industry |
|--|--|--|
| <p>Dangerous incident IncNot0047433 Underground metals mine Roads or other vehicle operating areas</p> | <p>A load haul dump (LHD) lost traction while going down a 1:4 drift and travelled for about 150 m - unable to stop. The LHD collided with the rib and conveyor structure along the way.</p> | <p>The Resources Regulator is concerned in the increasing number of lost traction incidents.</p> <p>Operators are reminded that they must operate vehicles at a speed that is appropriate to the prevailing conditions. Engineering controls that minimise the risk of loss of control should be considered, including the use of speed-limiting devices, speed monitoring and alarms.</p> |

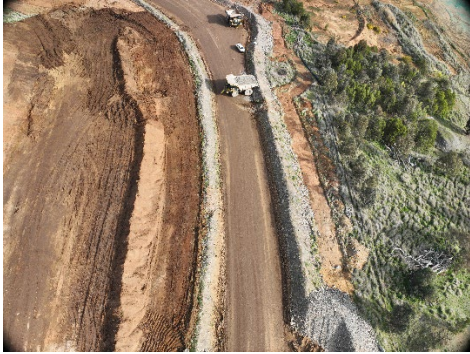
| Incident type | Summary | Comments to industry |
|--|--|--|
| <p>Dangerous incident IncNot0047438 Metals processing</p> | <p>A loaded haul truck slid on a wet surface (slight downhill gradient) and contacted the windrow. The haul road is a designated single lane area. An empty truck was waiting at the end of the single lane section which was</p> | <p>Refer to incident above.</p> |

| Incident type | Summary | Comments to industry |
|--|--|---|
| Roads or other vehicle operating areas | approximately 50 m from where the truck came to a stop. The slide was approximately 30 m. | |
